Cultural Heritage Evaluation Report (CHER) and Heritage Impact Assessment (HIA)

Bridge 34/B-T9 (Bridge Street Bridge) Township of Wilmot, Regional Municipality of Waterloo

October 20, 2020 revised June 28, 2021

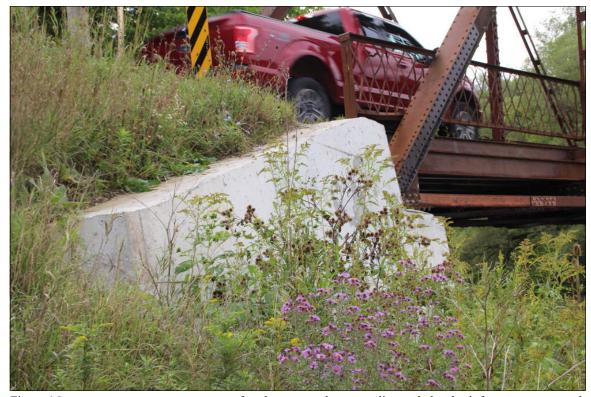
Figure 16

refaced concrete abutment, diagonal chord reinforcement, east end

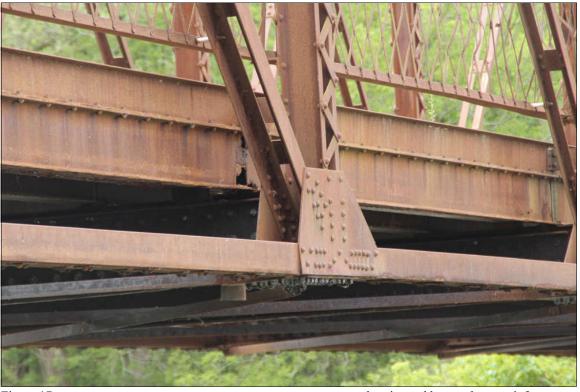
Figure 17

deteriorated beams, beam reinforcement

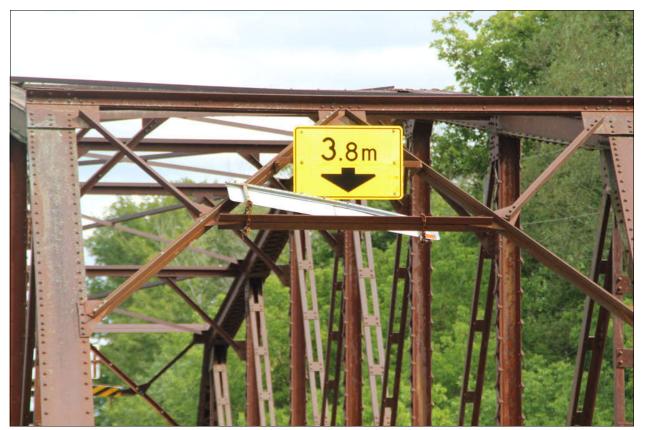
Figure 18

west portal - maximum height 3.8 metres

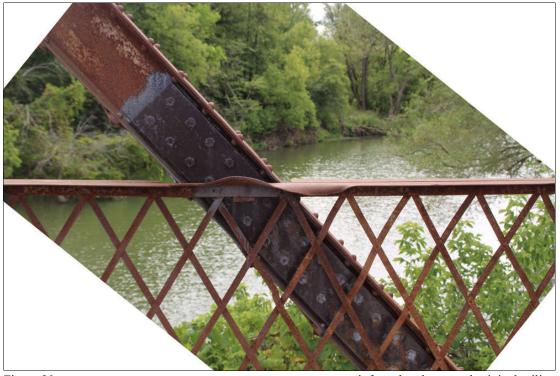
Figure 20

reinforced end post and original railing

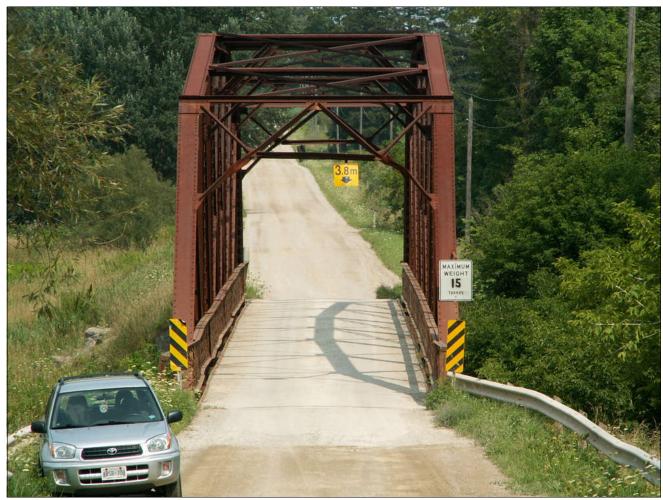
west approach - Nathan Holth 2006, HistoricBridges.org

Figure 19 is a 2006 photograph that shows the weight limit at 15 tonnes versus today's 11 tonnes and also shows a gravel surfaced Bridge Street in 2006.

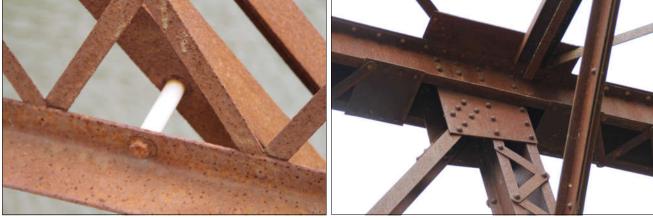
Figure 20 railing standoff Figure 21 top chord connection

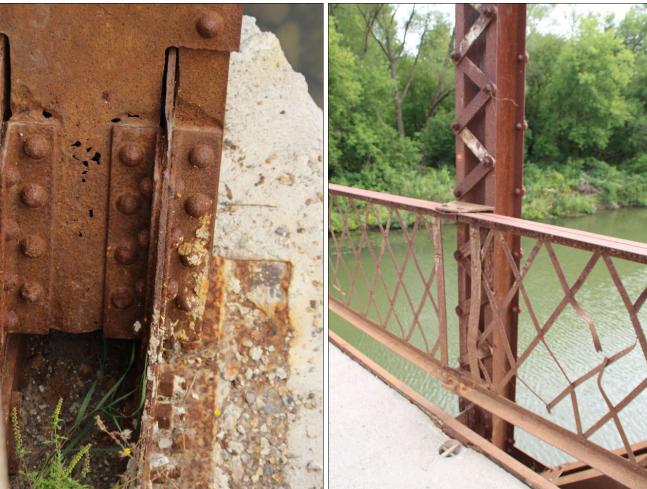
Figure 22 deteriorated end post to abutment connection Figure 23

V-laced vertical member & damaged railing

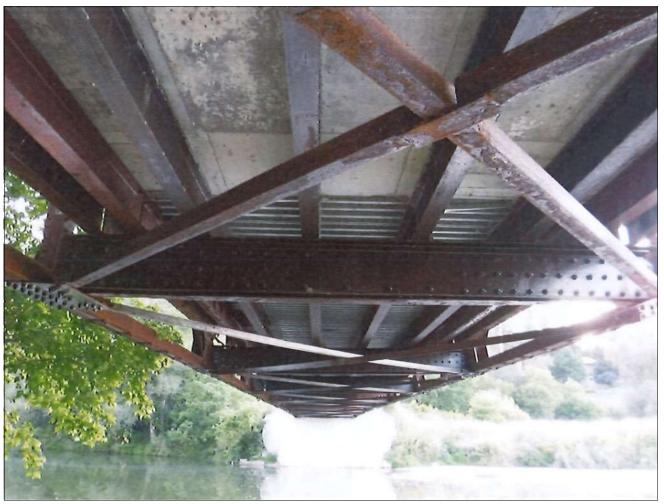
Figure 28

underside of bridge showing extensive repairs - K. Smart Associates photo

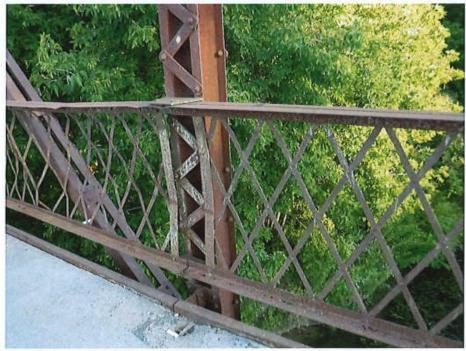
Photo 6:

- Barriers (Railing Systems) Existing railing system is substandard and should be replaced with a code compliant railing system; Medium corrosion; Bent top and bottom rails; perforations at bottom rail; Missing rivets; Broken, bent and twisted lattice

- Barriers (Posts) Existing railing system is substandard and should be replaced with a code compliant railing system; Posts are connected to truss; Loose; Twisted

Substandard railing system over structure

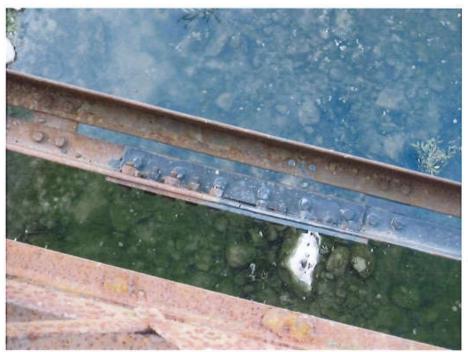
- Trusses/Arches (Top Chords) Light to severe corrosion; Perforations
- Trusses/Arches (Bottom Chords) Medium to severe corrosion; Gravel accumulation; Repairs noted

Photo 7: Repairs at bottom chord

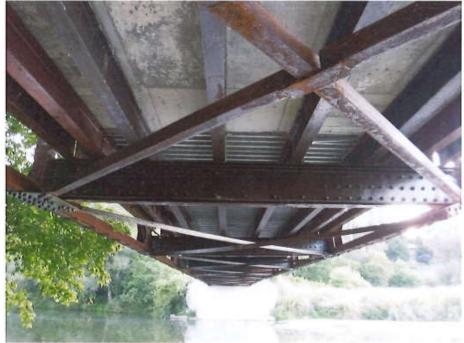
Photo 8: Underside of structure

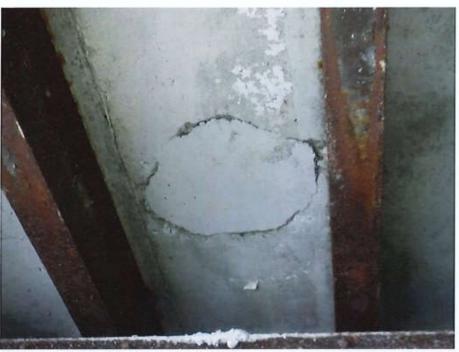
- Decks (Soffit/Thin Slab) Localized Wide Cracks; Delamination; Severe corrosion at ends of deck
- Beams/Main Longitudinal Elements (MLE's) (Floor Beams) Medium to severe corrosion and section loss; Perforations at west floor beam; Floor beams ends have all been previously repaired, and some floor beams replaced

Photo 9: Severe delamination at soffit interior

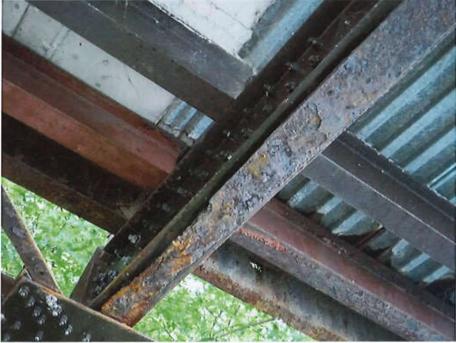
Photo 10: Repairs at floor beam

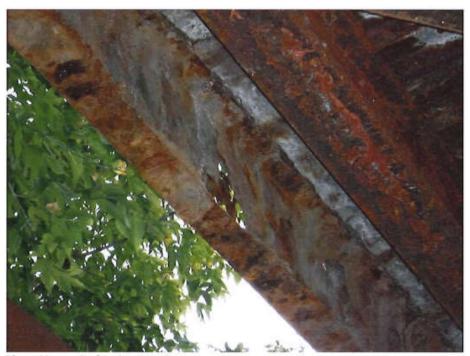
- Beams/Main Longitudinal Elements (MLE's) (Stringers) Exterior stringers repaired with new stringers; Medium corrosion; Exterior stringers connected to channel on deck level which is loose and moving

Photo 11: Perforations at stringer

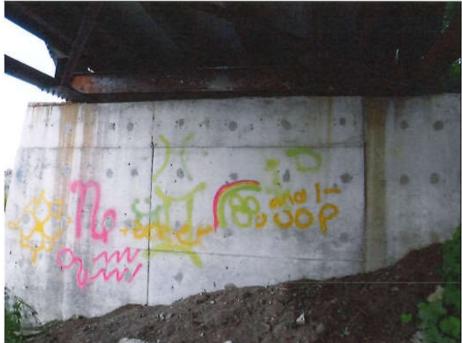
Abutment wall Photo 12:

- Abutments (Bearings) Covered with vegetation and debris; Severe corrosion; Seized bearings; Jammed joint
- Abutments (Abutment Walls) Localized wide crack at bearing seat; Construction joint misaligned up to 20 mm at west abutment; Stains at bearing seat locations at west abutment
