**BRIDGE 34/B-T9
(BRIDGE STREET BRIDGE)**

TOWNSHIP OF WILMOT

**JANUARY 2022
REVISED APRIL 2022**

FILE NO. 20-145

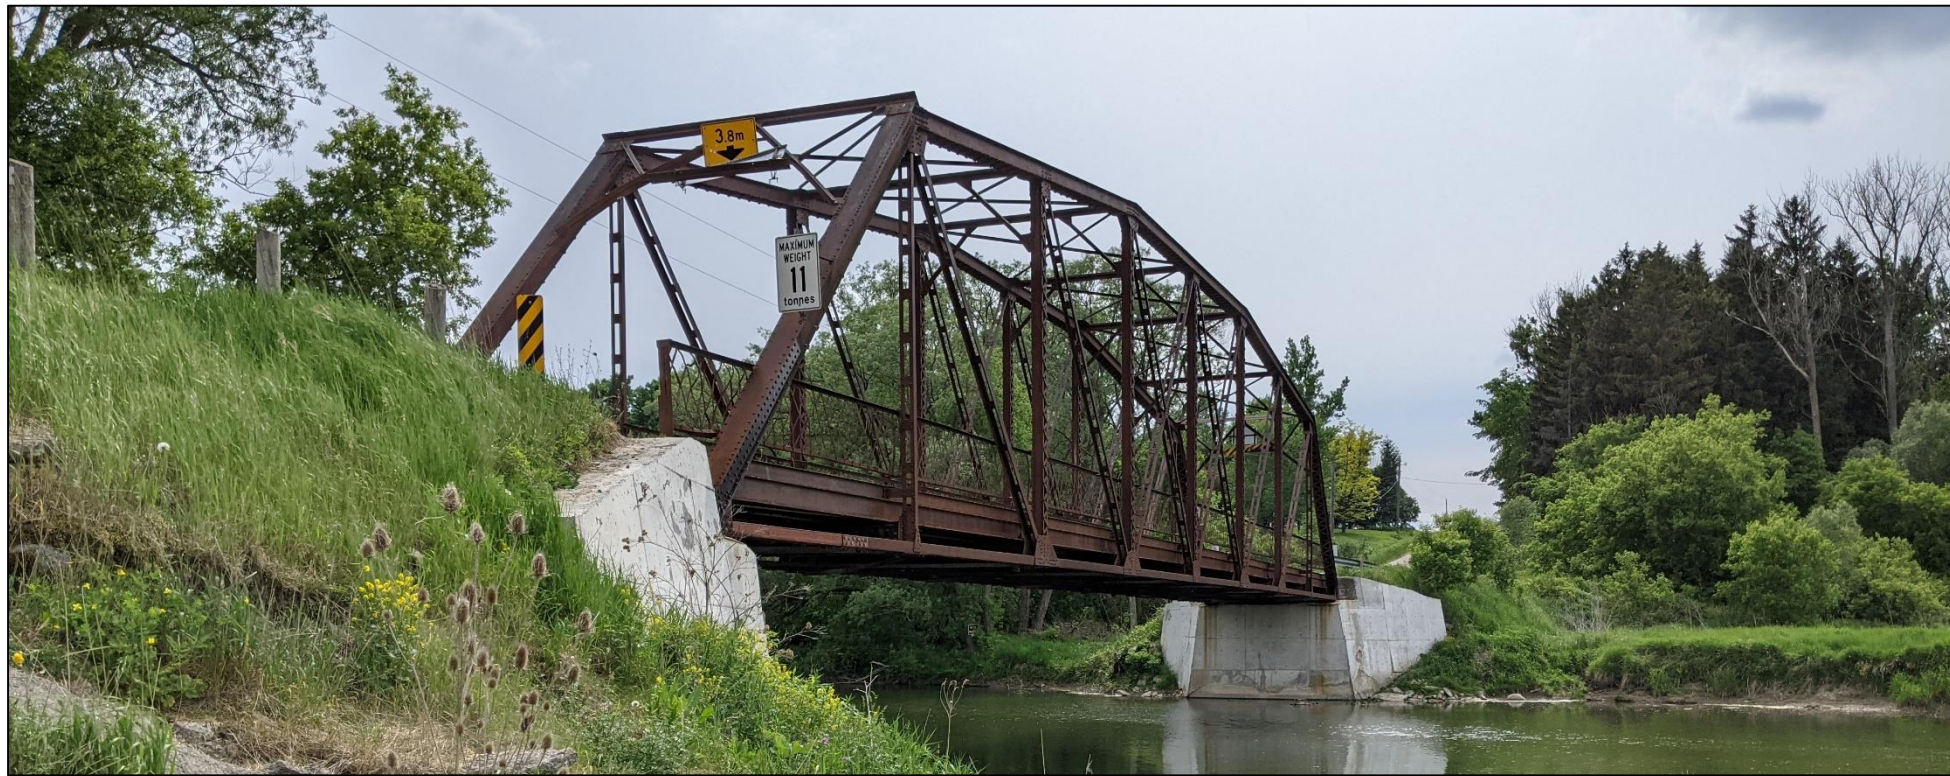
North / Upstream Elevation (looking south)

- › **Bridge Street Bridge spans the Nith River on Bridge Street between Tye Road and Puddicombe Road.**
- › **Bridge Street Bridge is in overall poor condition and nearing the end of its useful life. In addition, it is deficient in width, vertical clearance, and loading capacity.**
- › **The study is being completed as a Schedule ‘B’ project, following the Municipal Class Environmental Assessment (October 2000, as amended)**
- › **The Municipal Class EA provides a decision-making process to ensure that all relevant engineering and environmental features are considered in the planning and design of municipal infrastructure. The process requires public and agency involvement.**

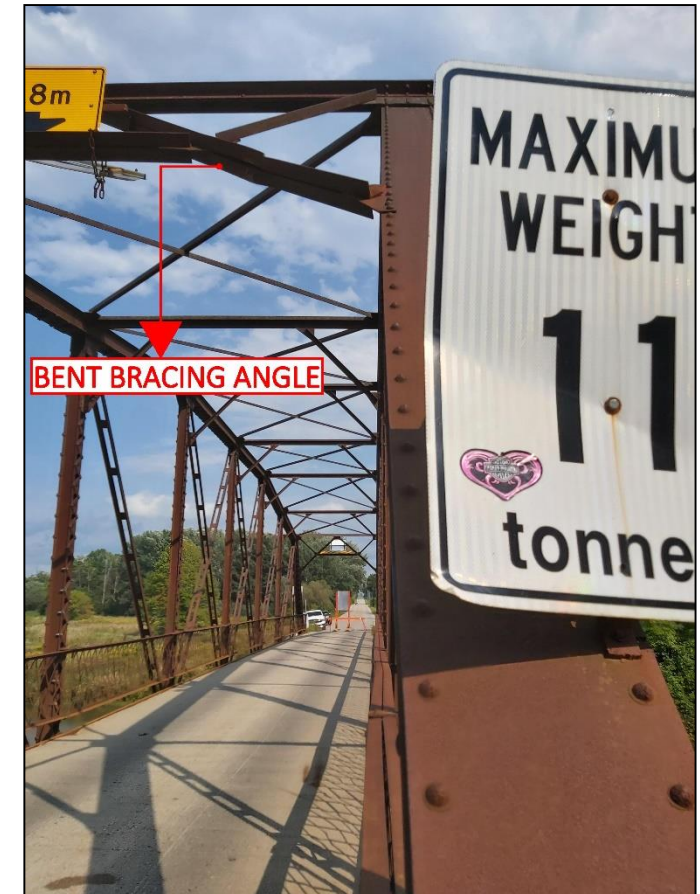
The latest road closure started from mid-September 2021 due to vehicular collision with the overhead bracings. Note one of the bent bracing angles in picture above.

- ▶ **During the last 10 years, this bridge has been closed multiple times. This averages to almost 1 closure per year.**
- ▶ **The overhead bracing (portal bracing) is routinely struck by vehicles. This results in the need for frequent repairs to this element.**
- ▶ **Despite the numerous repairs completed over the last 15 years, every year more of the original remaining bridge continues to deteriorate. It is not sustainable to continually repair this bridge.**

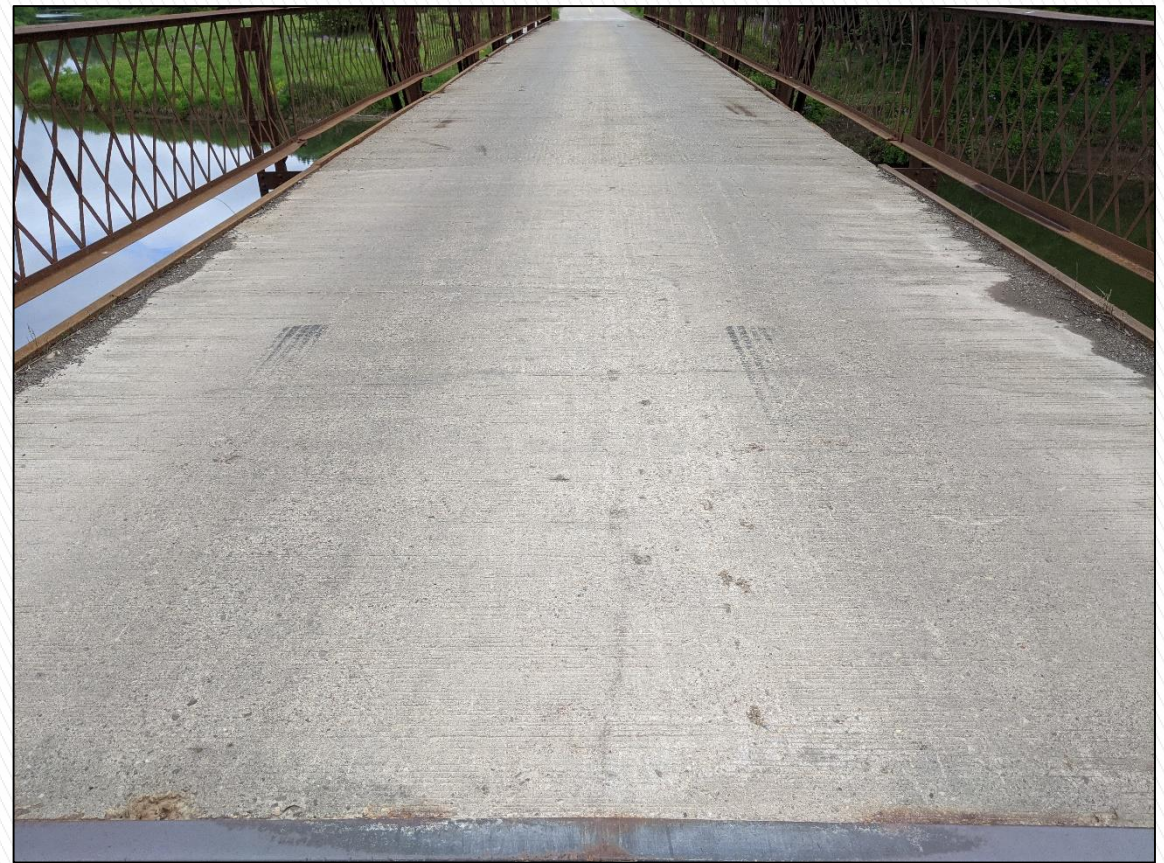
Deck Surface

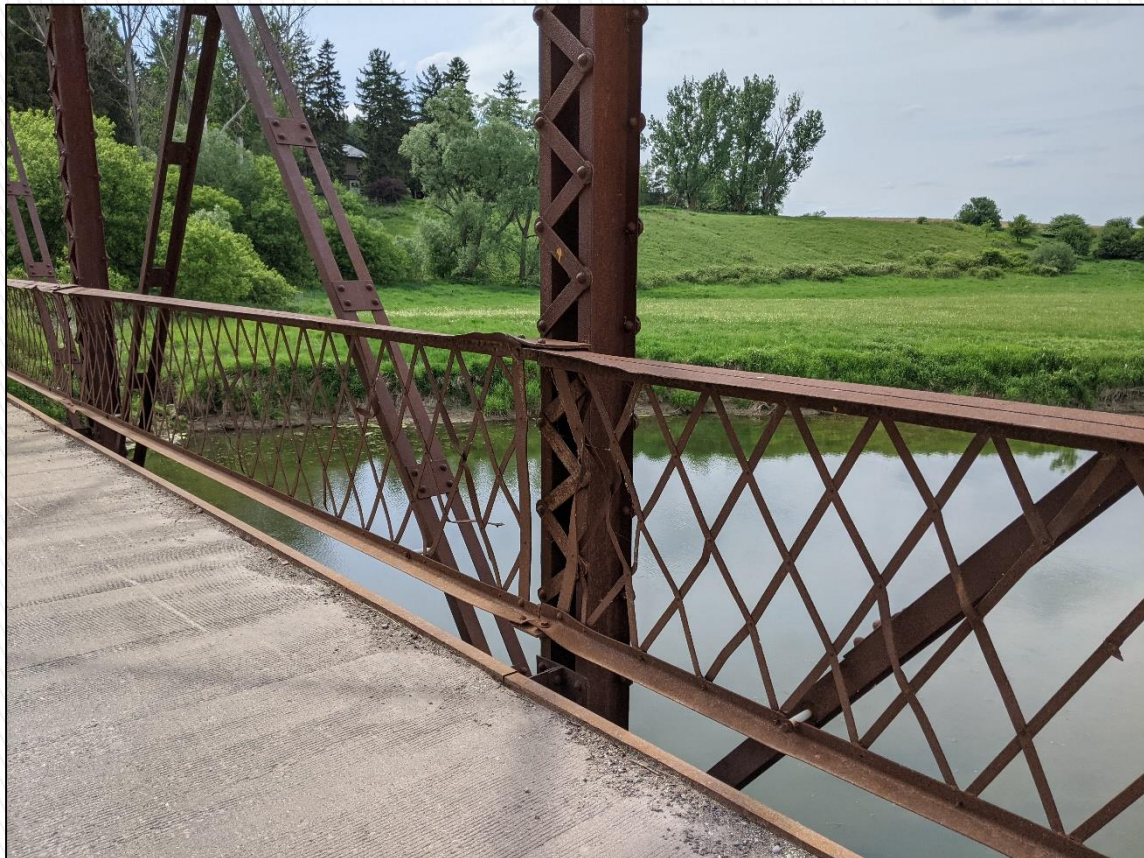
Typical Railing

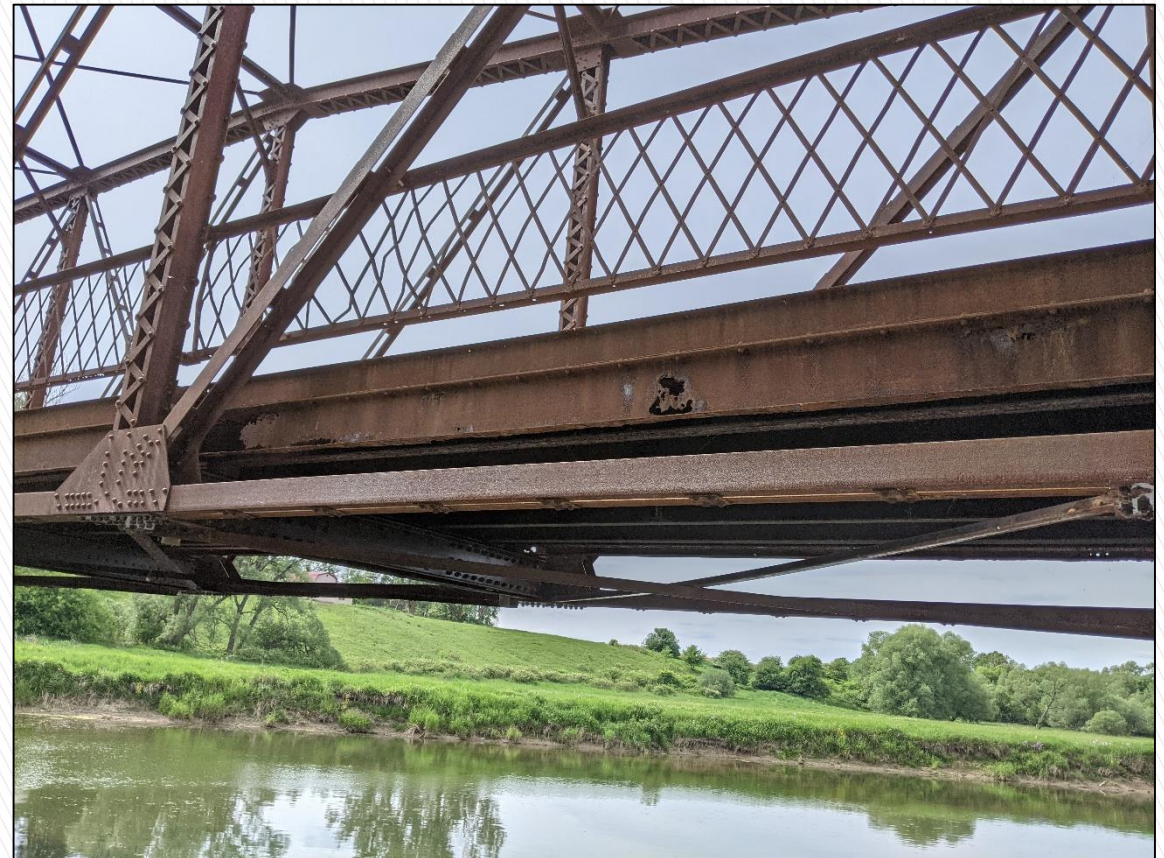
Typical Perforated Stringer

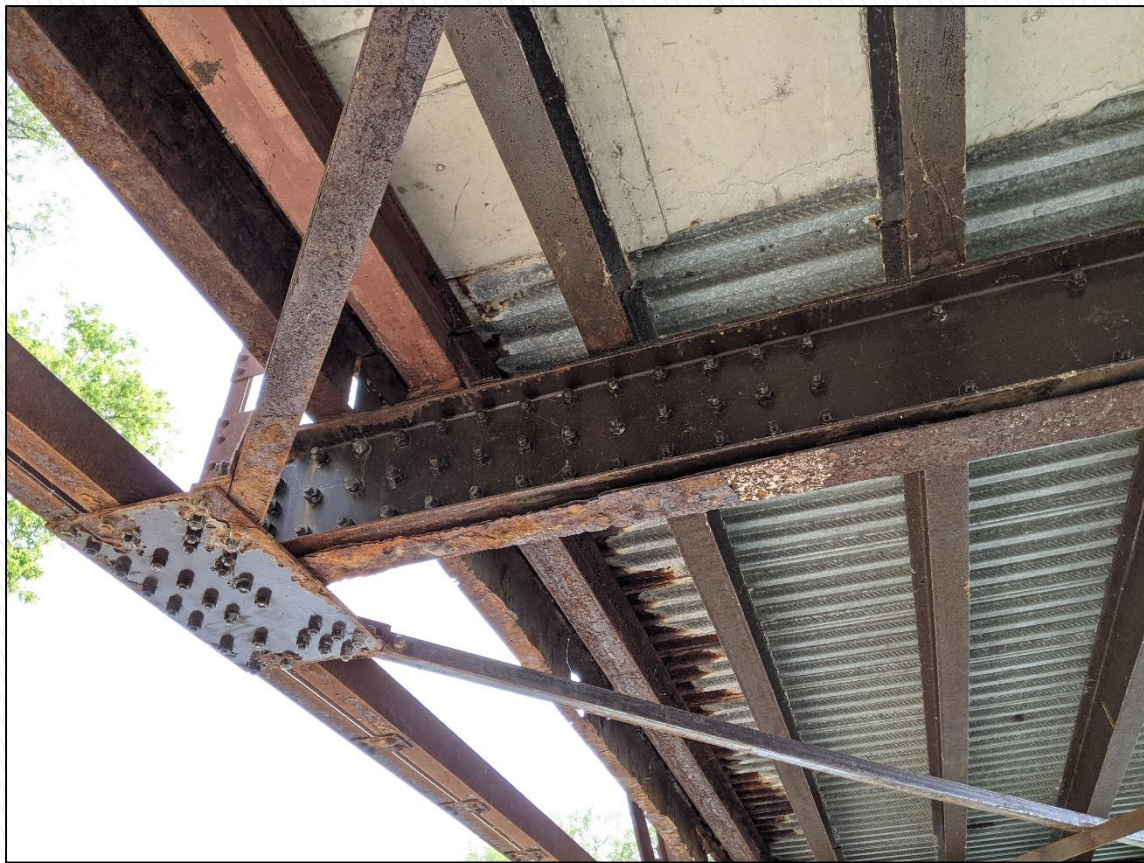
Typical Repaired Floor Beam

- All floor beams are severely rusted with perforations and loss of material. Remainder of floor beams exhibit medium to severe rusting with section loss. The severe corrosion at the ends of all beams were repaired in 2005 and 2011.
- Exterior stringers are severely rusted with perforations and loss of material. One outside stringer web has completely disintegrated at end for a distance of 600mm \pm (2nd from east at south side). New stringers were placed next to the outside stringers (sistered) in 2011.
- Inside stringers exhibit medium surface rust.

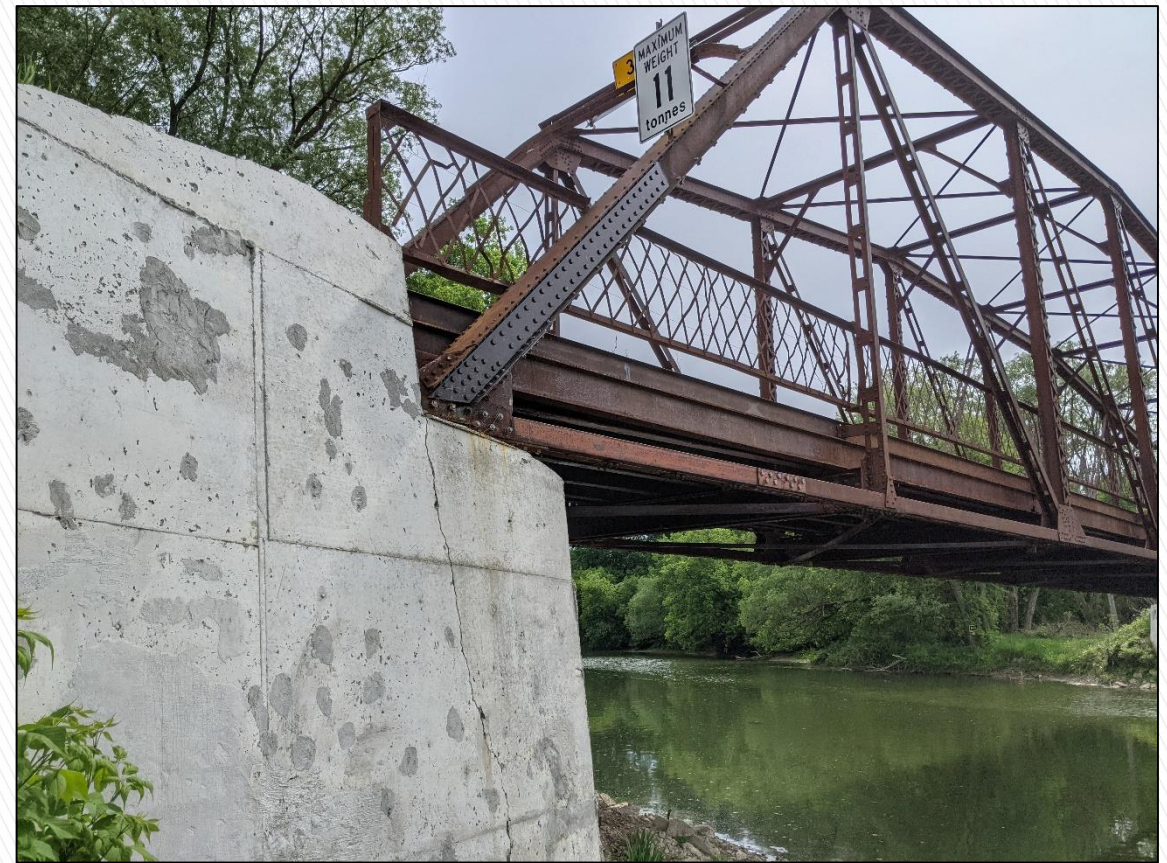
Typical Repaired Truss Chord

The structure underwent several rehabilitations since 1982. The 1982 rehabilitation included repairs to the abutments and the placement of new concrete deck. In 2006 and 2011 rehabilitation included the repairs of all floor beams, placement of new stringers on the outer edges and repairs to the truss bottom chords at the four ends.

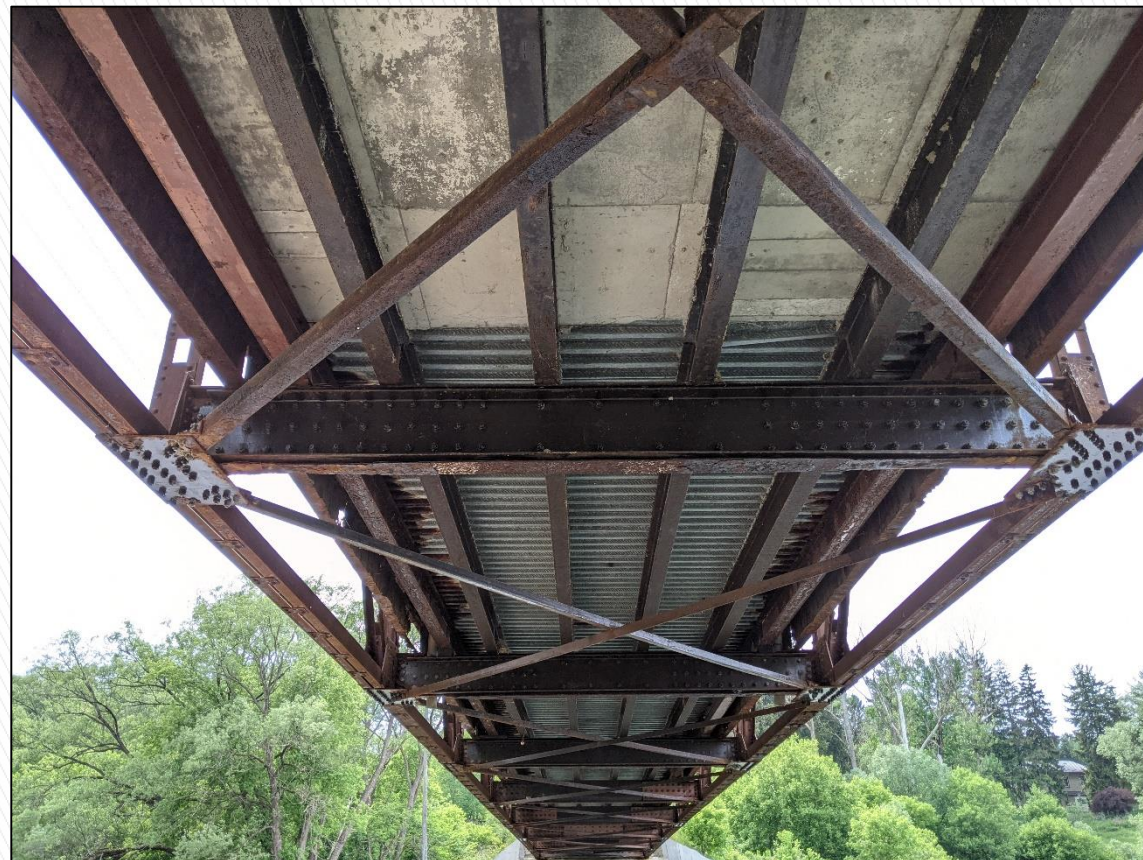
Typical Soffit

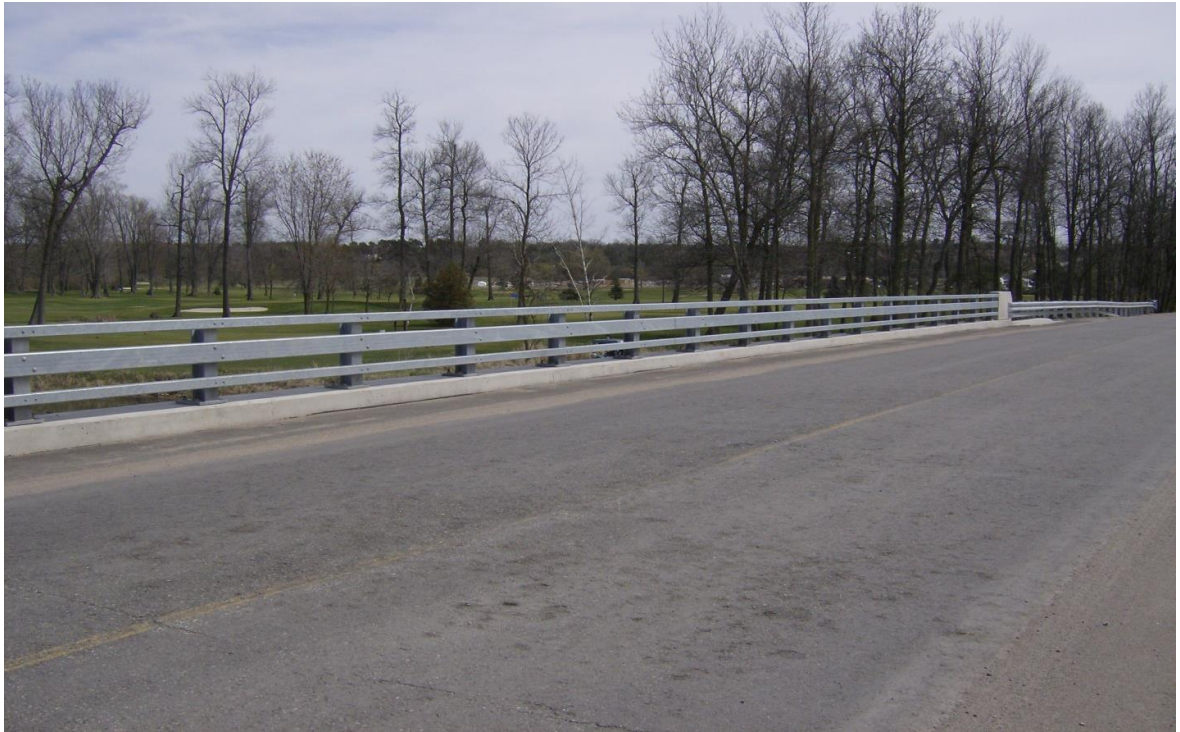
Railing Option 1 – Steel Box Beam

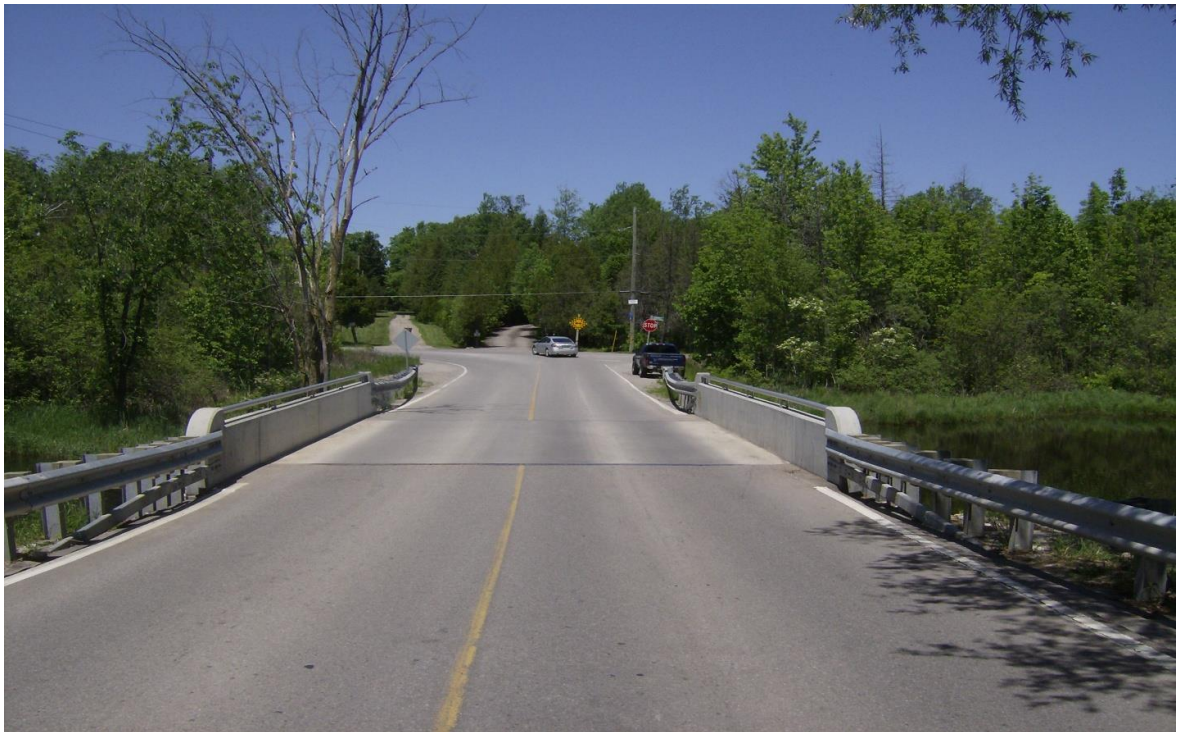
Railing Option 2 – Concrete Parapet Wall with Steel Railing

Style 2 – Concrete Parapet Wall With Steel Railing (Picture 2)

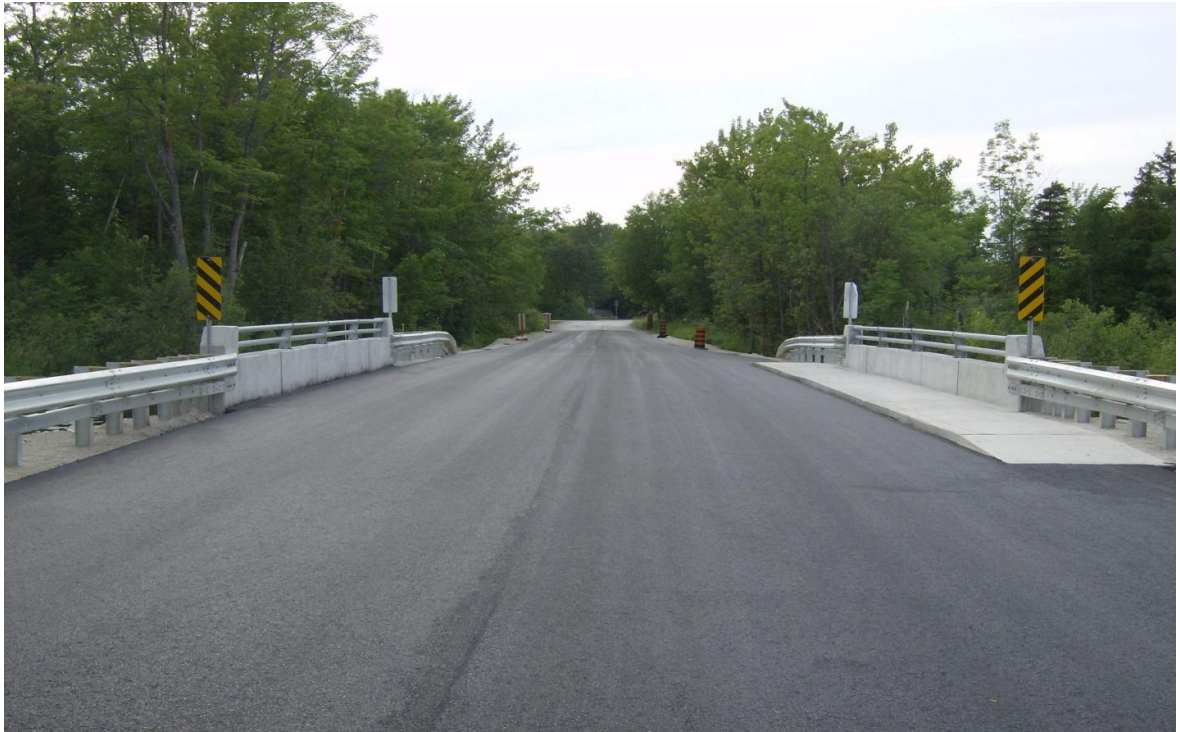
Railing Option 3 – Concrete Parapet Wall with Double Tube Railing

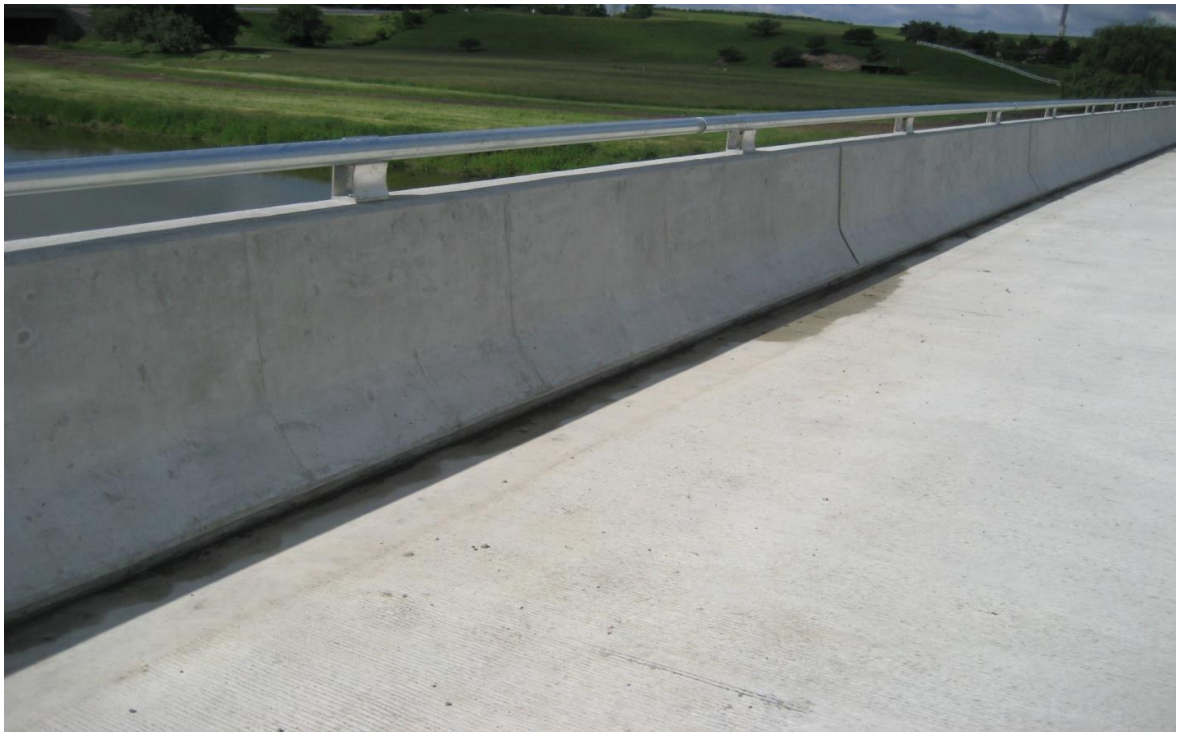
Railing Option 4 – Safety Shape Barrier with Steel Railing (New Jersey Style)

Style 4 –Safety Shape Barrier with Steel Railing (New Jersey Style) (Picture 4)

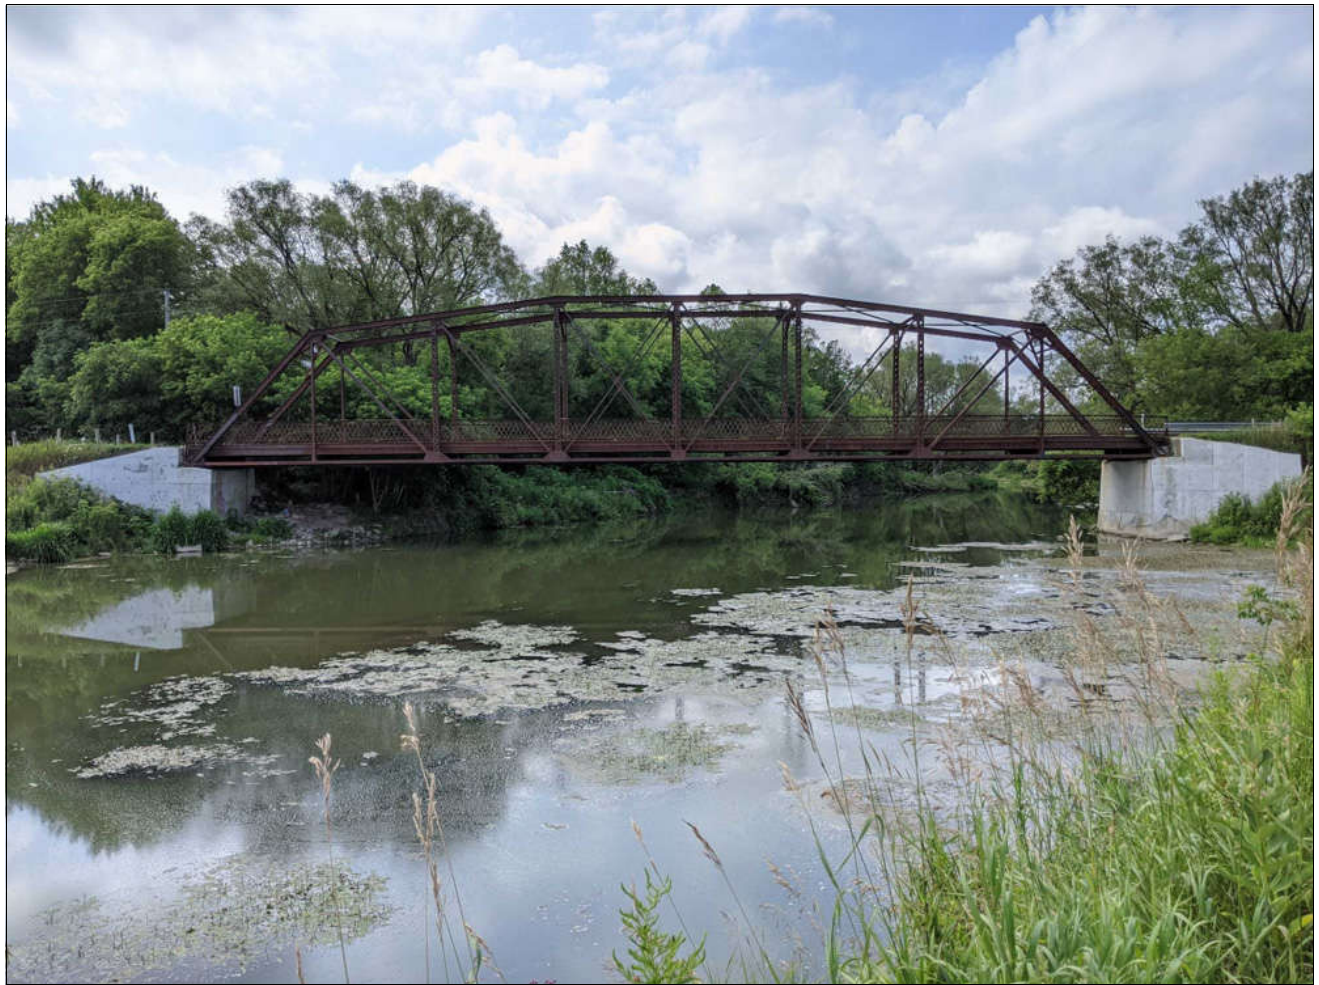
Figure 4

Bridge Street Bridge looking south - K. Smart & Associates photo

The Bridge Street Bridge (Figure 4) is an eight-panel, riveted, single-span, 46 m long x 4.08 m wide, Parker (camelback) truss bridge with a clearance height of 3.8 metres. It was built by the Hamilton Bridge Company in 1913. The Bridge Street Bridge - 1913, is part of a group of steel truss bridges in Wilmot Township. The other bridges are Shade Street Bridge - 1953, Hartman Bridge - 1936 - (Part V designated *OHA*), Holland Mills Bridge -

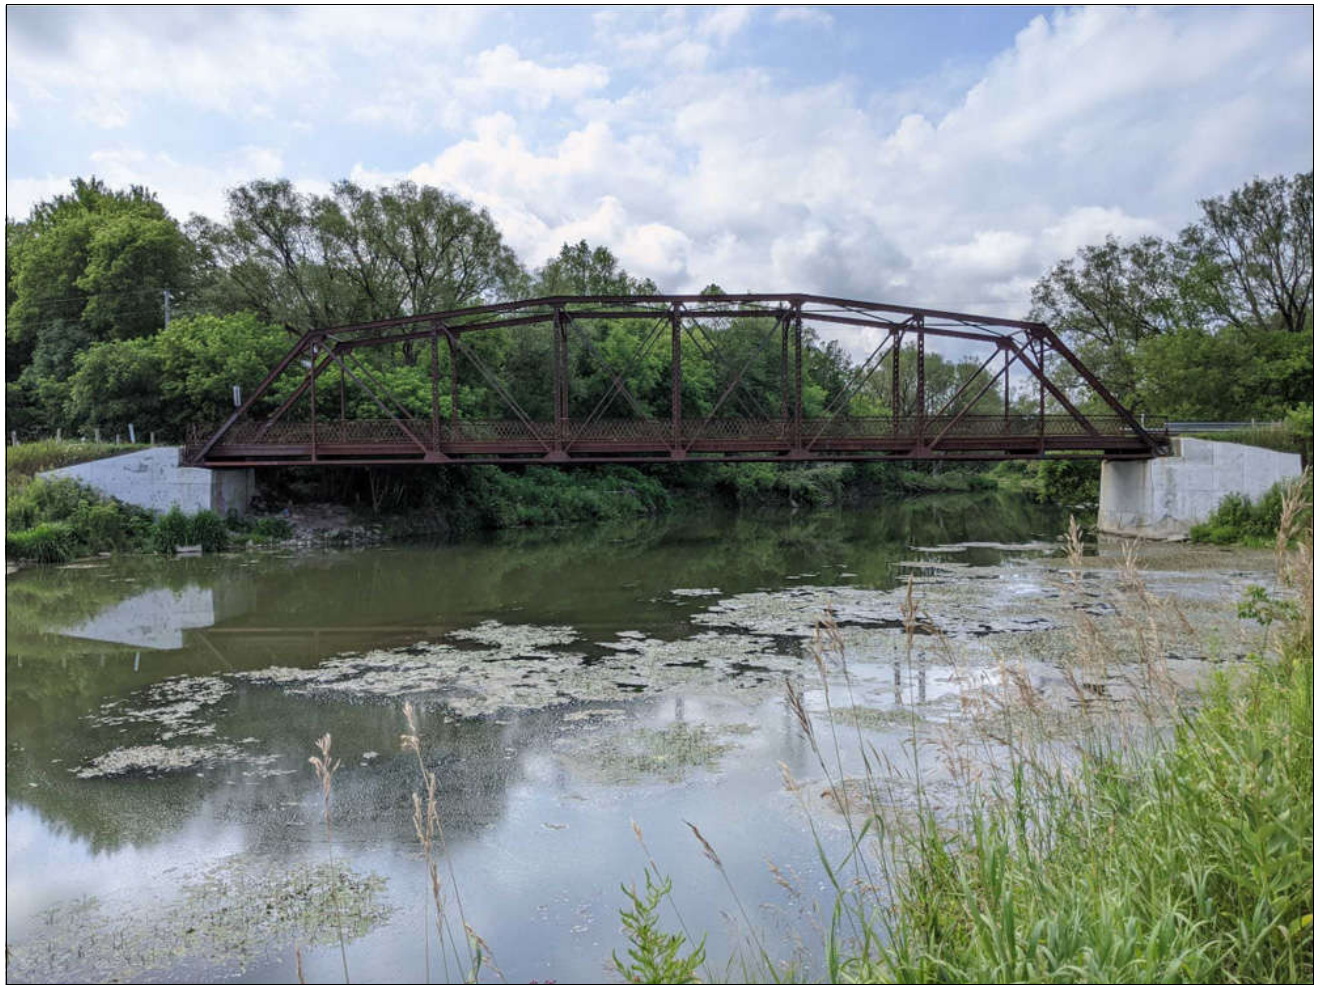
Figure 11

Bridge Street Bridge looking south - *K. Smart & Associates photo*

The Bridge Street Bridge is an eight-panel, riveted, single-span, 46 m long x 4.08 m wide, Parker (camelback) truss bridge with a clearance height of 3.8 metres. It was built by the Hamilton Bridge Company in 1913.

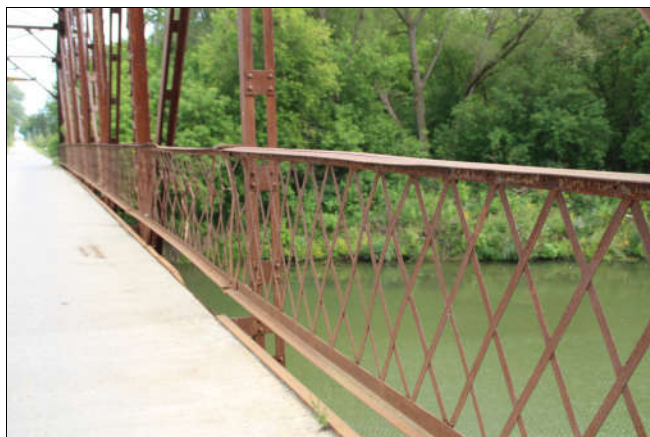
Figure 12

railings Figure 13

The bridge retains its original railings, while its concrete deck is a 1982 replacement of the original and the concrete abutments were refaced in 2018 (Figures 12, 13 & 15).

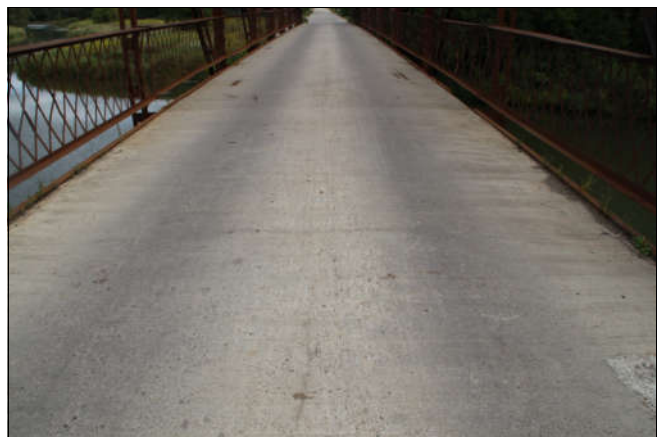
concrete deck

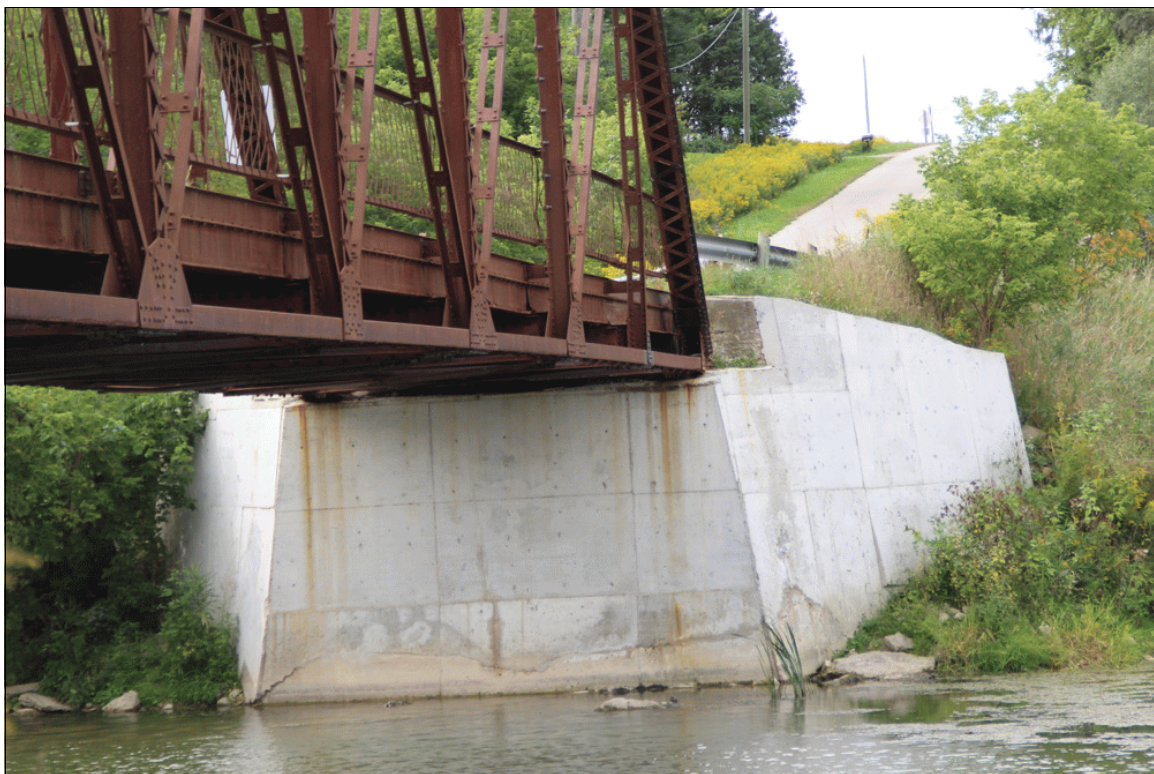
Figure 15 concrete abutment, west end

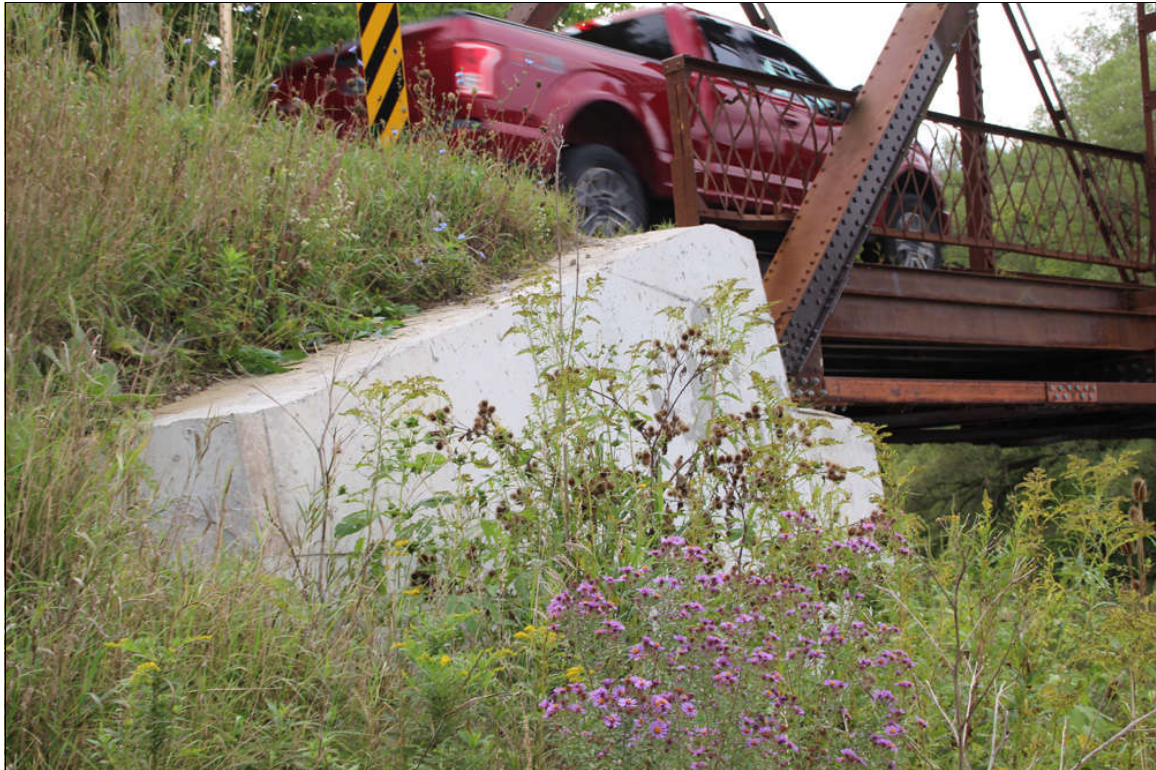
Figure 16

refaced concrete abutment, diagonal chord reinforcement, east end

Over the years, the bridge has been damaged by flood and hurricane (Hazel 1954). In 2018 a tender was issued to effect extensive repairs to the bridge (Appendix 1). The concrete abutments were refaced (Figures 15 & 16); connection plates were replaced, floor beams and chords were reinforced (Figures 16 & 17).

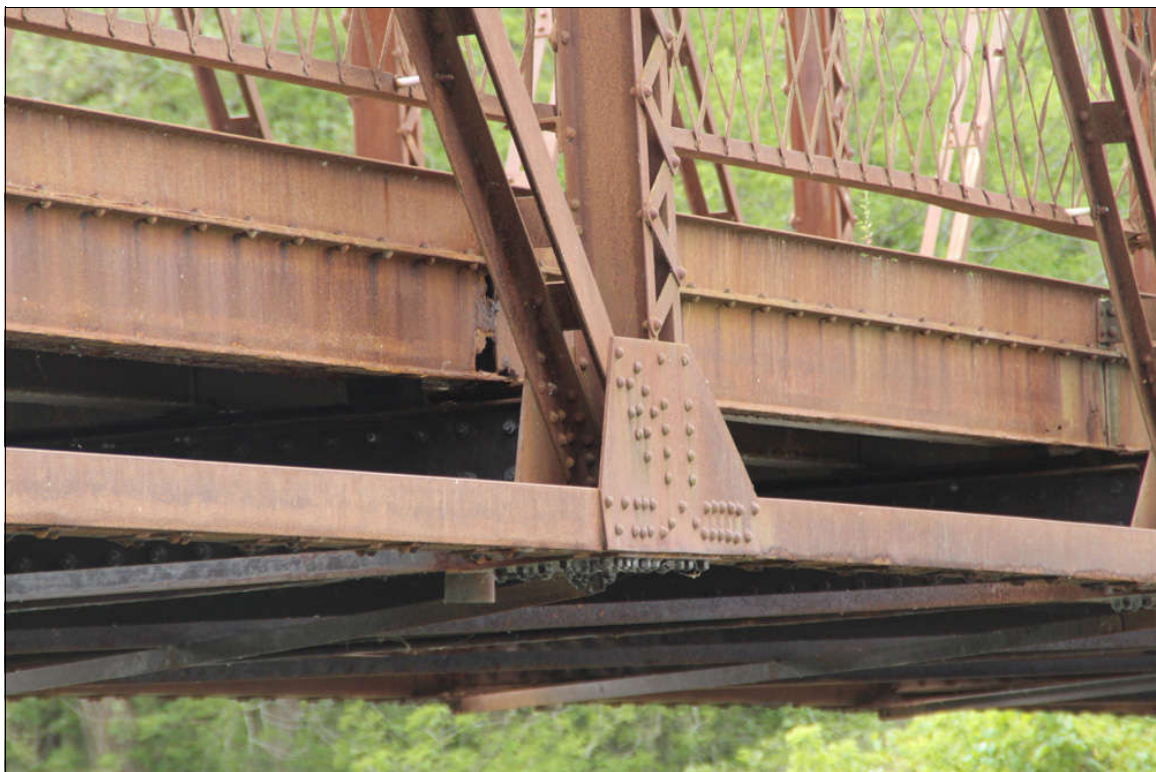
Figure 17

deteriorated beams, beam reinforcement

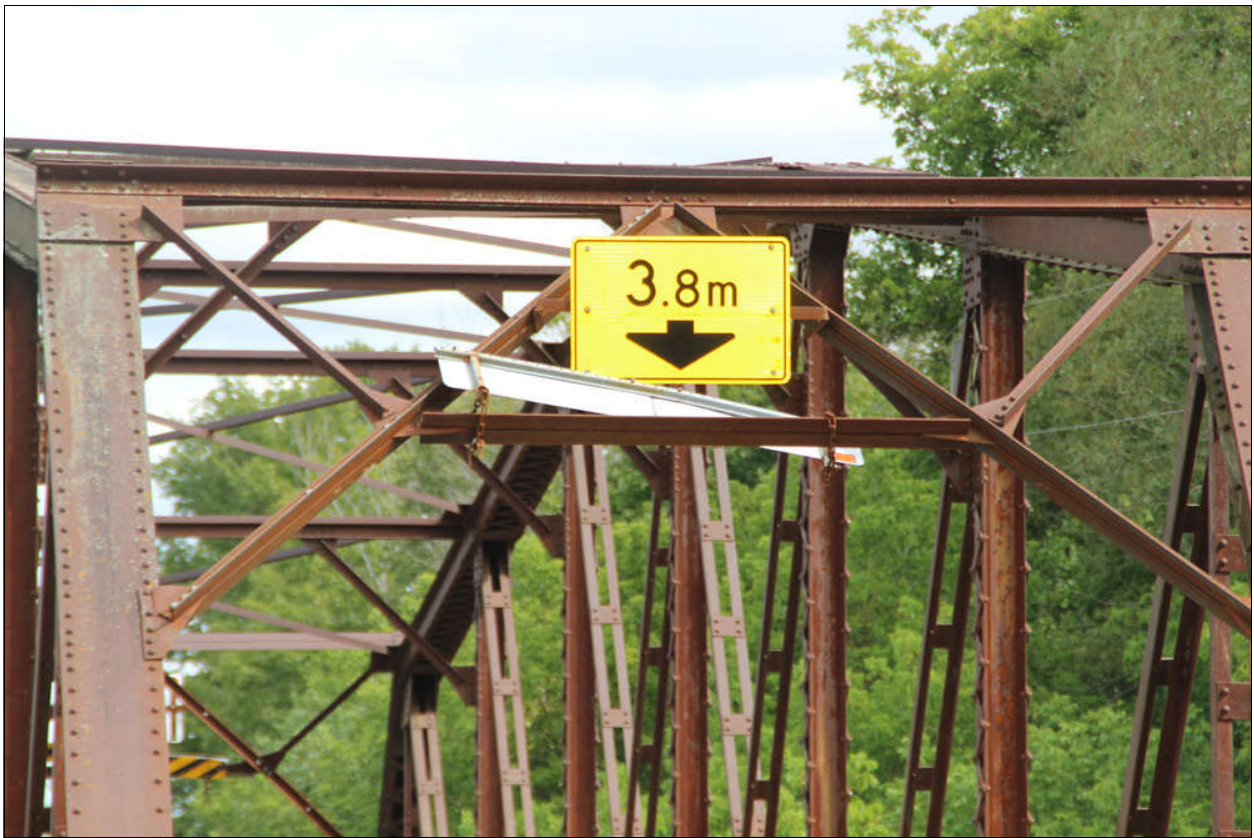
Figure 18

west portal - maximum height 3.8 metres

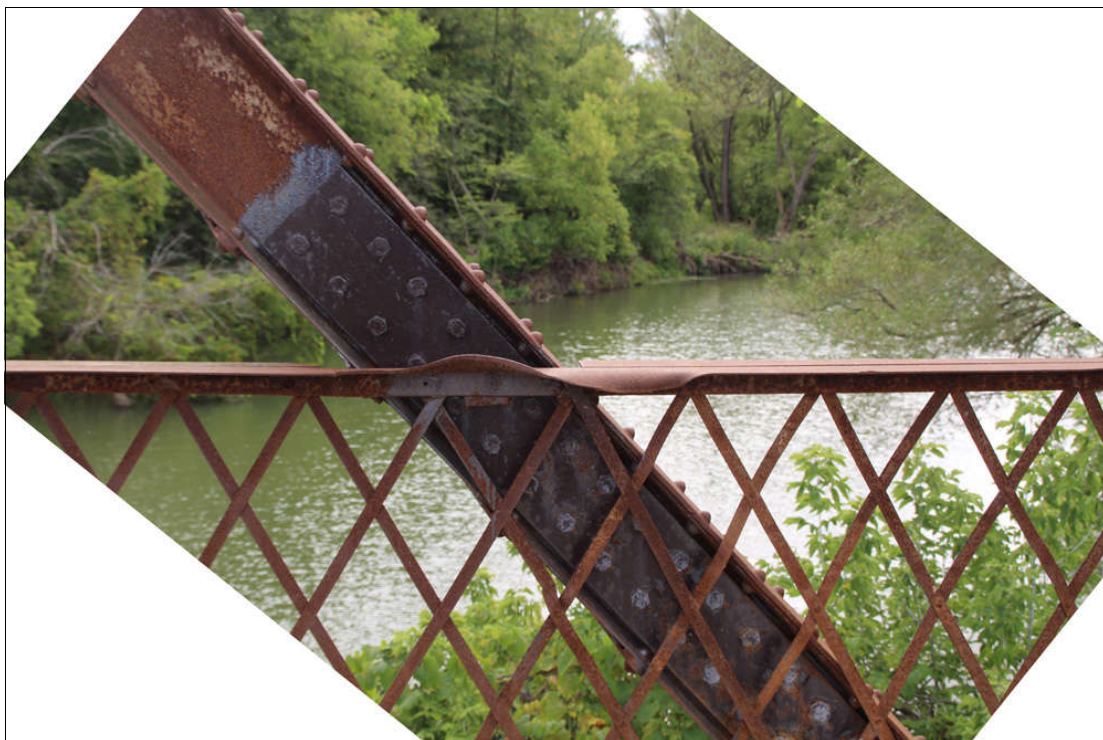
Figure 20

reinforced end post and original railing

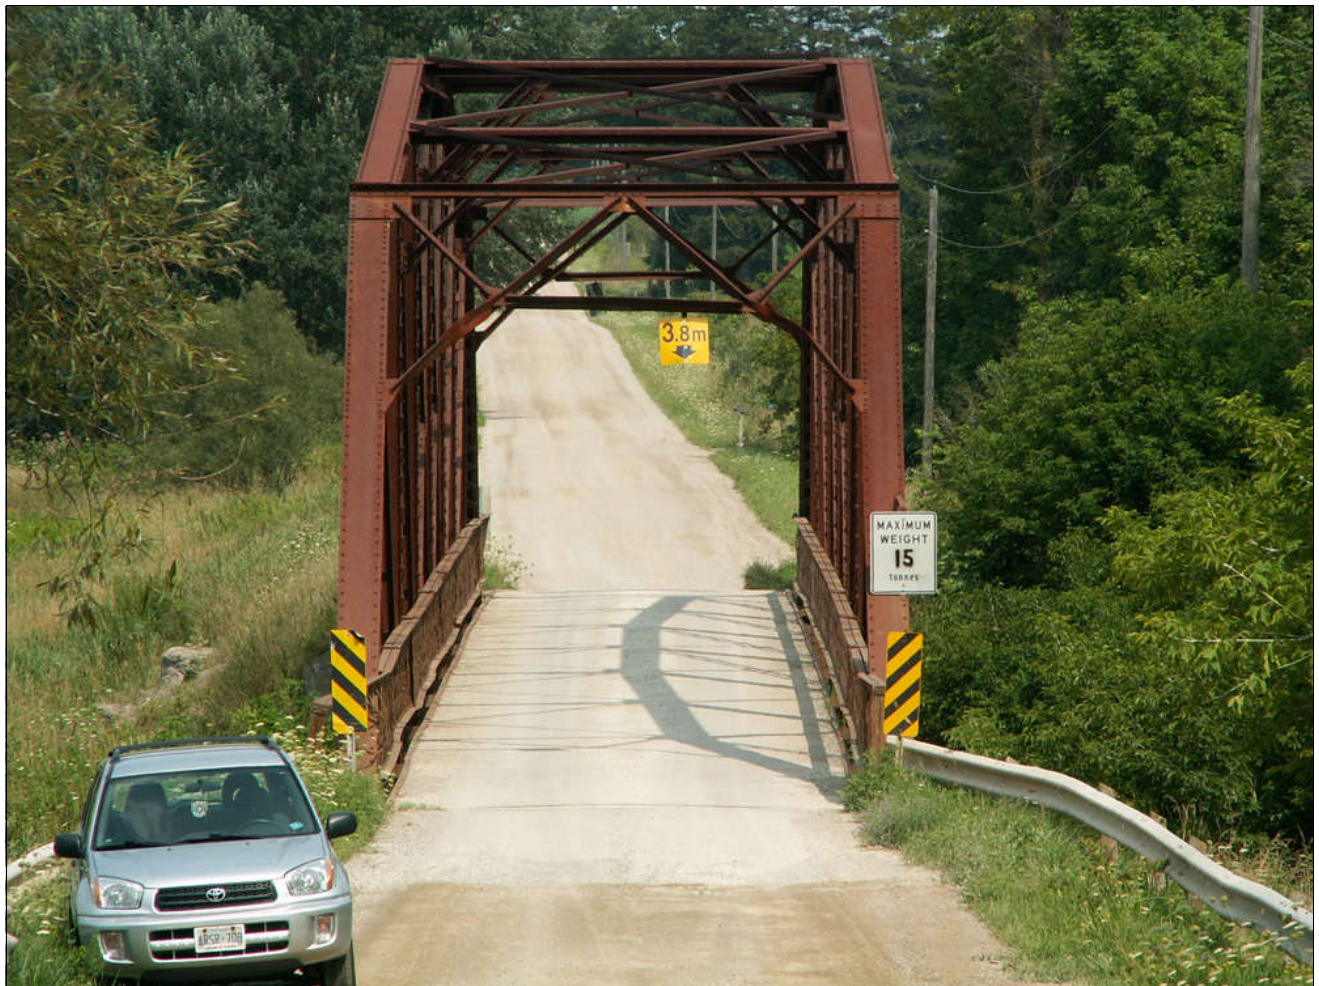
west approach - Nathan Holth 2006, *HistoricBridges.org*

Figure 19 is a 2006 photograph that shows the weight limit at 15 tonnes versus today's 11 tonnes and also shows a gravel surfaced Bridge Street in 2006.

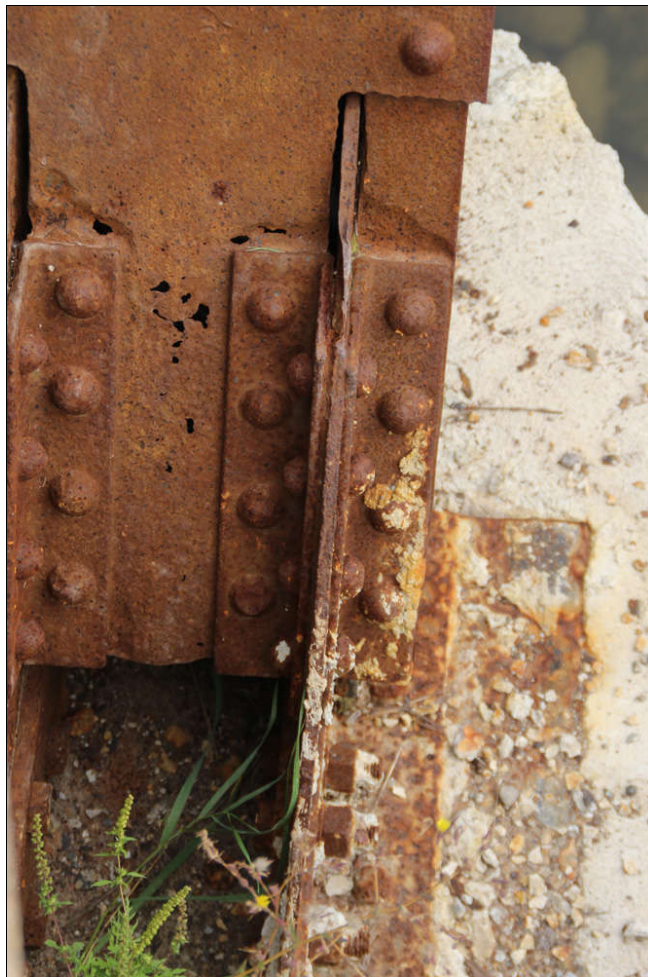
Figure 22 deteriorated end post to abutment connection

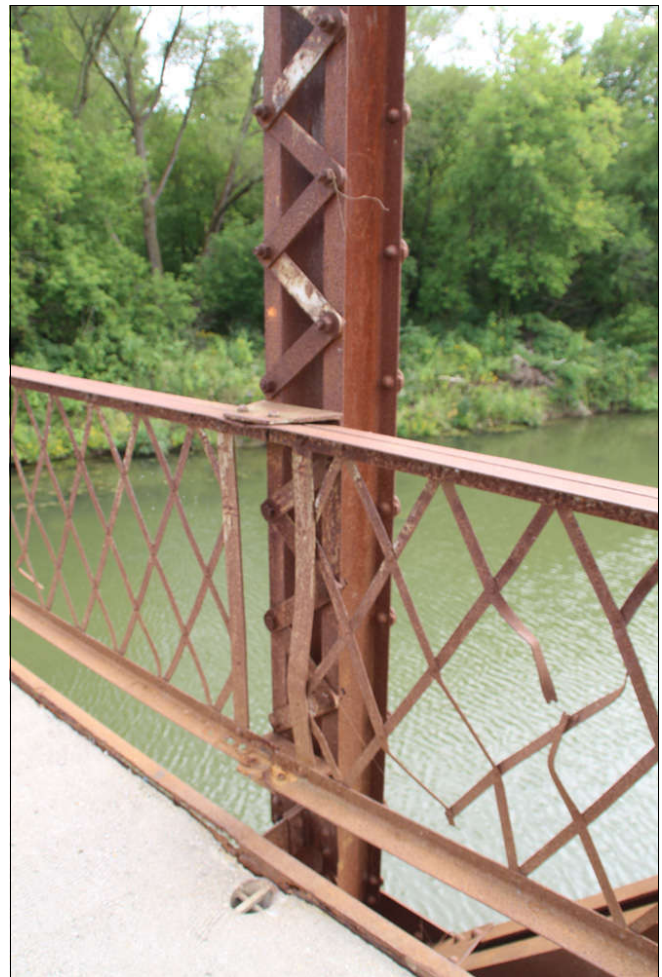
Figure 23 V-laced vertical member & damaged railing
