**BRIDGE 34/B-T9
(BRIDGE STREET BRIDGE)**

TOWNSHIP OF WILMOT

**JANUARY 2022
REVISED APRIL 2022**

FILE NO. 20-145

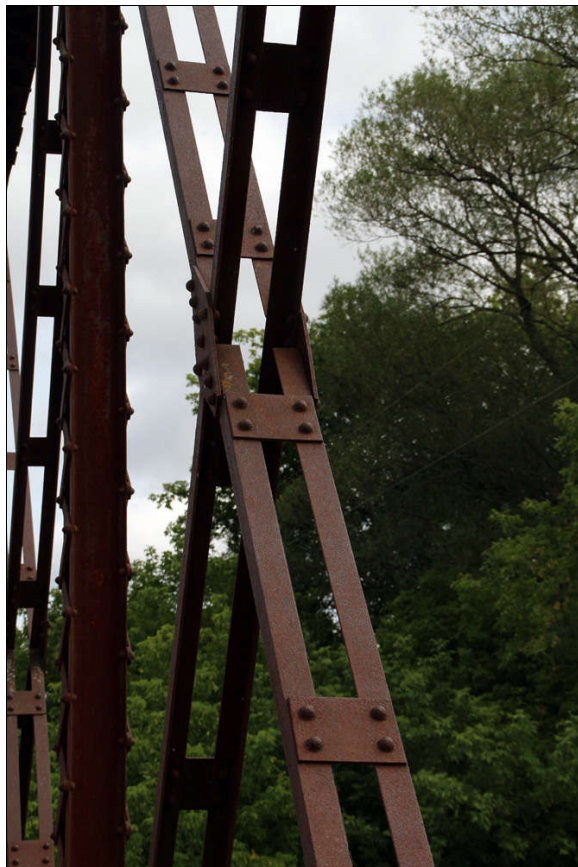
Figure 25 diagonal bracing

Although no builder's name or markings were found by the author; there is documentation that indicates the bridge was built by the Hamilton Bridge Company in 1913¹⁶. The steel is rusty, with a fair amount of perforation which has been reinforced with new steel. Bridge connections are mostly rivets; bolt and nut connections are used to fashion the recent steel reinforcing plates.

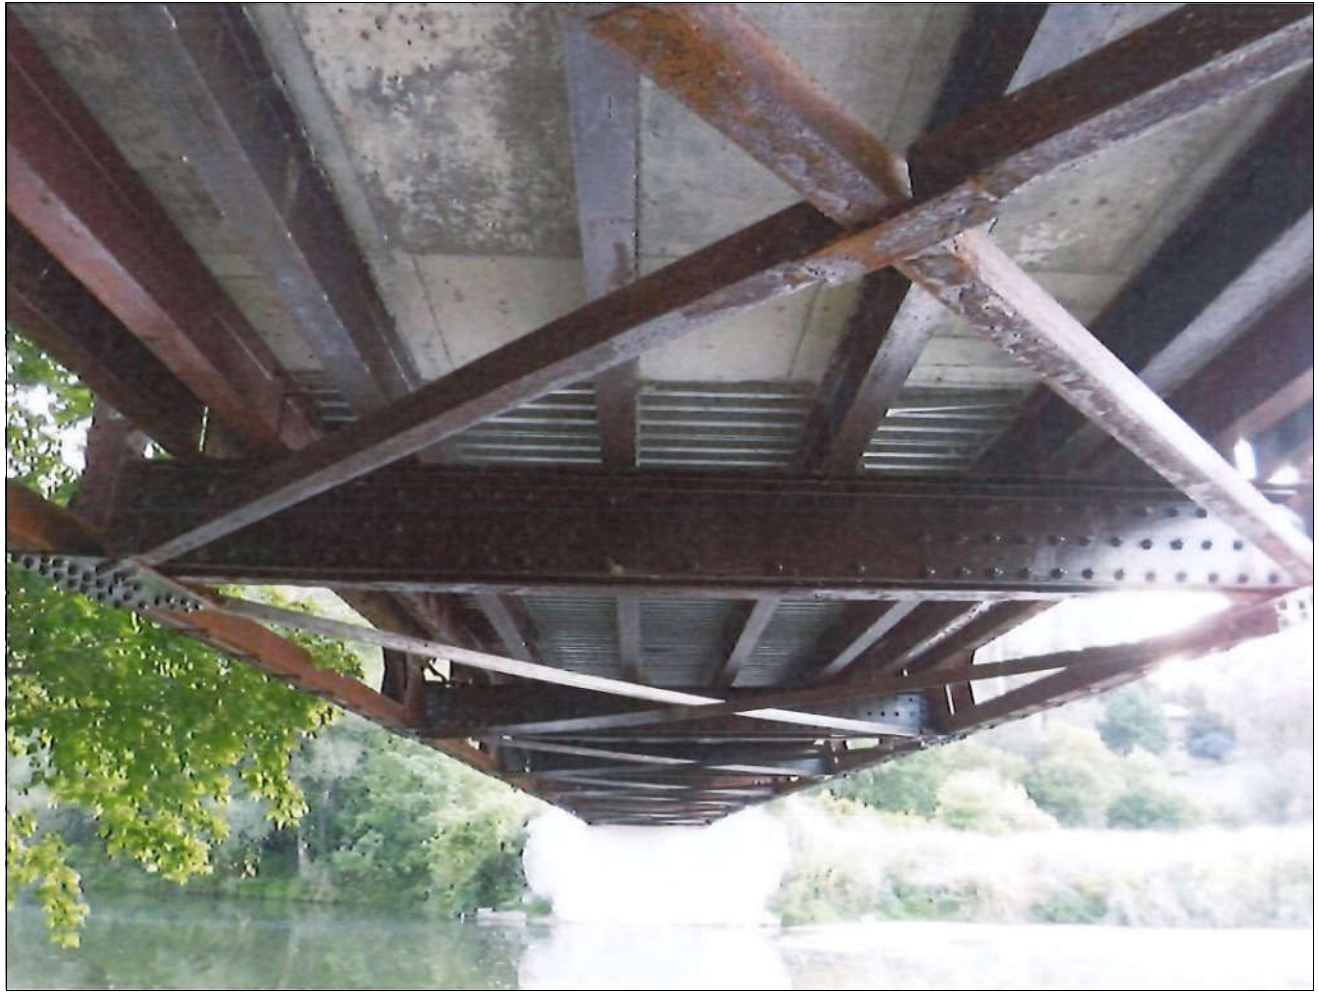
Figure 28 underside of bridge showing extensive repairs - K. Smart Associates photo

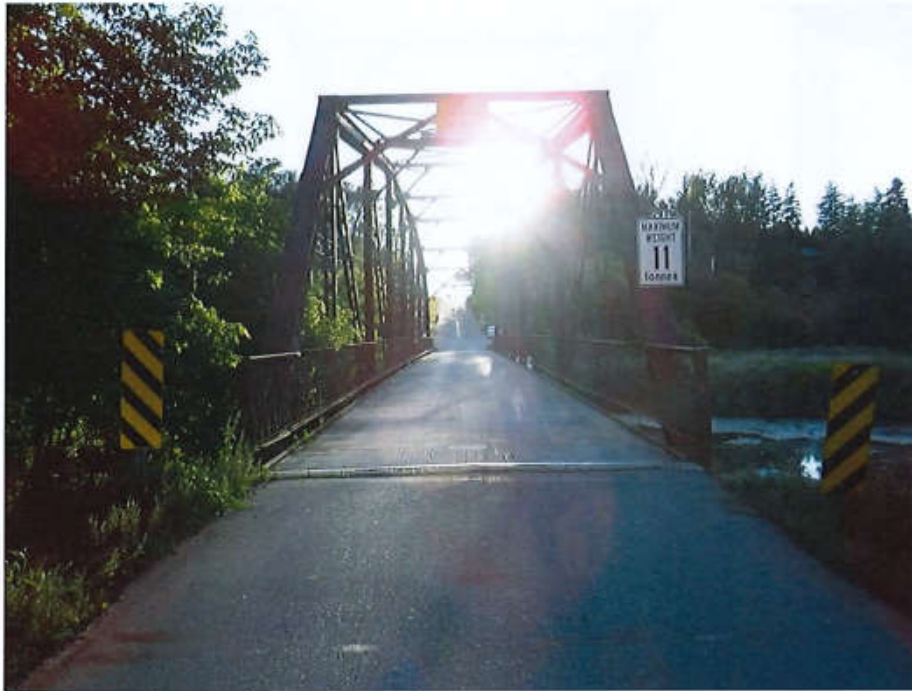
Photo 1: Structure from east approach

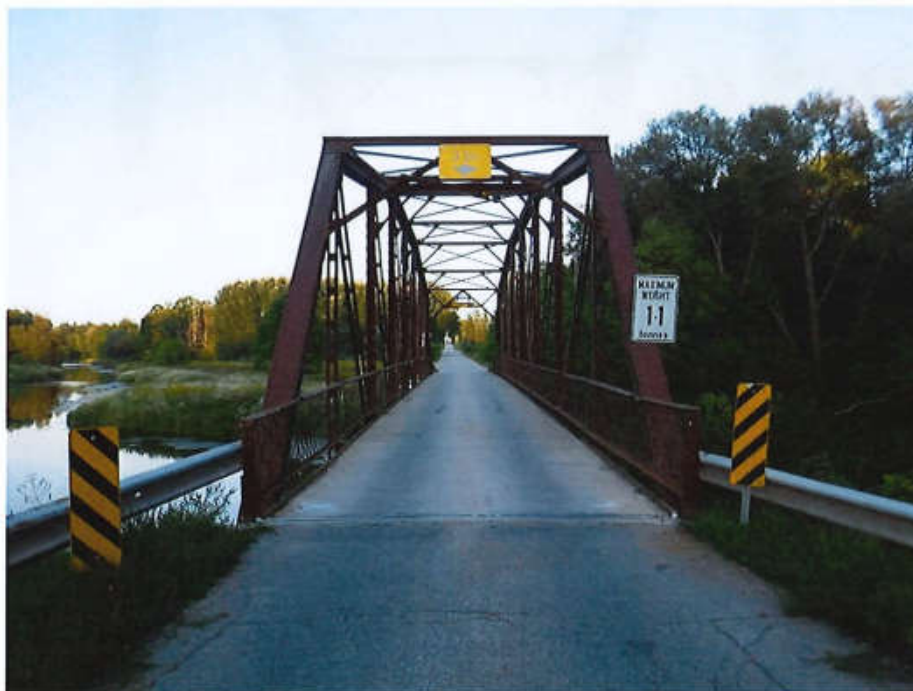
Photo 2: Structure from west approach

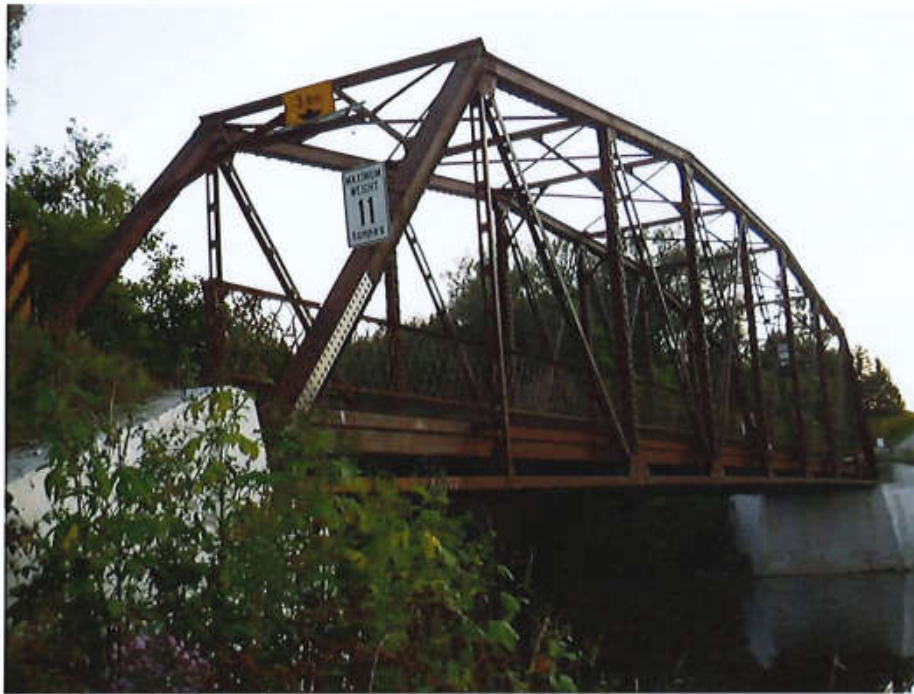
Photo 5: North elevation

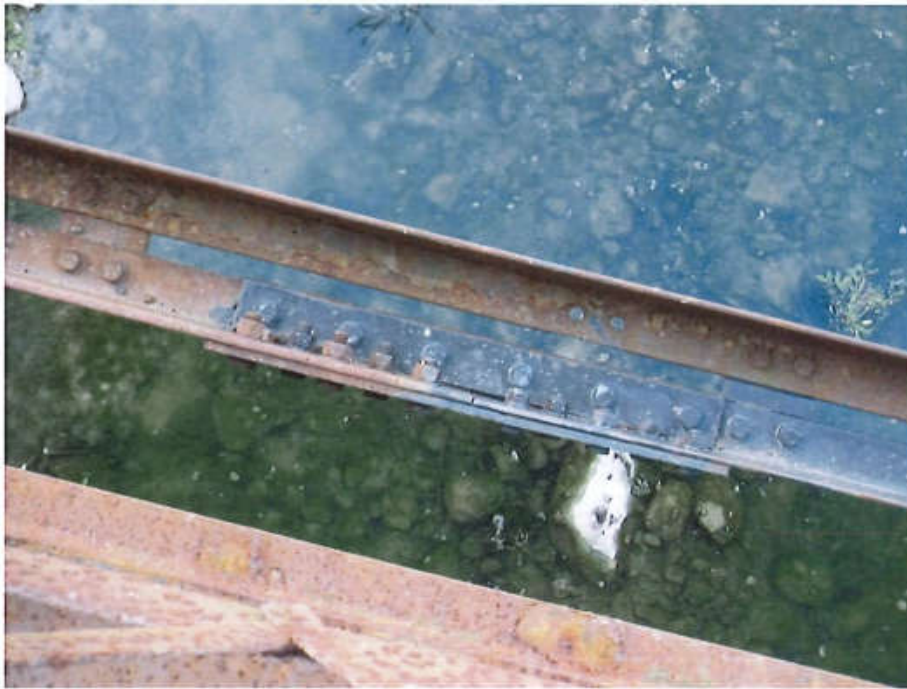
Photo 7: Repairs at bottom chord

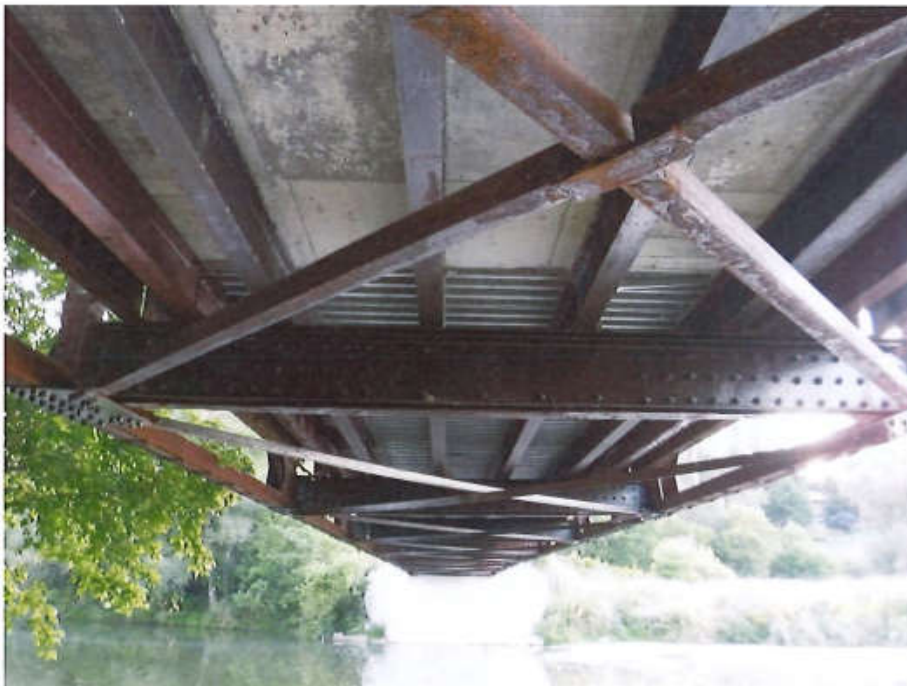
Photo 8: Underside of structure

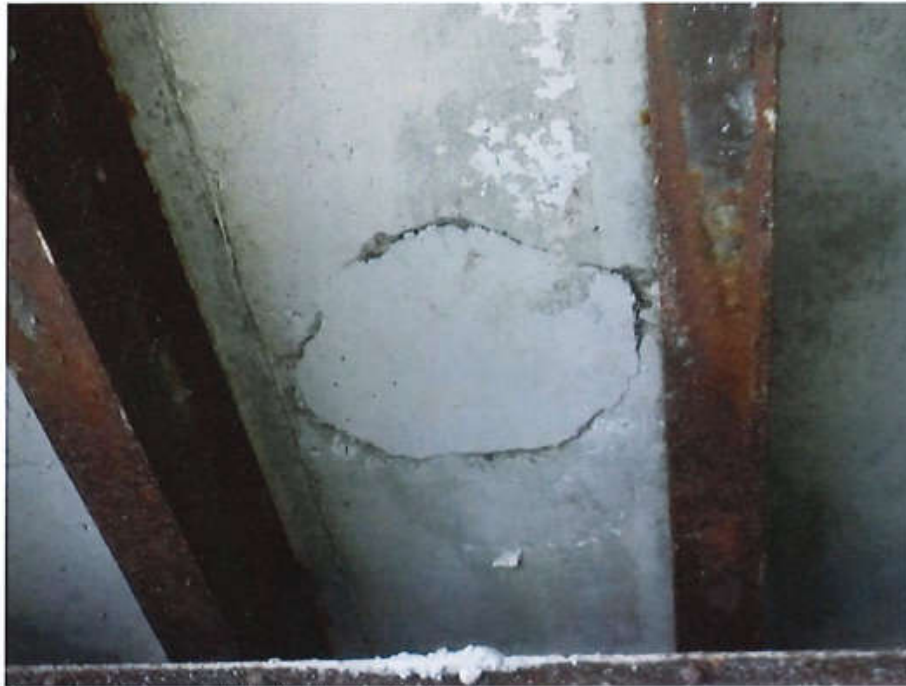
Photo 9: Severe delamination at soffit interior

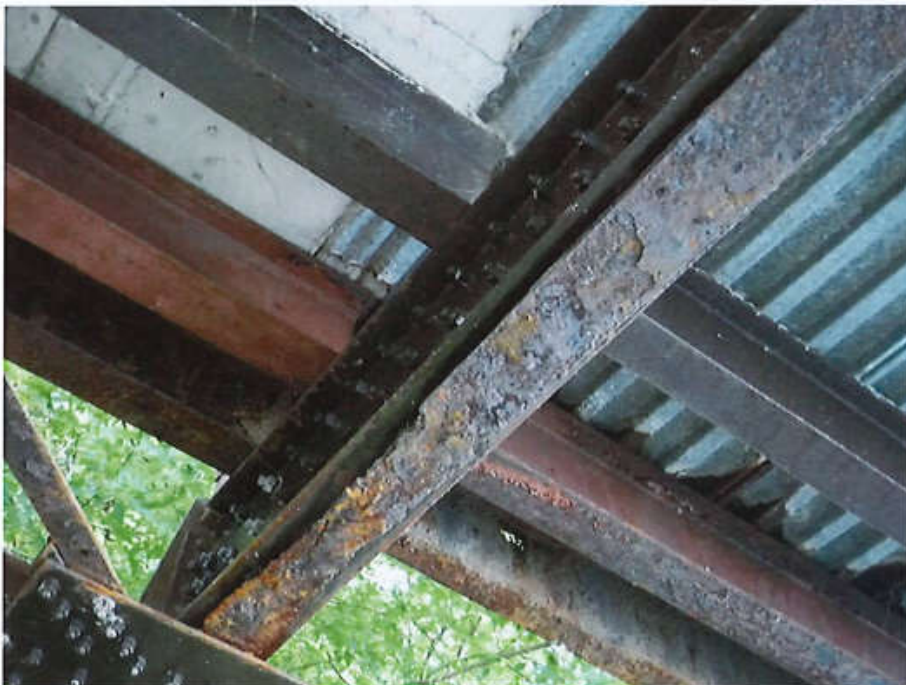
Photo 10: Repairs at floor beam

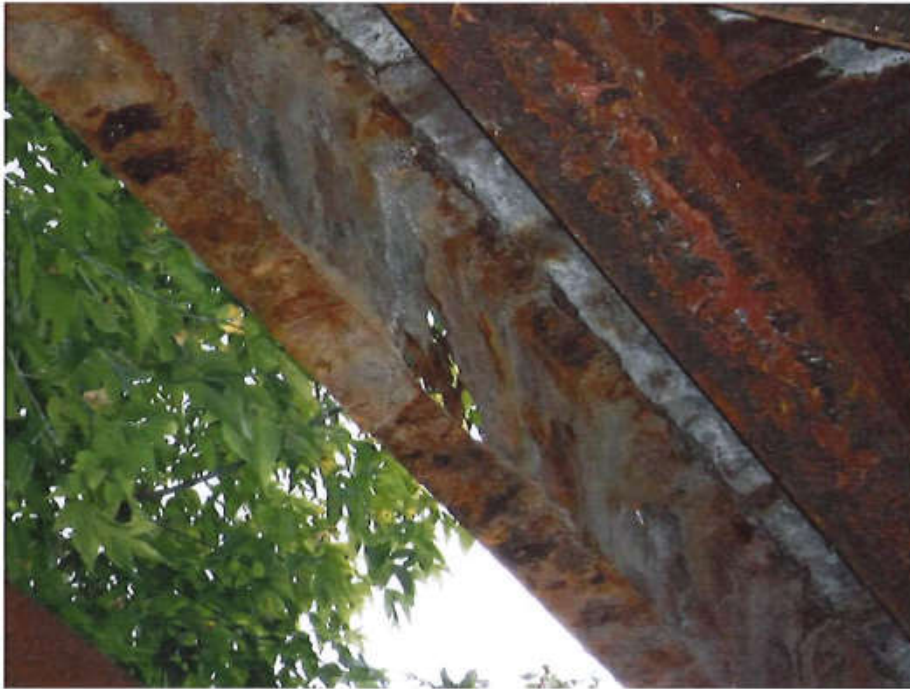
Photo 11: Perforations at stringer

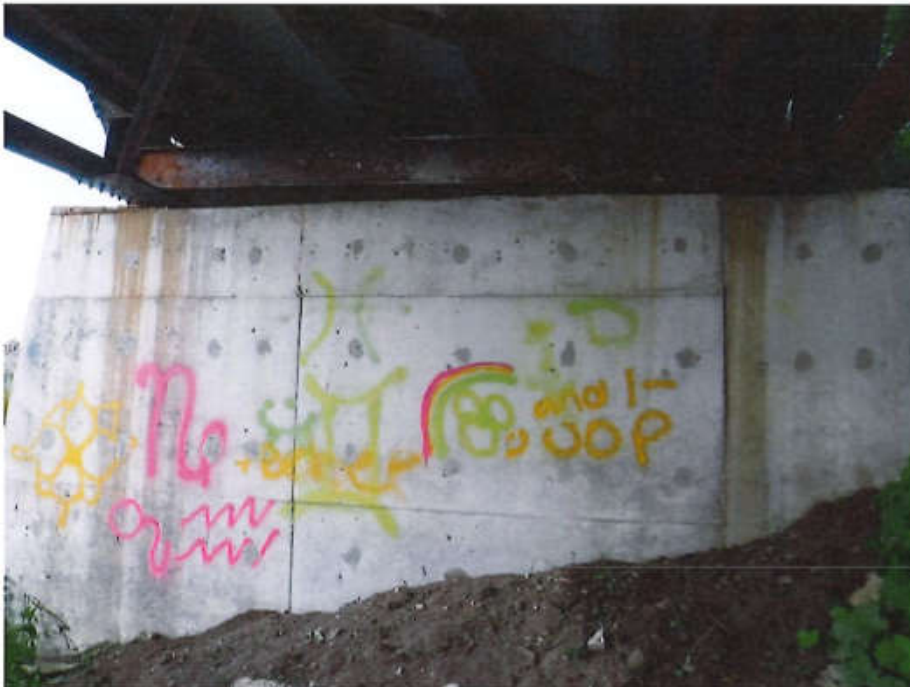
Photo 12: Abutment wall

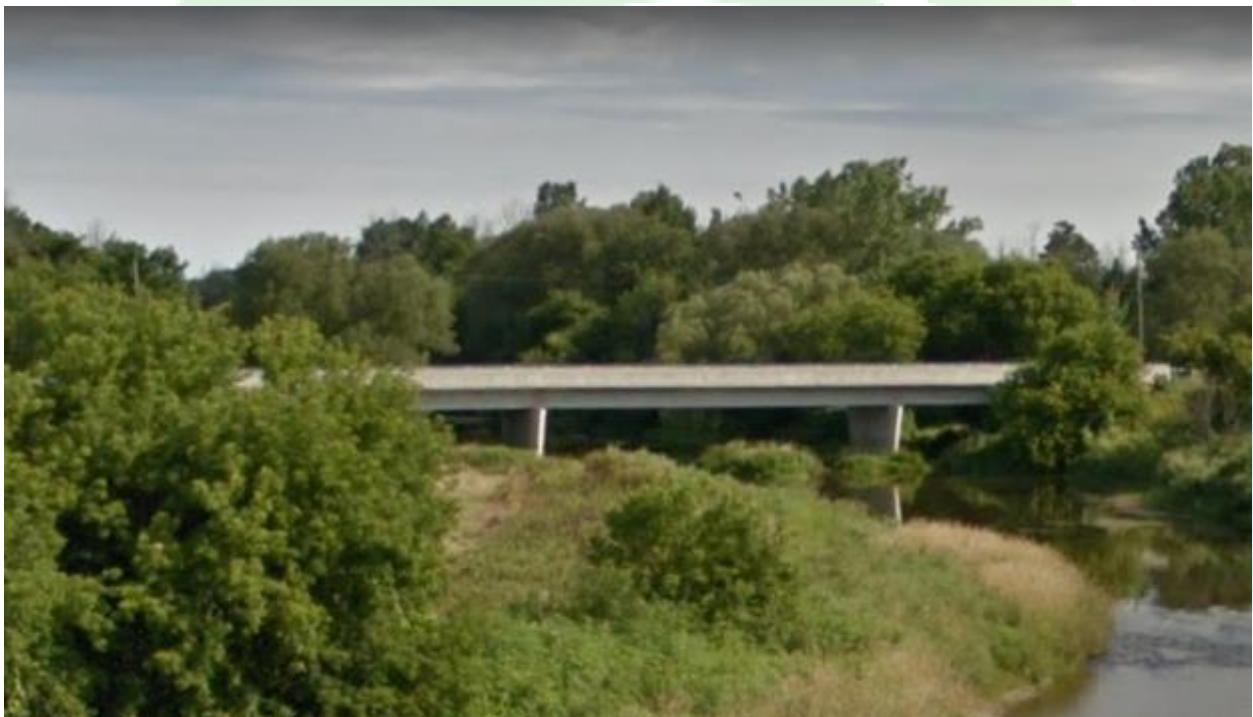
Figure 2a: View, looking south of a bridge located along Township Road 11, near Ayr, ON. This structure also crosses over the Nith River, and was constructed with two in-water pillars.

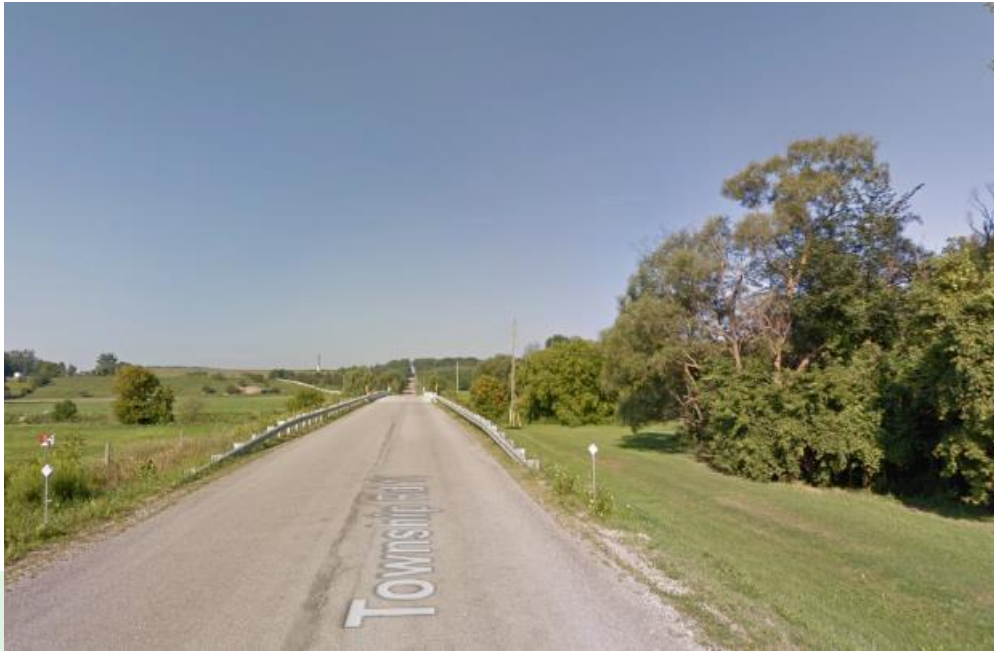
Figure 2b: View, looking east, atop a bridge located along Township Road 11, near Ayr, ON. This bridge appears to be constructed in a similar manner to that planned for the Bridge Street Bridge. This structure appears to include a gradual incline of the road upwards towards the bridge, likely completed to accommodate the seasonal flooding typical within the Nith River.

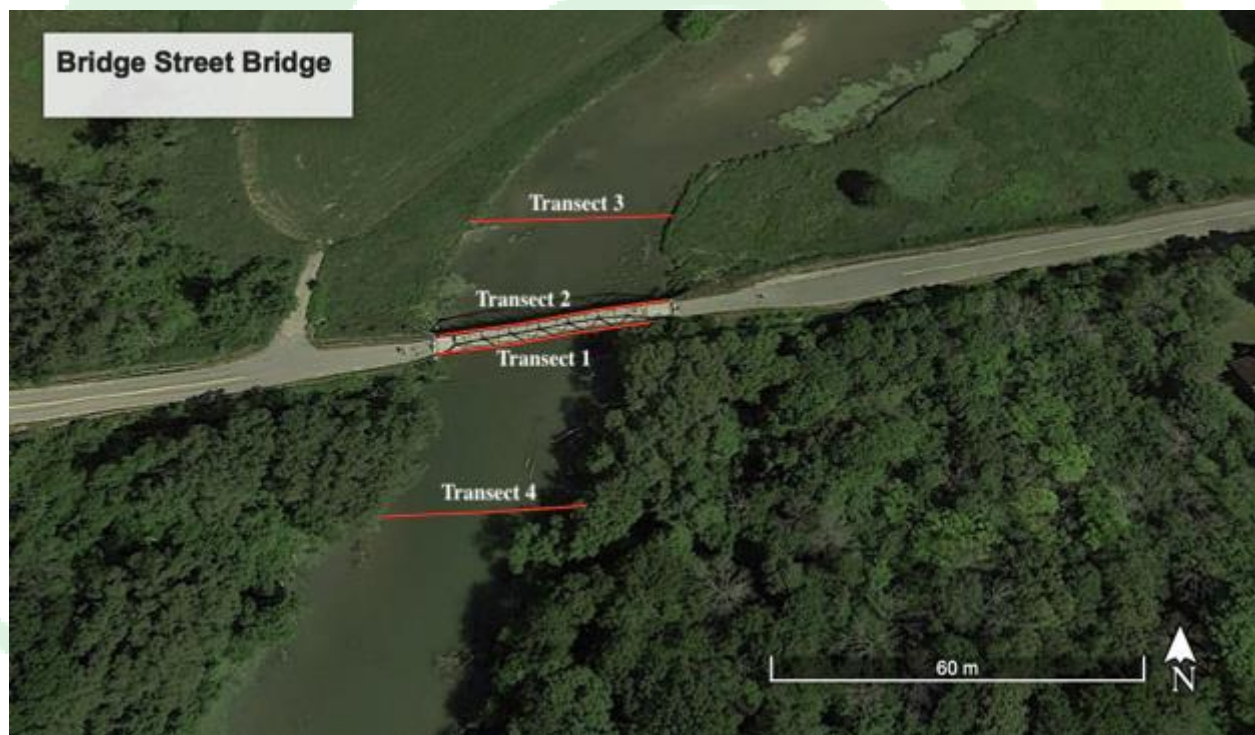
Figure 6: The depth of water across the Nith River was documented to range from approximately 30 cm along the shoreline to more than 1.5 m at the deepest points in proximity to the center of the River. Based on depth measurements, the River appears to be shallowest upstream of the Bridge and gradually gets deeper as water flows downstream.

Water depth across the River was measured at four different transects. All transects were measured from the eastern shoreline or abutment to the western shoreline or abutment. Measurements were completed using two, wooden 1-metre sticks. Transect 1 was measured from abutment to abutment beneath the southern edge of the Bridge. Transect 2 was measured from abutment to abutment beneath the northern edge of the Bridge. Transect 3 was measured from shoreline to shoreline approximately 30 m upstream of the Bridge, while Transect 4 was measured from shoreline to shoreline approximately 30 m downstream of the Bridge. Transects have been depicted within Figure 6.

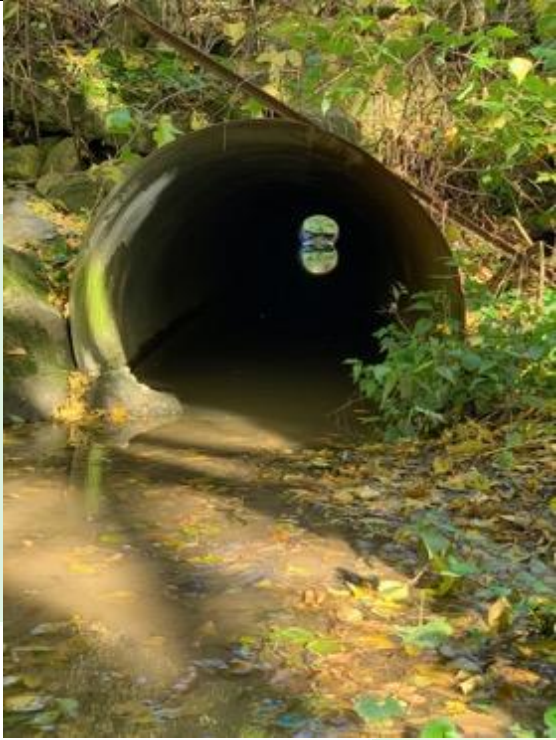
Photo No. 16

Date: October 13, 2020	
Description: Another view of a culvert, present in proximity to the south-facing rocky slope present along the edge of Bridge Street. This culvert likely allows the safe passage of wildlife under Bridge Street.	
Photo No. 18

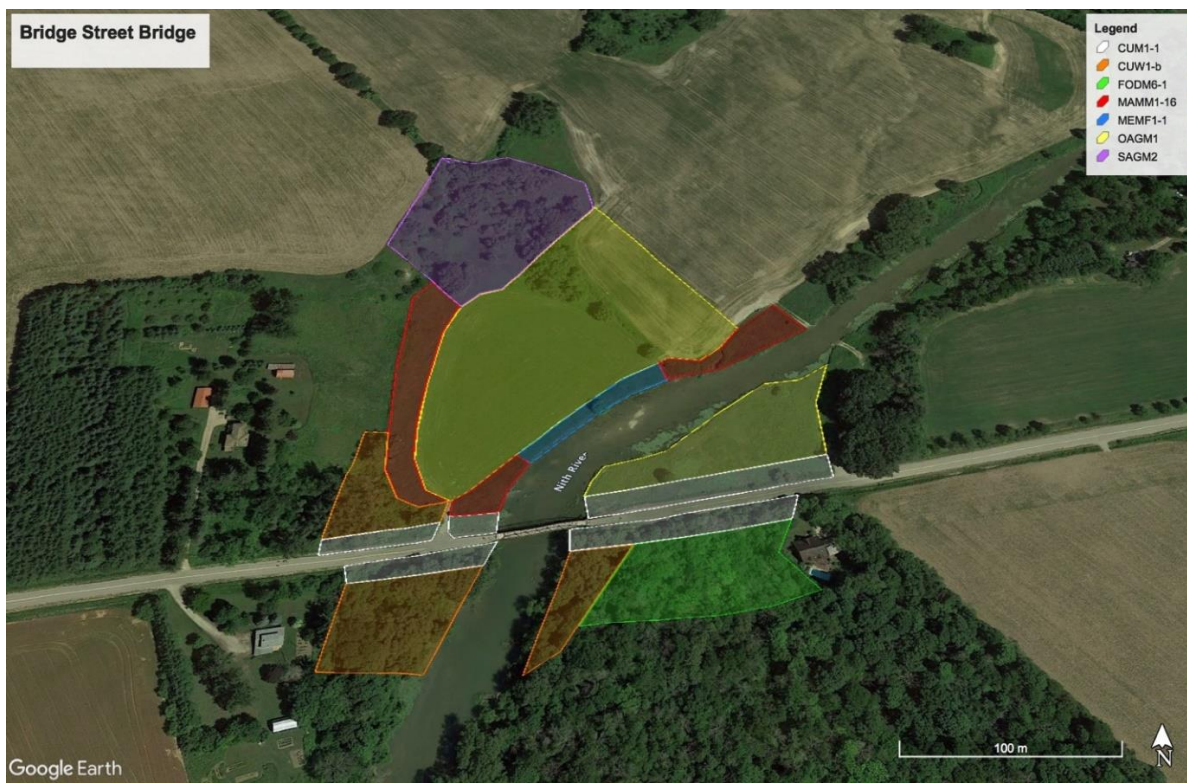
Figure 7: Aerial view of the Bridge Street Bridge with ELC polygons overlaid. A total of seven different ELC polygons were documented based on vegetation communities and soil.

Various information collected on-Site was used to designate these lands following the ELC framework (Lee et al., 1998; Lee, 2008). Information applied for the designation of lands included general land use, vegetation species, slope, and evidence of past, recent, and current disturbance; surface water features also contributed to this analysis. From this information, a total of seven ELC ecosite polygons types were documented and presented within Figure 7.

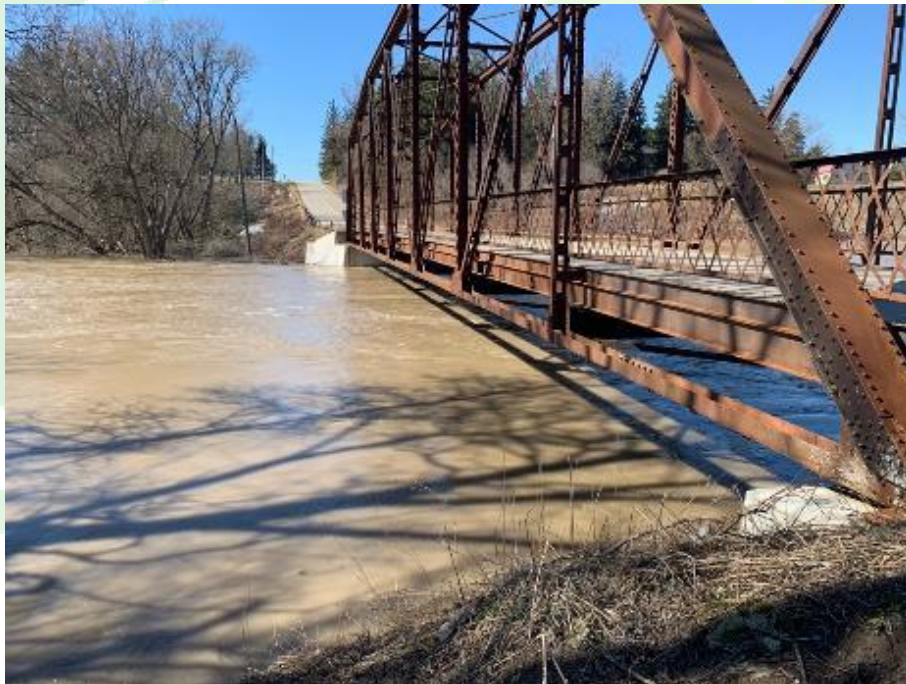
Figure 8: View of the Nith River during the March 12, 2021 flooding event. Water was documented to exist nearly 30 cm from the Bridge deck, and flood into surrounding fields and woodlands.

In order to capture the extent of the flooding, the Site was visited on March 12, 2021 by staff from ELM. Upon arriving at the Bridge, water was documented to exist approximately 30 cm below the base of the bridge deck (Figure 8). Water was observed as fast flowing, and very turbulent. Flooding was documented to extend into all surrounding fields and woodlands (Figures 9 and 10).

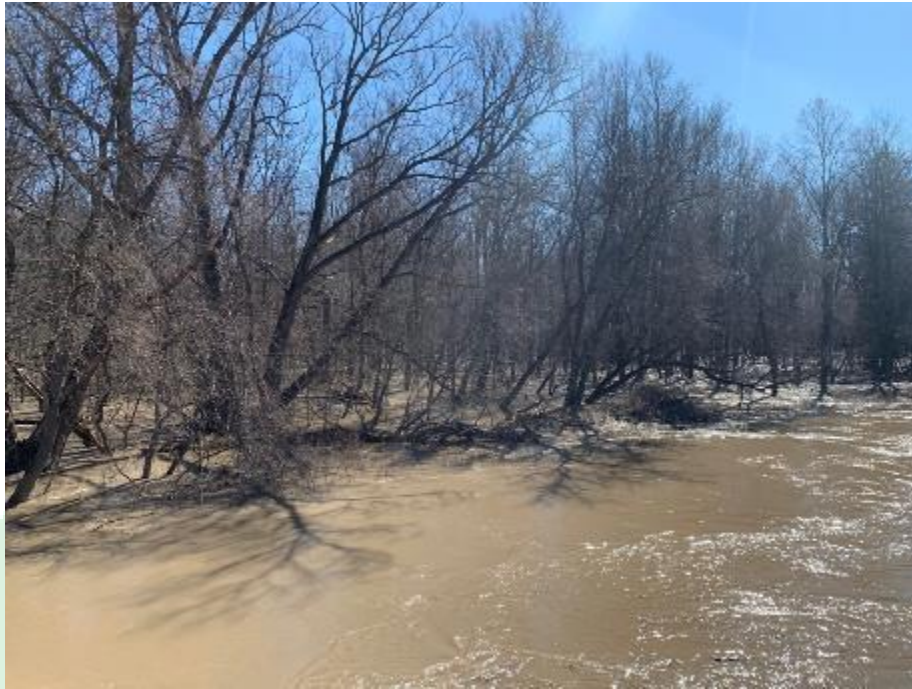
Figure 9: View of the southeastern woodland from atop the Bridge on May 12, 2021. Water was documented to be fast flowing and very turbulent flowing through the woodlands and fields.

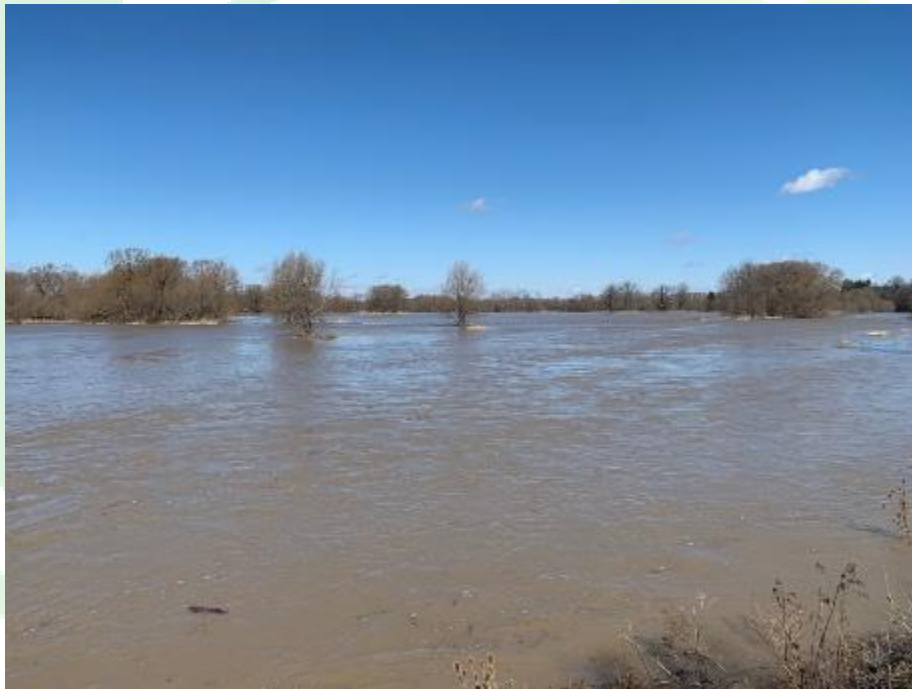
Figure 10: View of the northeastern and northwestern agricultural fields from the roadside of Bridge Street on March 12, 2021. Water was documented to be fast flowing and very turbulent flowing through the woodlands and fields.

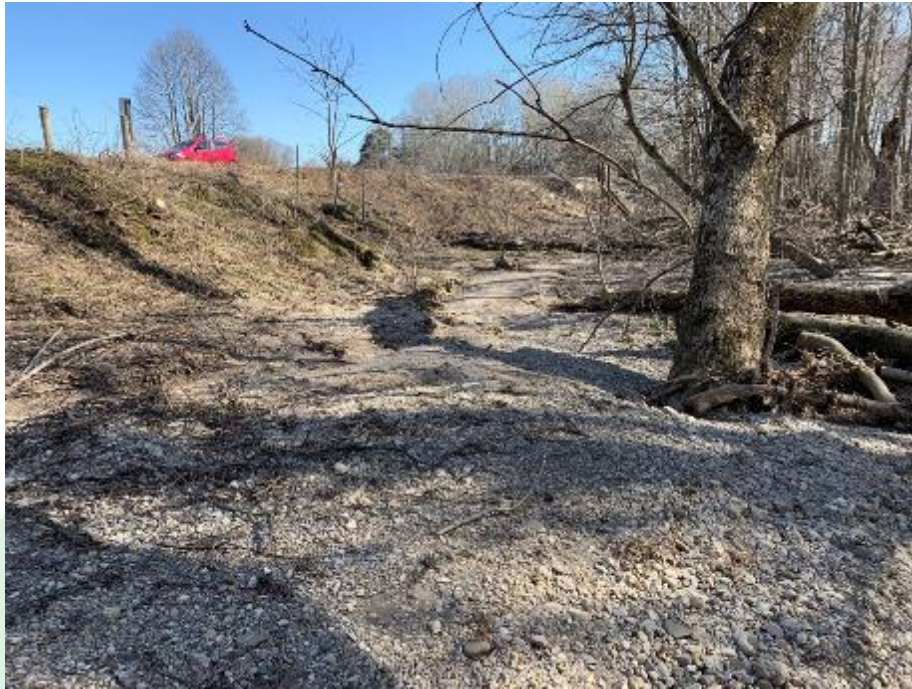
Figure 11: View of a large depositional area of gravel and rock present within the southeastern woodland, approximately 10 m from the shoreline of the Nith River, on March 19.

Follow-up field visits were completed exactly a week later on March 19 and March 20. These follow-up visits documented that water had returned back to a near-normal flow scenario, with little to no standing water remaining within the southeastern woodlands. It is prudent to note that the flooding resulted in significant scouring and disturbance of the woodland. Large amounts of displaced sand, silt, gravel, garbage, wood and other debris were observed upwards of 60 m east into the woodlands (Figure 11). Depositional areas of fine sand were typically observed deeper within the woodlands, while deposition of gravel and larger rock was most frequently observed along the shoreline and within the first 20 m between the woodland and the shore. Similarly, large amounts of garbage, broken glass, and metal fragments were observed. Additionally, depositional areas of vegetation, including tree trunks, branches, sticks, leaves, and grasses were documented to be collecting in different parts of the woodland (Figure 12).

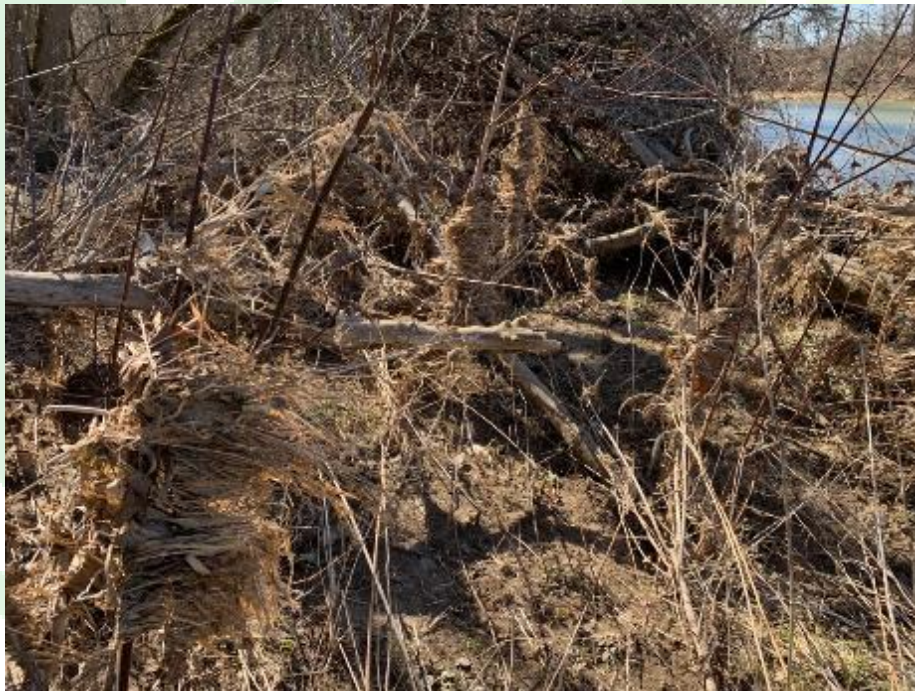
Figure 12: View of a large depositional area of trees, branches and vegetation, present within the southeastern woodland, approximately 5 m from the shoreline of the Nith River, on March 19.

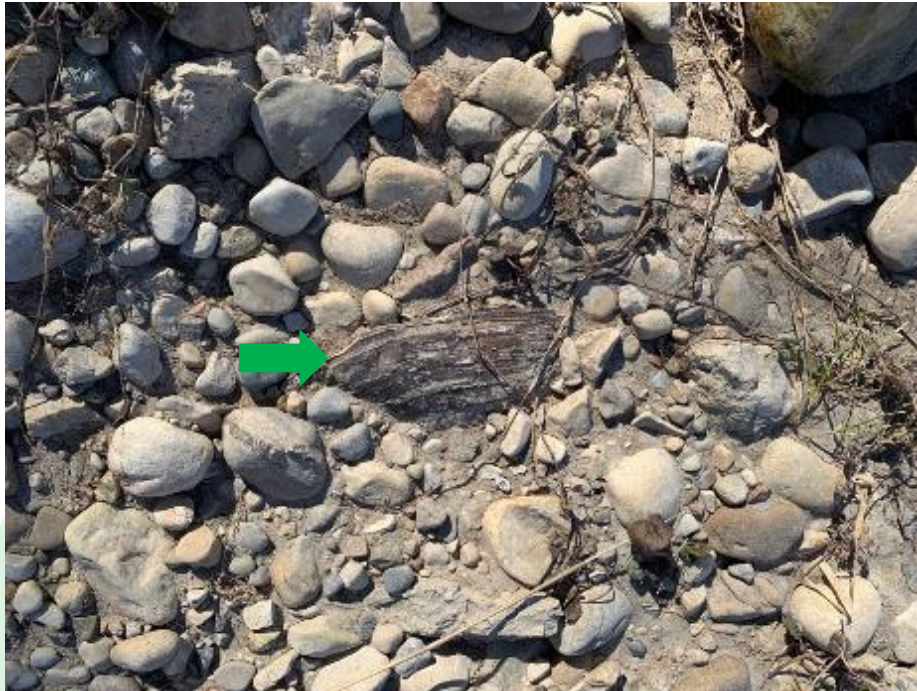
Figure 13: View of a mussel shell (marked with green arrow), displaced from the Nith River during the flood. This mussel shell was buried in displaced gravel and sand, and frozen into the ground, on March 19. It was necessary to use a shovel to carefully extract the specimen.

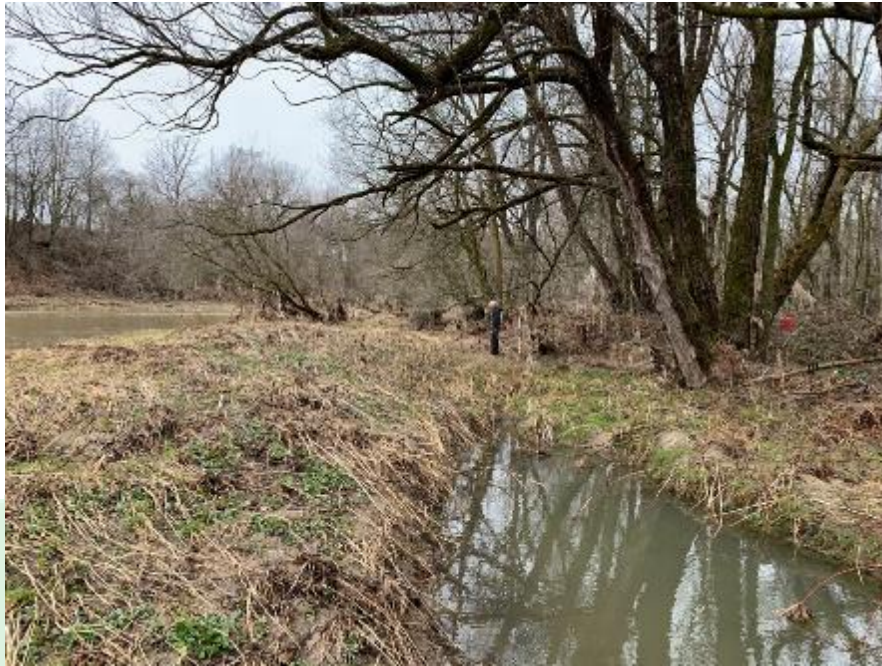
Figure 14: View of the shoreline, looking north, of an area that appeared to be recently flooded. This area included pools of standing water, as well as a large number of deposited mussel shells.

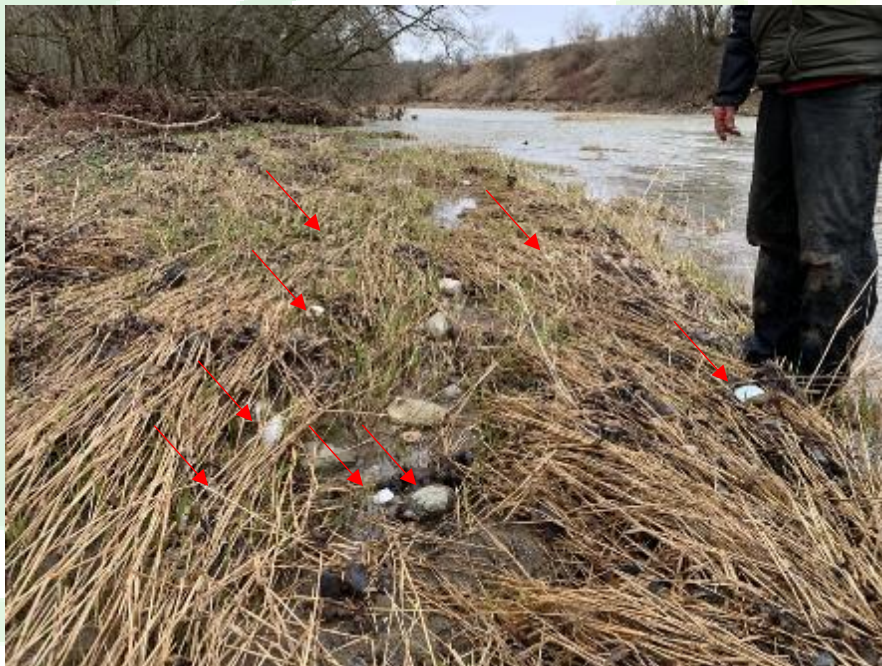
Figure 15: View of the deposited mussel shells on March 26, 2021 in an area of shoreline approximately 225 m downstream of the Bridge. This area was titled to be a “mussel graveyard” as a result of the large number of dead and deposited shells. It is expected that the shoreline will again appear like this following the receding of flooding on March 27, 2021. A number of shells have been highlighted with red arrows.

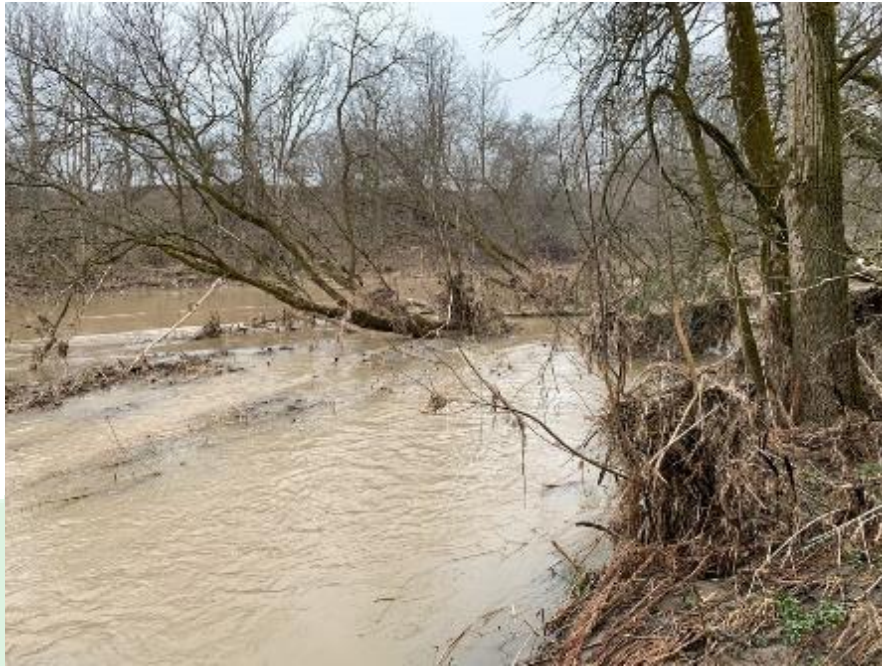
Figure 16: View of the same shoreline, looking north, now flooded. This area now included fast flowing, and turbulent water, documented to be upwards of 45 cm deep off the shoreline.

The Bridge was again visited on March 27, 2021 following the occurrence of an overnight rainstorm. This storm resulted in approximately 2-3 mm of precipitation. Field visits completed on this day documented that the area of shoreline surveyed the previous afternoon was now flooded and inaccessible (Figure 16). Flowing water through this location was documented to be relatively fast flowing, turbulent and upwards of 45 cm deep directly off the shoreline.

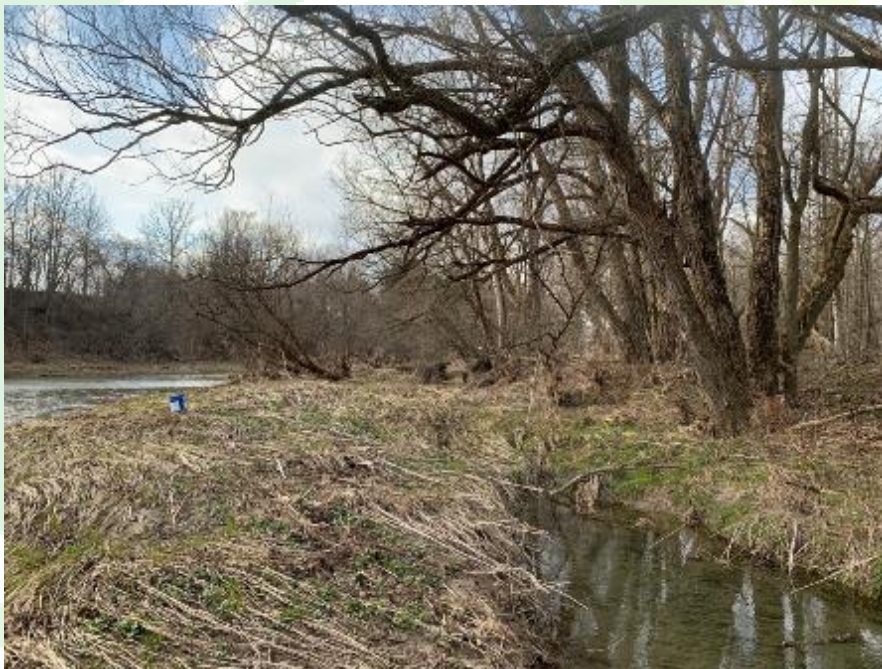
Figure 17: View of the same shoreline on April 1, looking north, once flooding has receded. This photo demonstrates the effects of episodic flooding, vegetation may be observed to have been matted down in the downstream direction, as a result of past fast flowing water moving through the area.

Follow-up surveys of the area downstream of the bridge were completed to quantify the displacement of mussels to the floodplain, as reviewed within Table 5 (Figures 17 to 19). The survey dates extended from March 19 until May 11, 2021. The goal of these surveys was to view the flood plain area after precipitation events in order to document mussel deposition patterns. Results of these varied field visits indicate that natural areas downstream of the Bridge repetitively flood following even minor precipitation after the major spring flood that follows snow melt. Furthermore, as a result of the repetitive flooding downstream of the Bridge after each precipitation event, it demonstrates this process displaces mussels and represents a constant source of mortality. In general, after each rain, mussels are displaced to the floodplain and apparently do not make it back to the river. For example, during surveys of Area 6 on March 27, nearly 600 mussel shells or mussel shell fragments were collected. In contrast, a total of 65 were found on April 21 and 20 on May 11. These surveys ended with growth of vegetation and baseflows in the river.

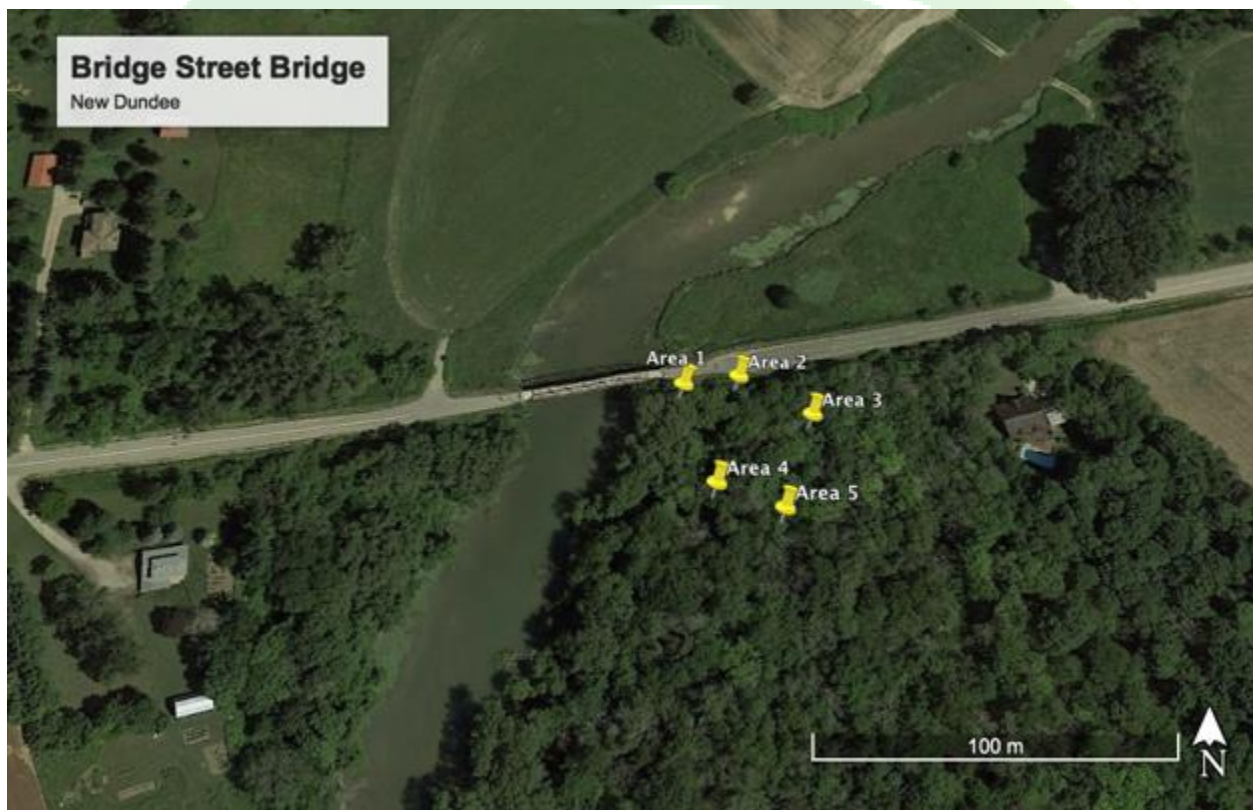
Figure 21: View of the five different areas from which mussel shells were collected. Collection of mussel shells was performed with a radius of approximately 10 m surrounding each marker.

Mussel shells included for this analysis were collected from five different areas of the woodland on October 13 and October 16, 2020, as well as when found along shorelines upstream and downstream of the Bridge (hereinafter, Areas 1 to 5; Figure 21). In addition, mussels were located during March 2021 from Areas 1 to 5. As a complement, mussel shells collected from Area 6 during visits from March to May of 2021 were excluded from this analysis as a result of their distance from the Bridge (~225 m). The majority of mussel shells were broken in half, with only a limited number including both the left and right halves of the shell. All collected mussel shells were documented to be free of flesh, and were likely displaced into the woodland as a result of seasonal flooding. A single live mussel was collected during surveys in April, 2021 and was gently placed back in the River into sand sediment with a water depth of ~30 cm.

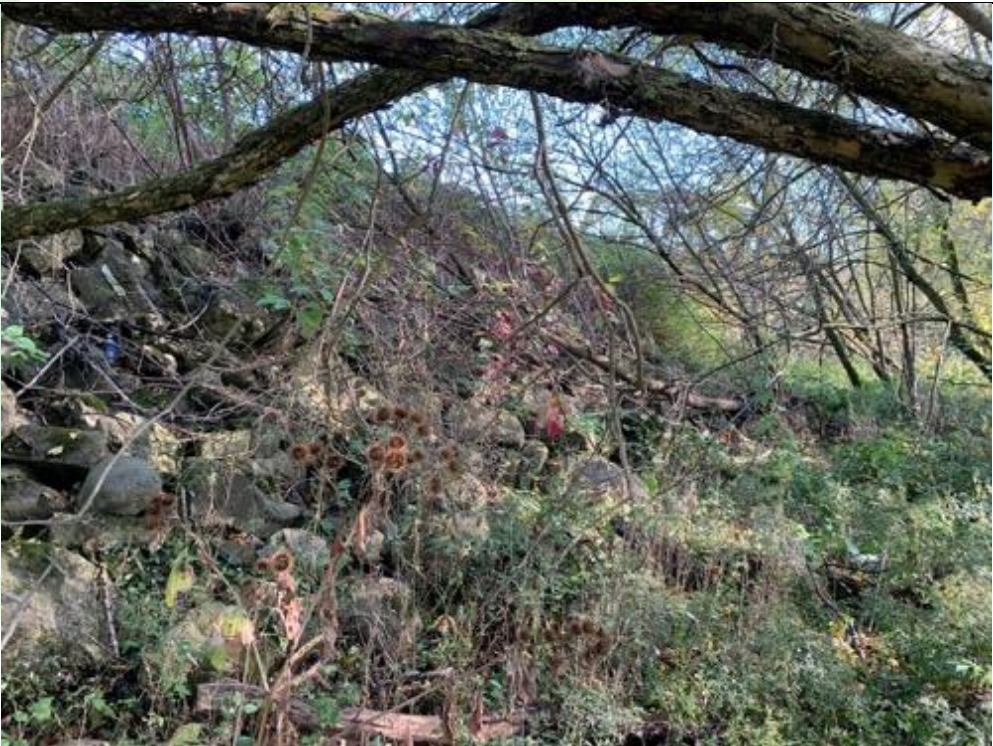
Photo No. 14

Date: October 13, 2020	
Description: Another view of woody debris present on top of a south-facing rocky slope along the edge of Bridge Street, approximately 20 m west of the Bridge.

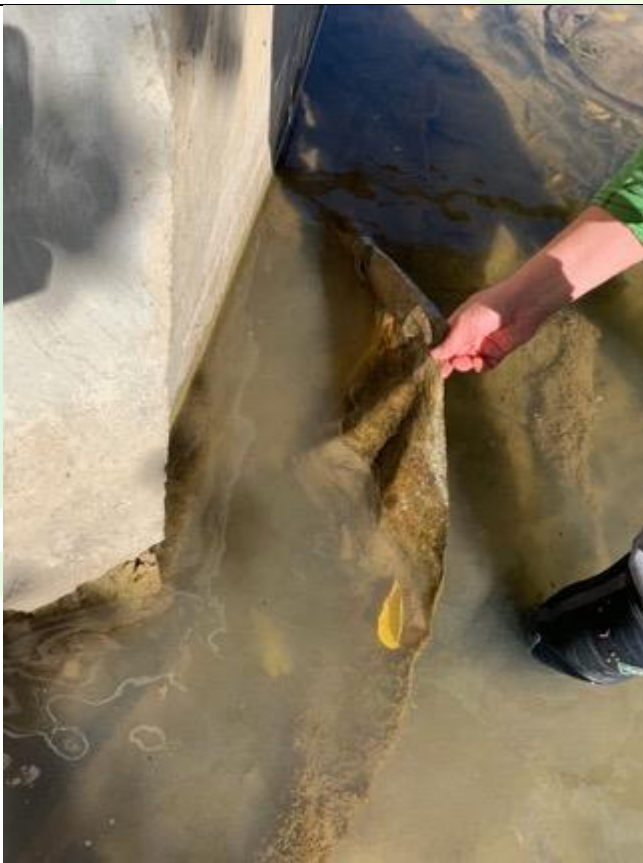
Photo No. 30

Date: October 13, 2020	
Description: A closer view of sheeting documented to be covering the River floor in proximity to the western abutment of the Bridge.
