**BRIDGE 34/B-T9
(BRIDGE STREET BRIDGE)**

TOWNSHIP OF WILMOT

**JANUARY 2022
REVISED APRIL 2022**

FILE NO. 20-145

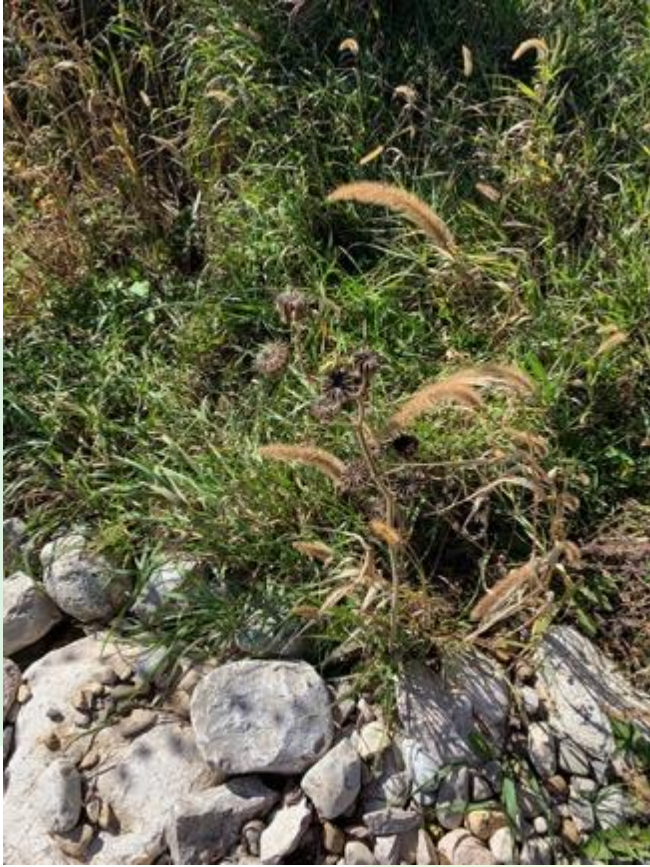
Photo No. 53

Date: October 13, 2020	
Description: View of Velvetleaf (<i>Abutilon theophrasti</i>), and Green Foxtail Grass (<i>Setaria viridis</i>), documented along the western bank of the River, in proximity to the drainage culvert.

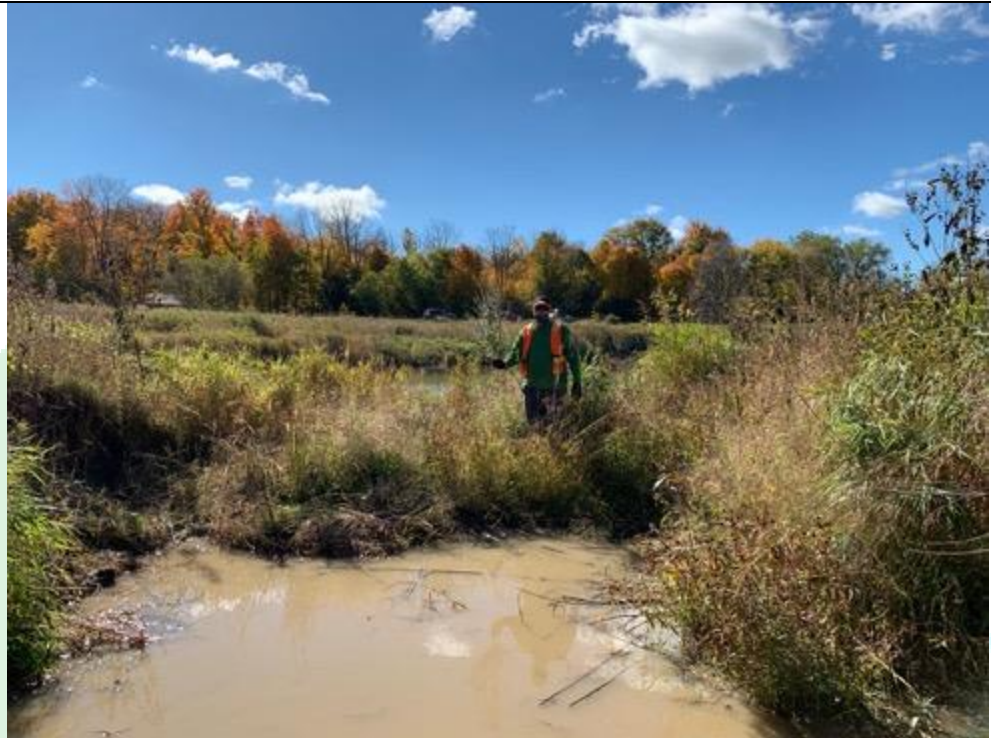
Another view of an area of standing water, present upstream of the Bridge and drainage culvert. Standing water appears to be a result of runoff from a nearby soybean field. In this photo, Dr. Fitzgerald holds up a single stalk of Purple Loosestrife (*Lythrum salicaria*).

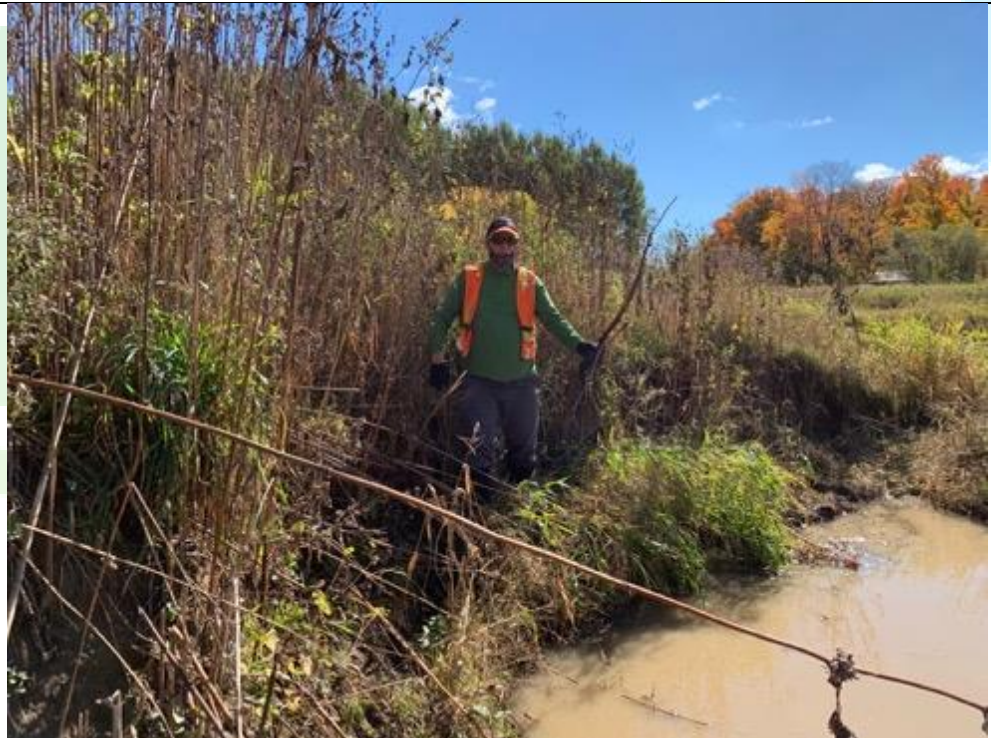
**Photo No. 58**

Another view of an area of standing water, present upstream of the Bridge and drainage culvert. Standing water appears to be a result of runoff originating from a nearby soybean field. In this photo, Dr. Dean Fitzgerald holds up a stalk of Wild Parsnip.

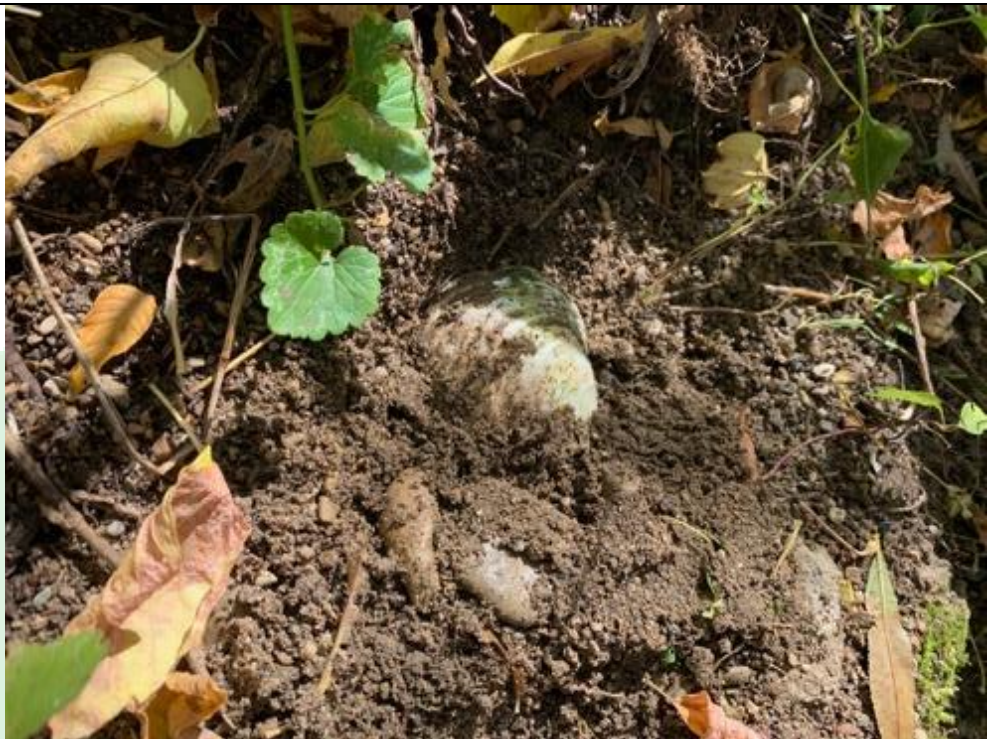
Photo No. 66	
Date: October 13, 2020	
Description: Another view of a pile of gravel and sediment observed within the Cultural Woodland, located southeast of the Bridge. Gravel and sediment is hypothesized to have been deposited along the floor of the woodland as a result of flooding.

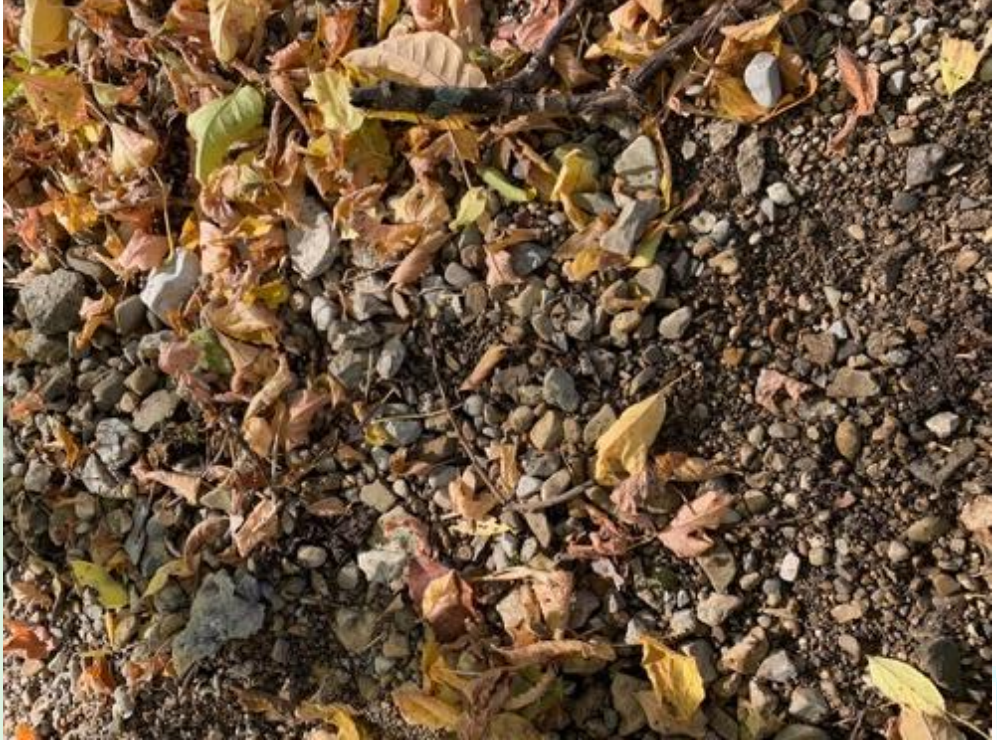
Photo No. 67

Date: October 13, 2020	
Description: Another view of a pile of gravel and sediment observed within the Cultural Woodland, located southeast of the Bridge. Gravel and sediment is hypothesized to have been deposited along the floor of the woodland as a result of flooding.

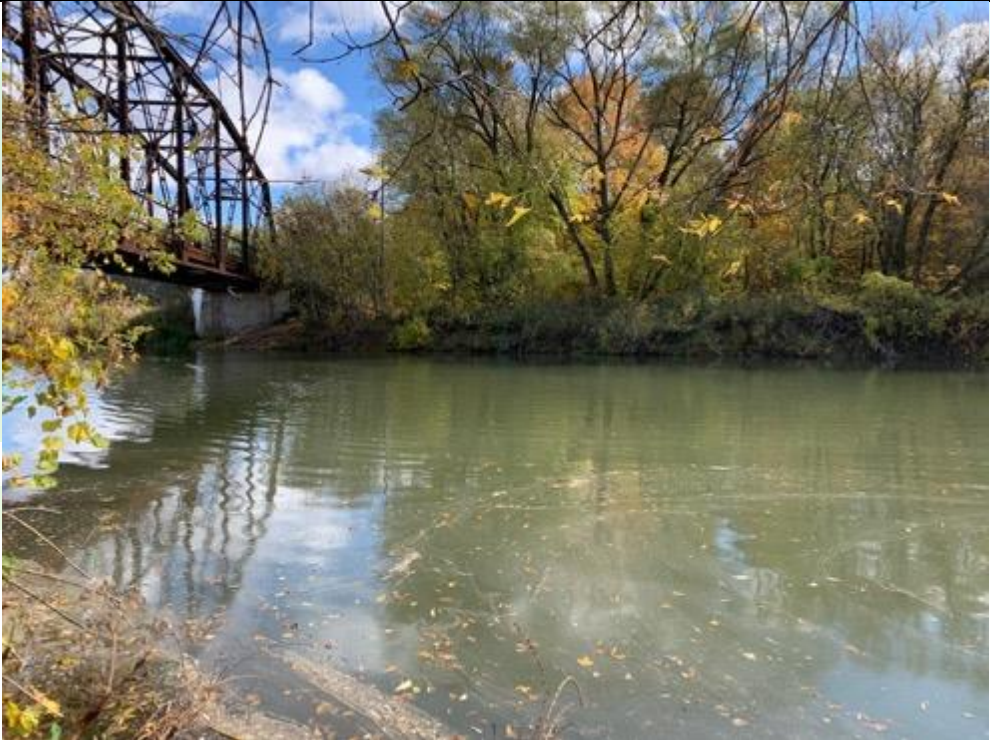
Photo No. 82

Date: October 16, 2020	
Description: View, looking east, from the south side of the western abutment. Water depth (Transect 1) was measured across the River, just under the southern edge of the Bridge Street Bridge.

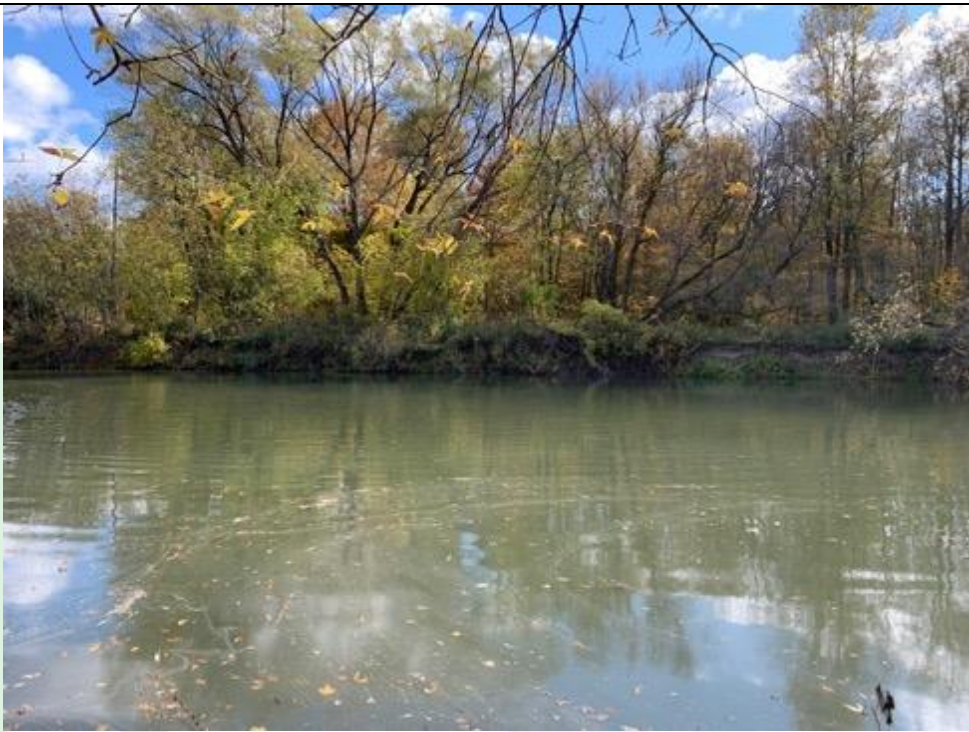
Photo No. 83

Date: October 16, 2020	
Description: View, looking east, from the western bank of the Nith River approximately 30 m downstream of the Bridge Street Bridge. Water depth (Transect 4) was measured across the River at this location.

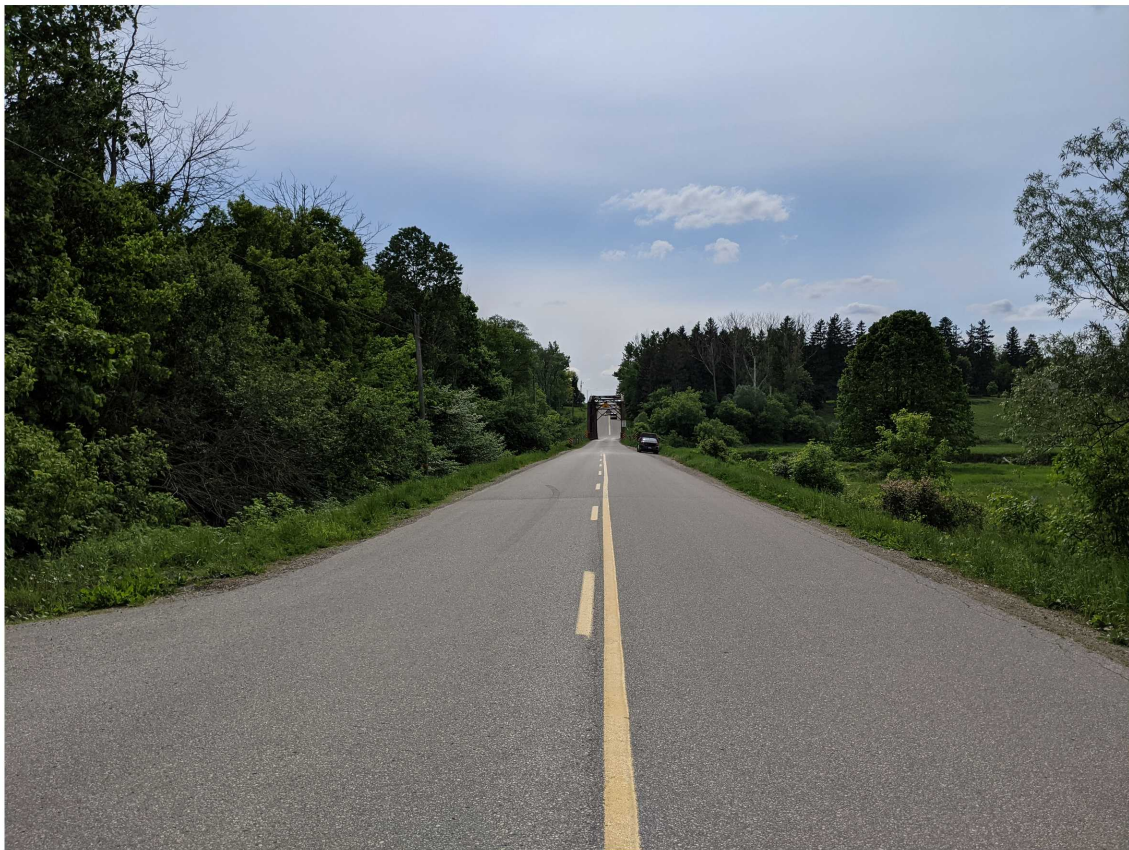
1. Far East Approach (looking west)

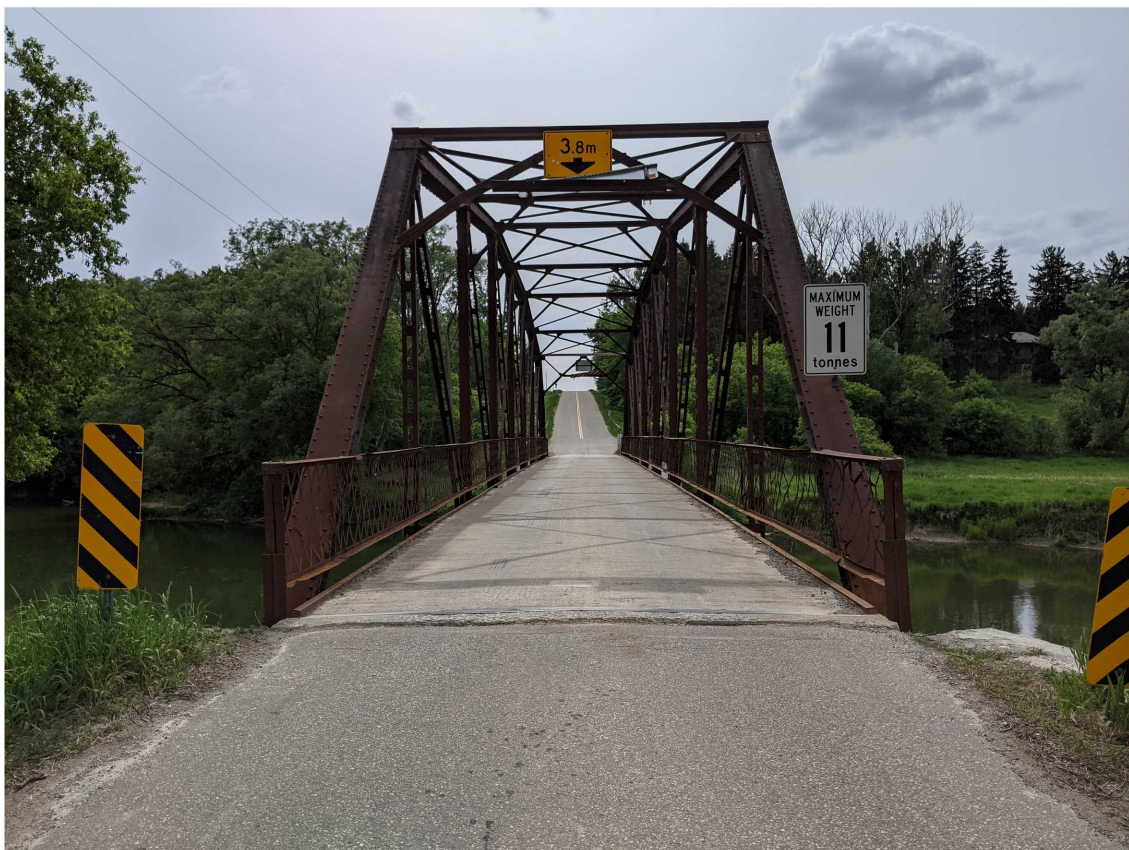
2. East Approach (looking west)

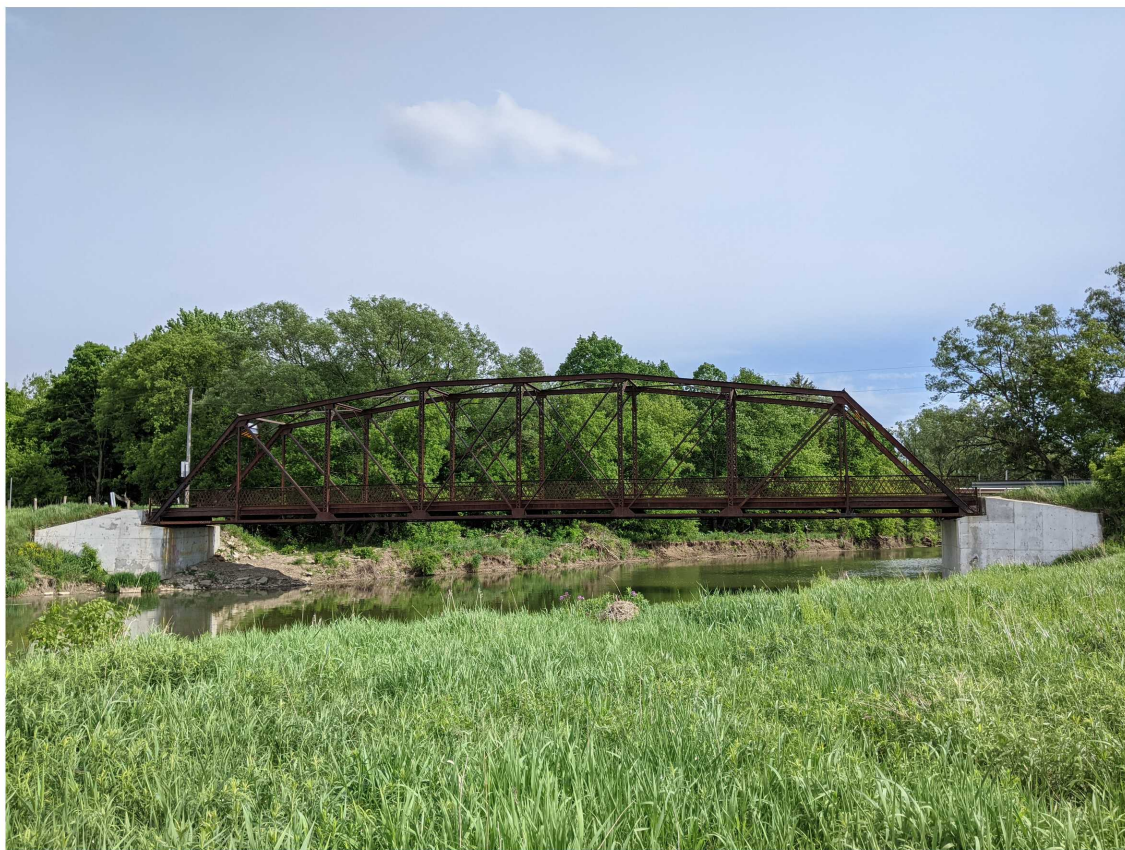
3. North Elevation (looking south)

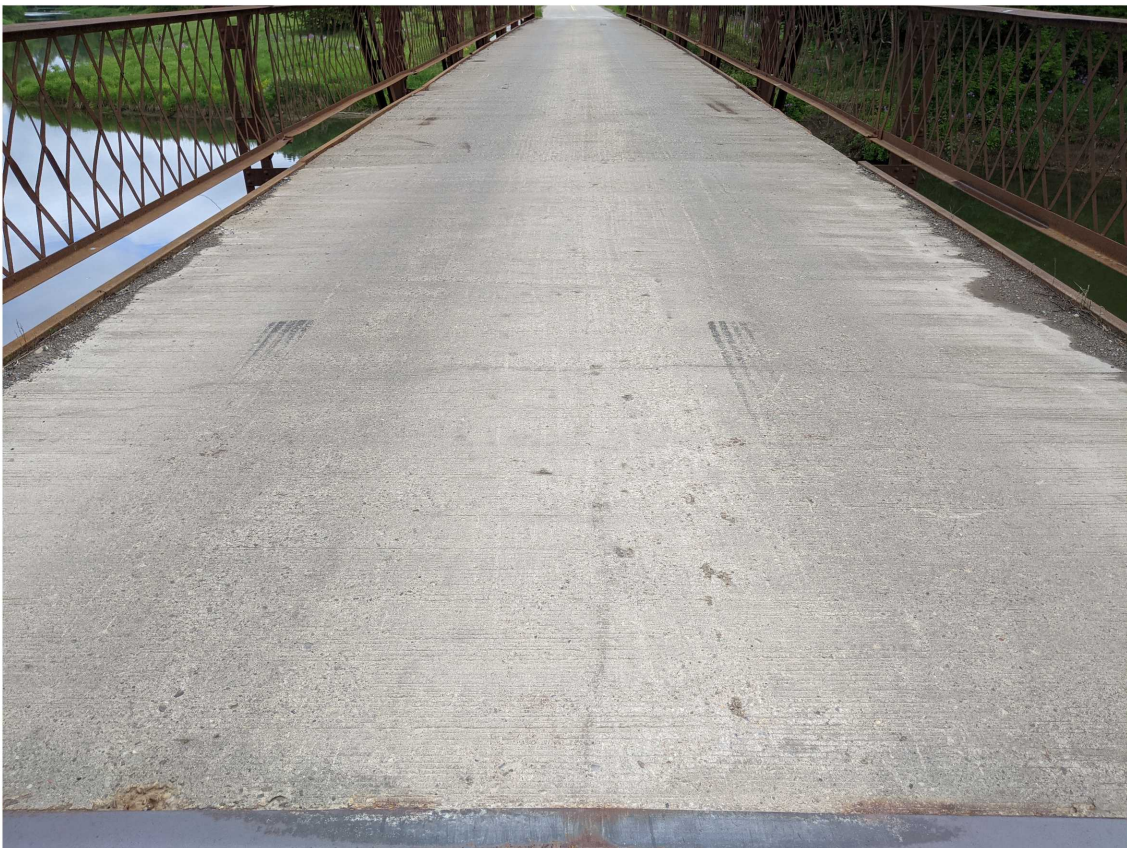
6. Deck Surface

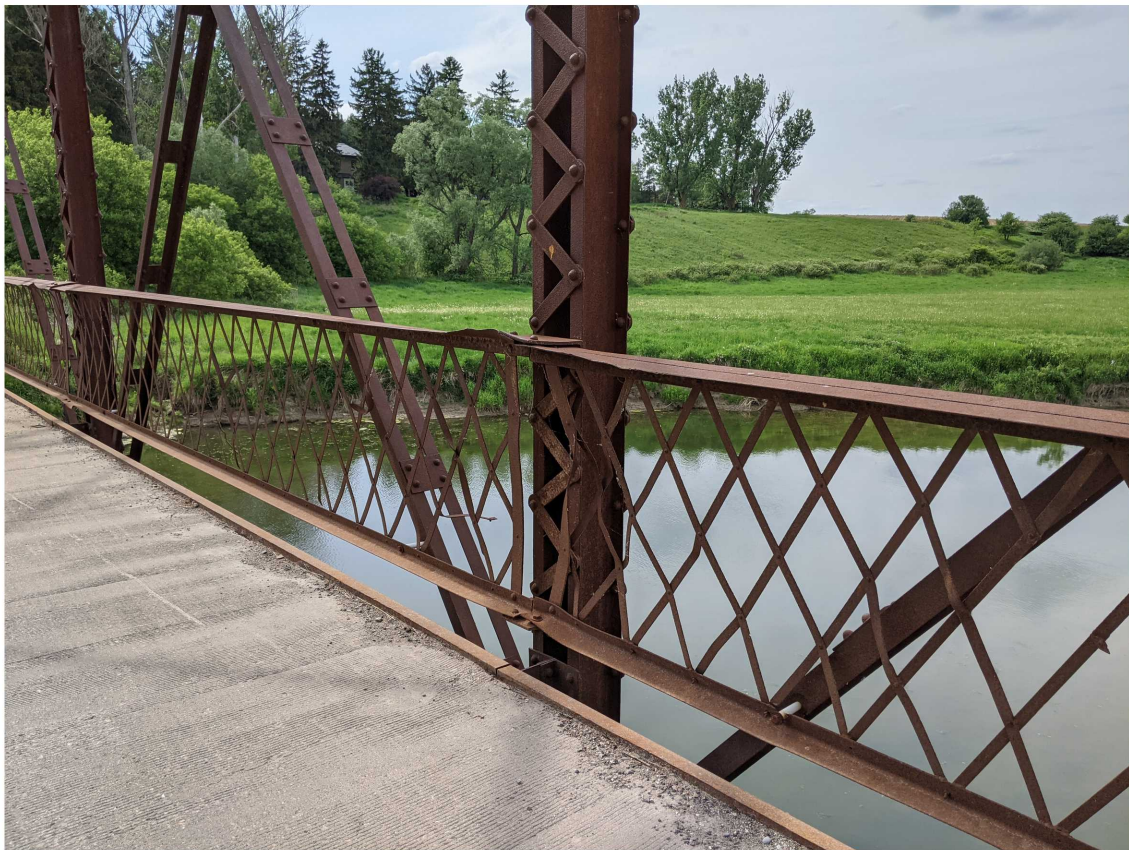
7. Typical Railing

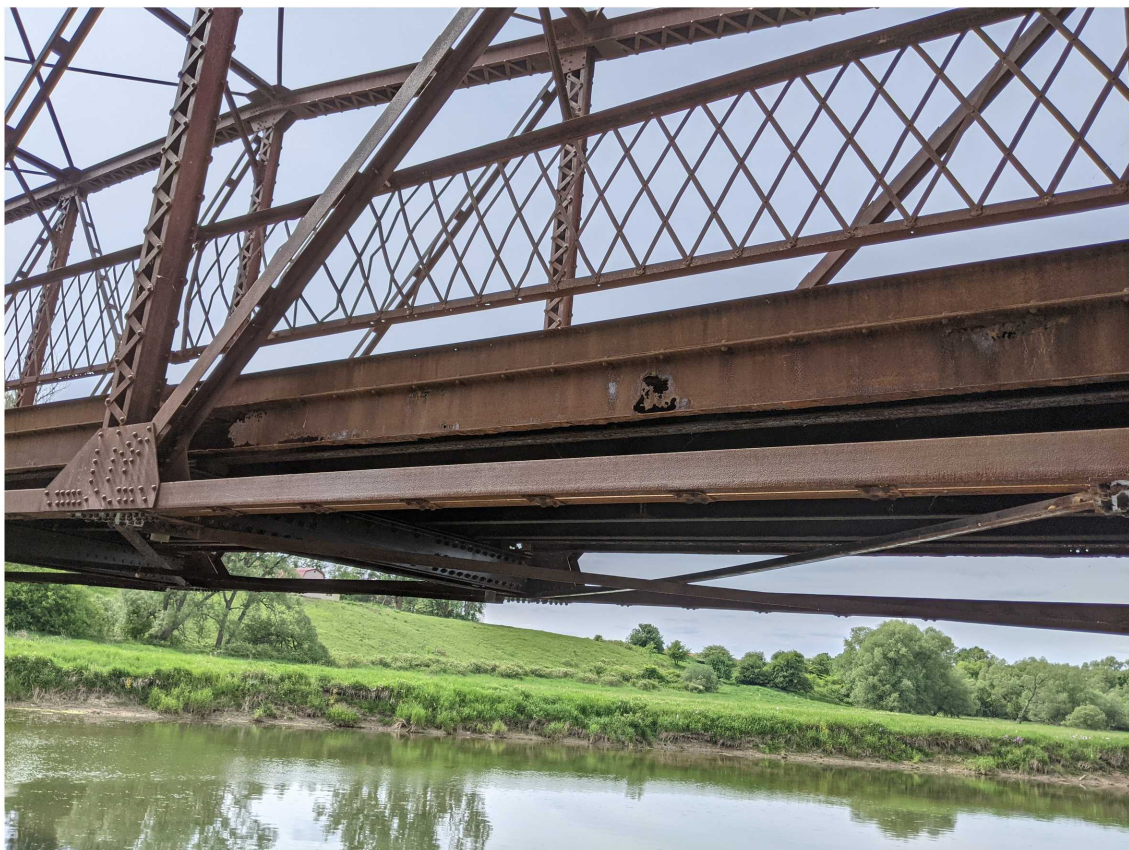
8. Typical Perforated Stringer

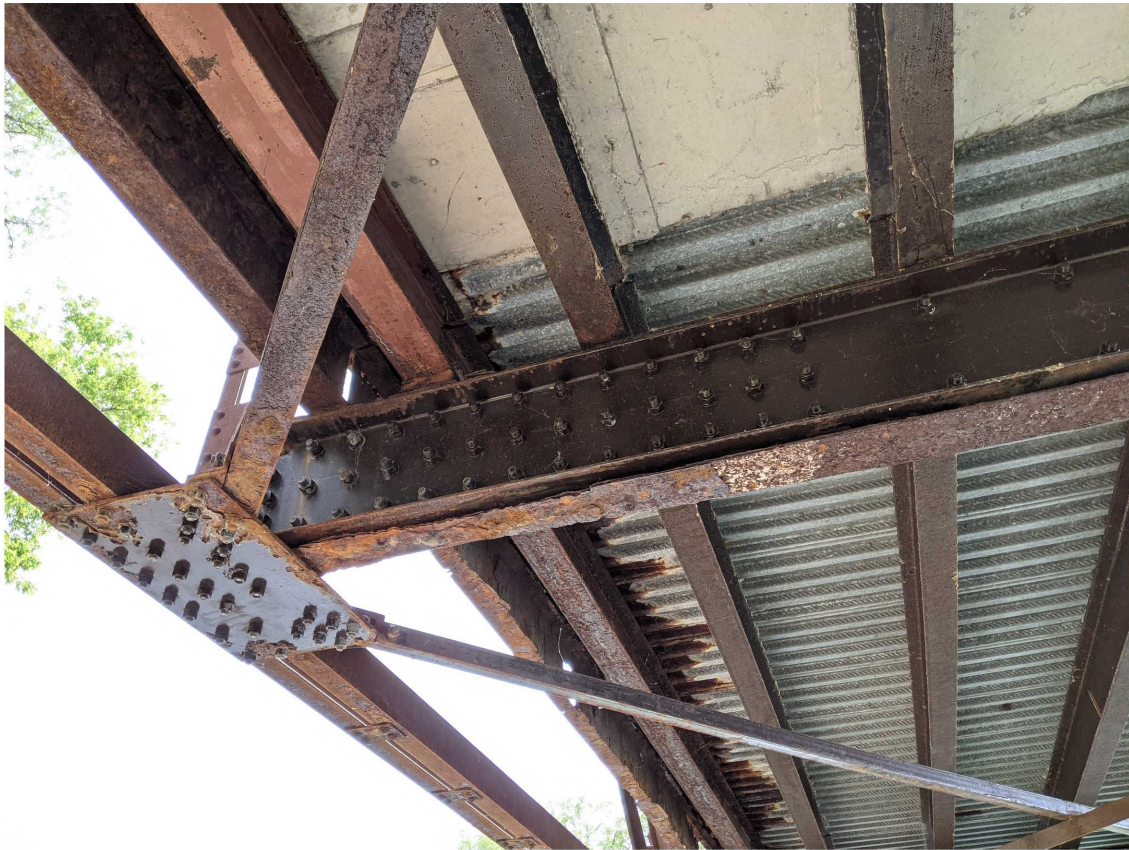
9. Typical Repaired Floor Beam

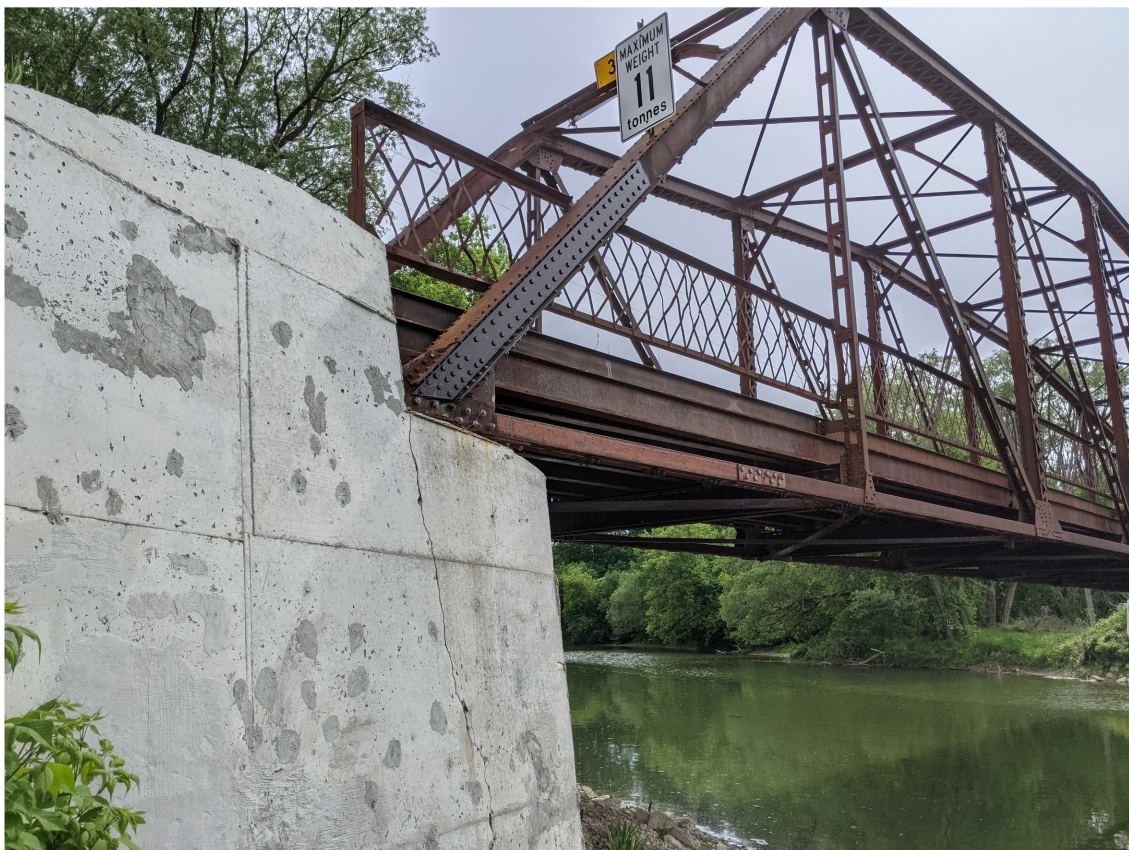
10. Typical Repaired Truss Chord

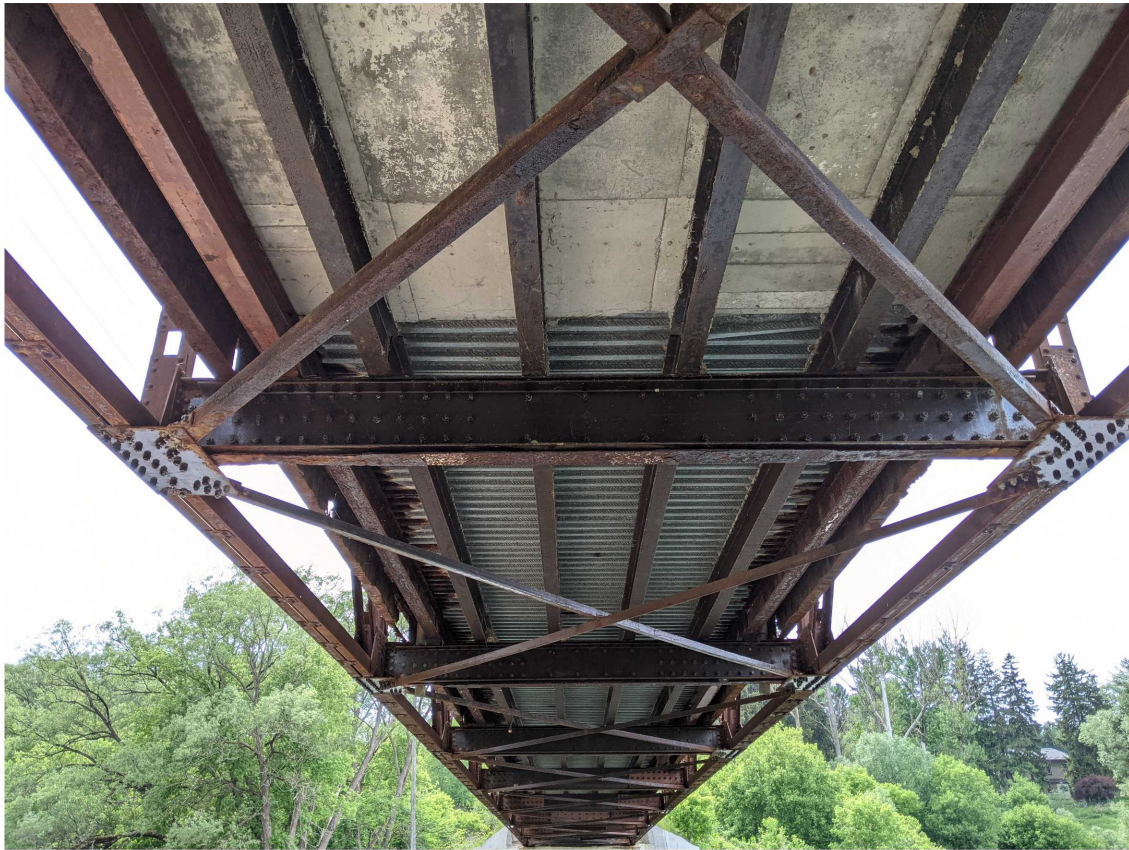
11. Typical Soffit

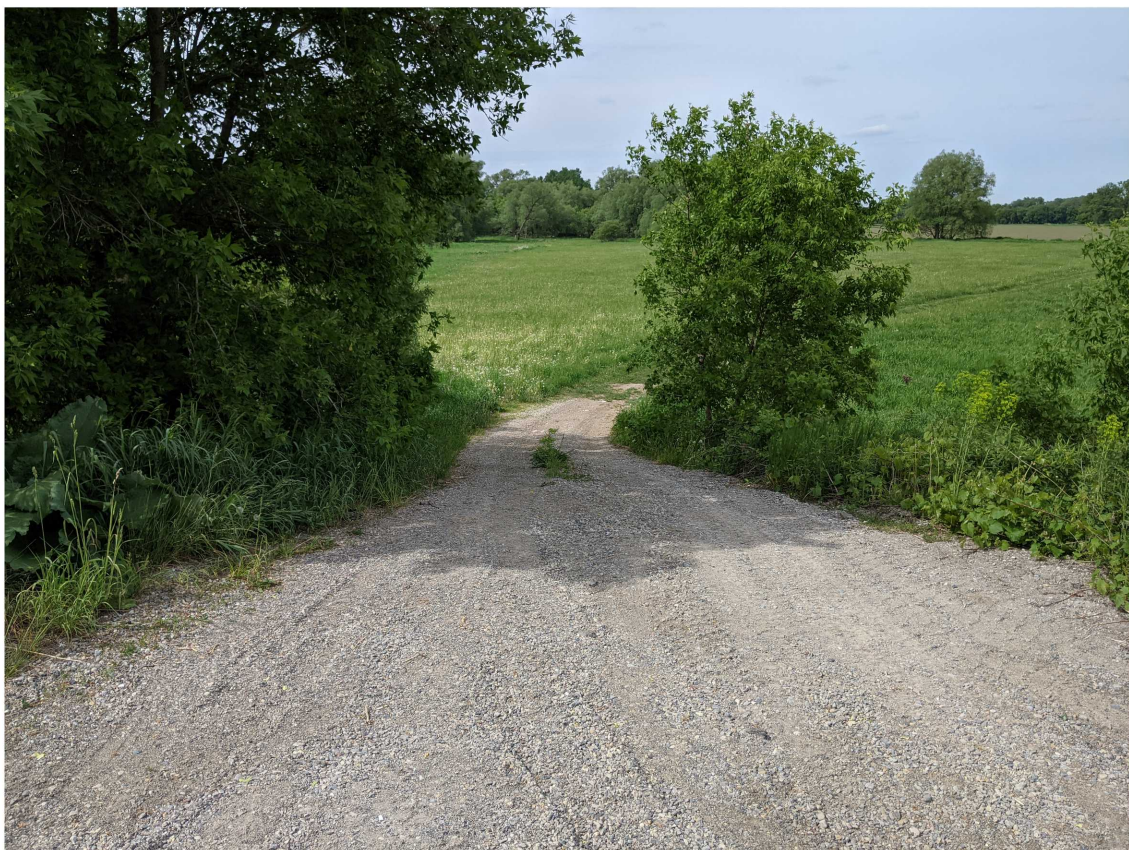
12. Field Entrance 1 - West of Bridge (looking north)

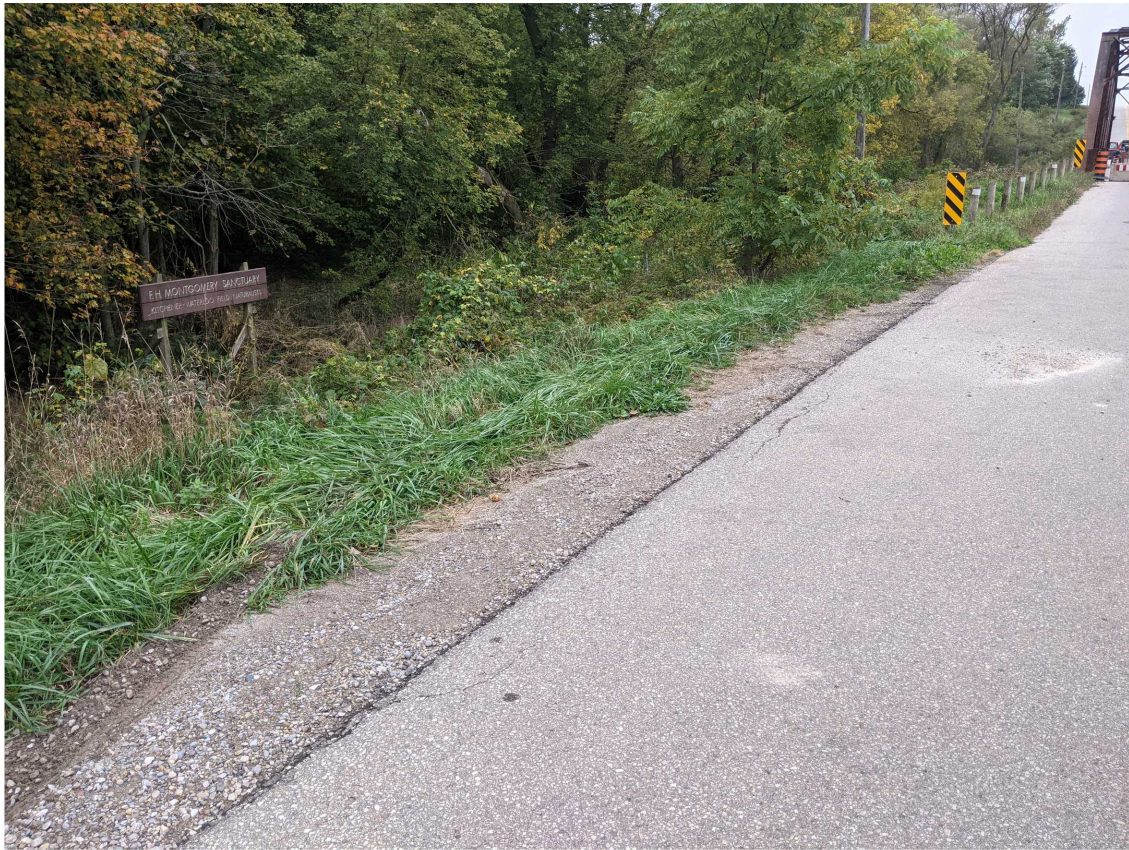
13. Field Entrance 2 - Future Driveway – East of Bridge

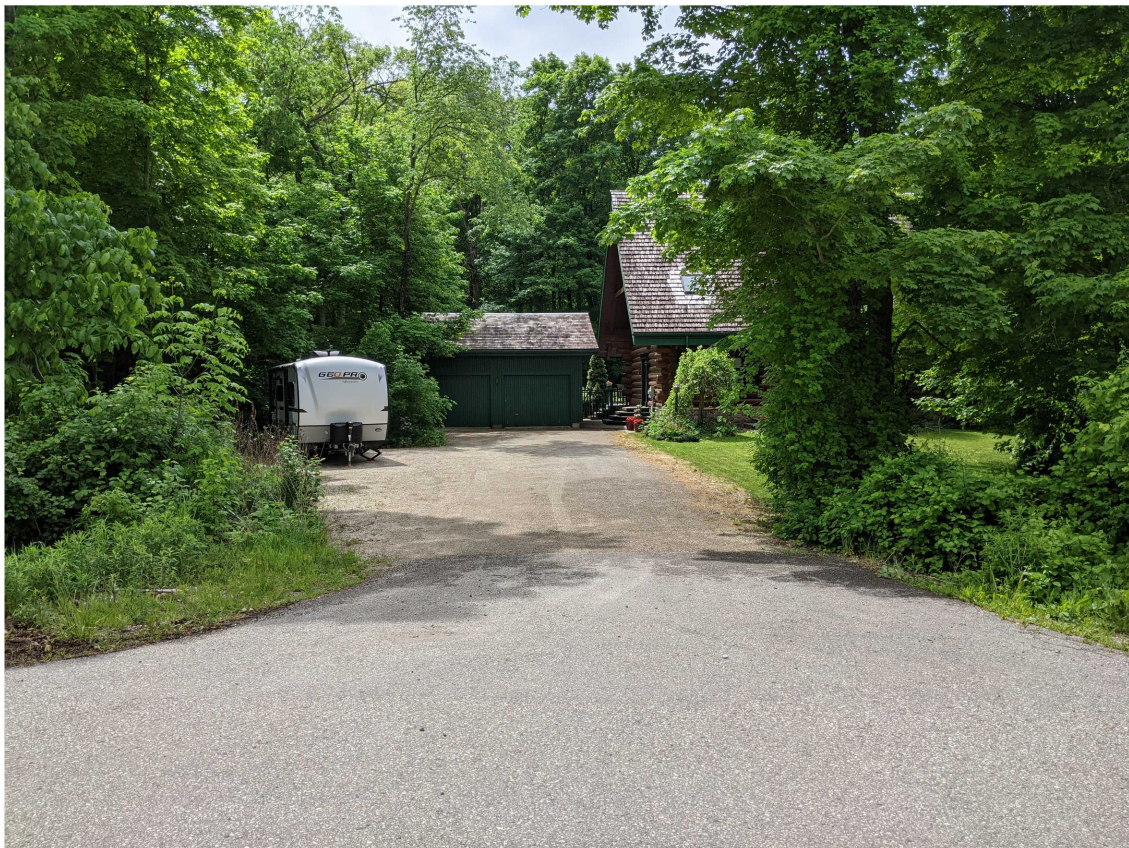
14. Entrance 3 - Residence East of Bridge (looking south)

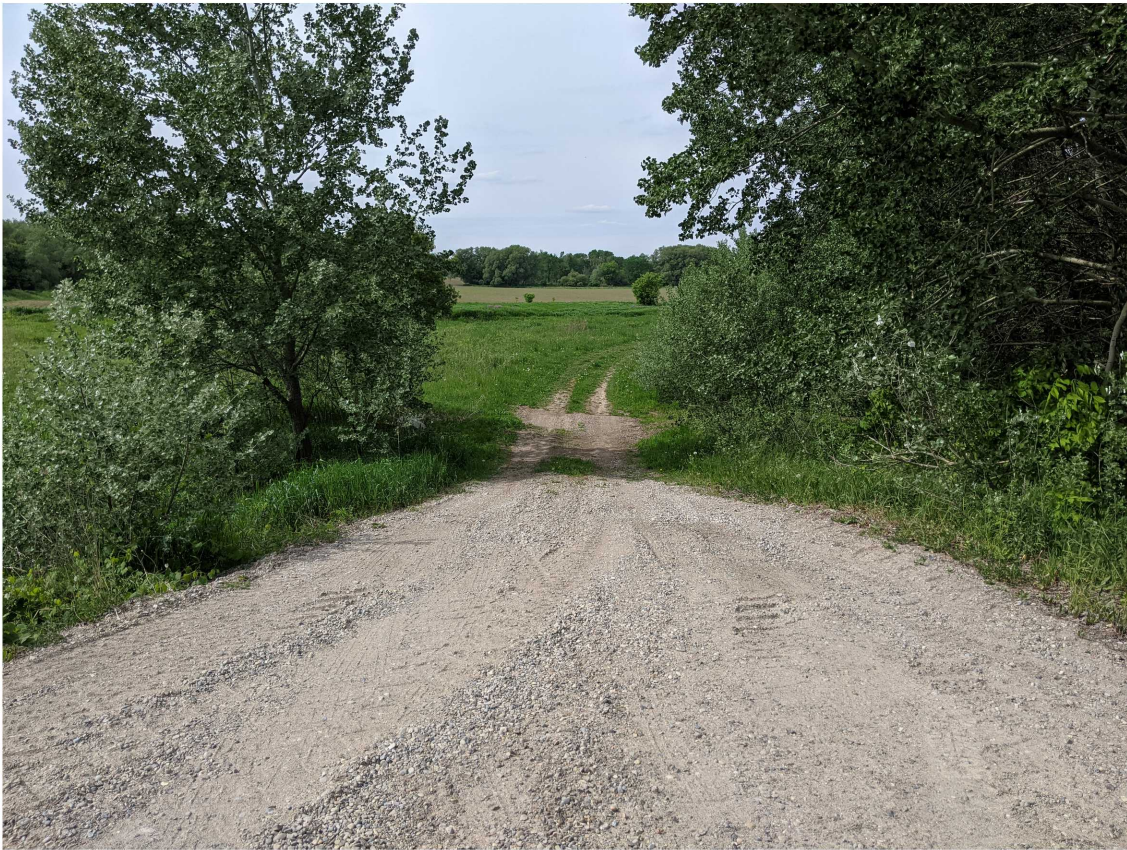
15. Field Entrance 4 - East of Bridge (looking north)
