# **BRIDGE STREET BRIDGE REPLACEMENT**

**(WILMOT BRIDGE 34/B-T9)**

## **SCHEDULE B MUNICIPAL CLASS ENVIRONMENTAL ASSESSMENT**

**Public Information Centre  
(Virtual)  
2021**

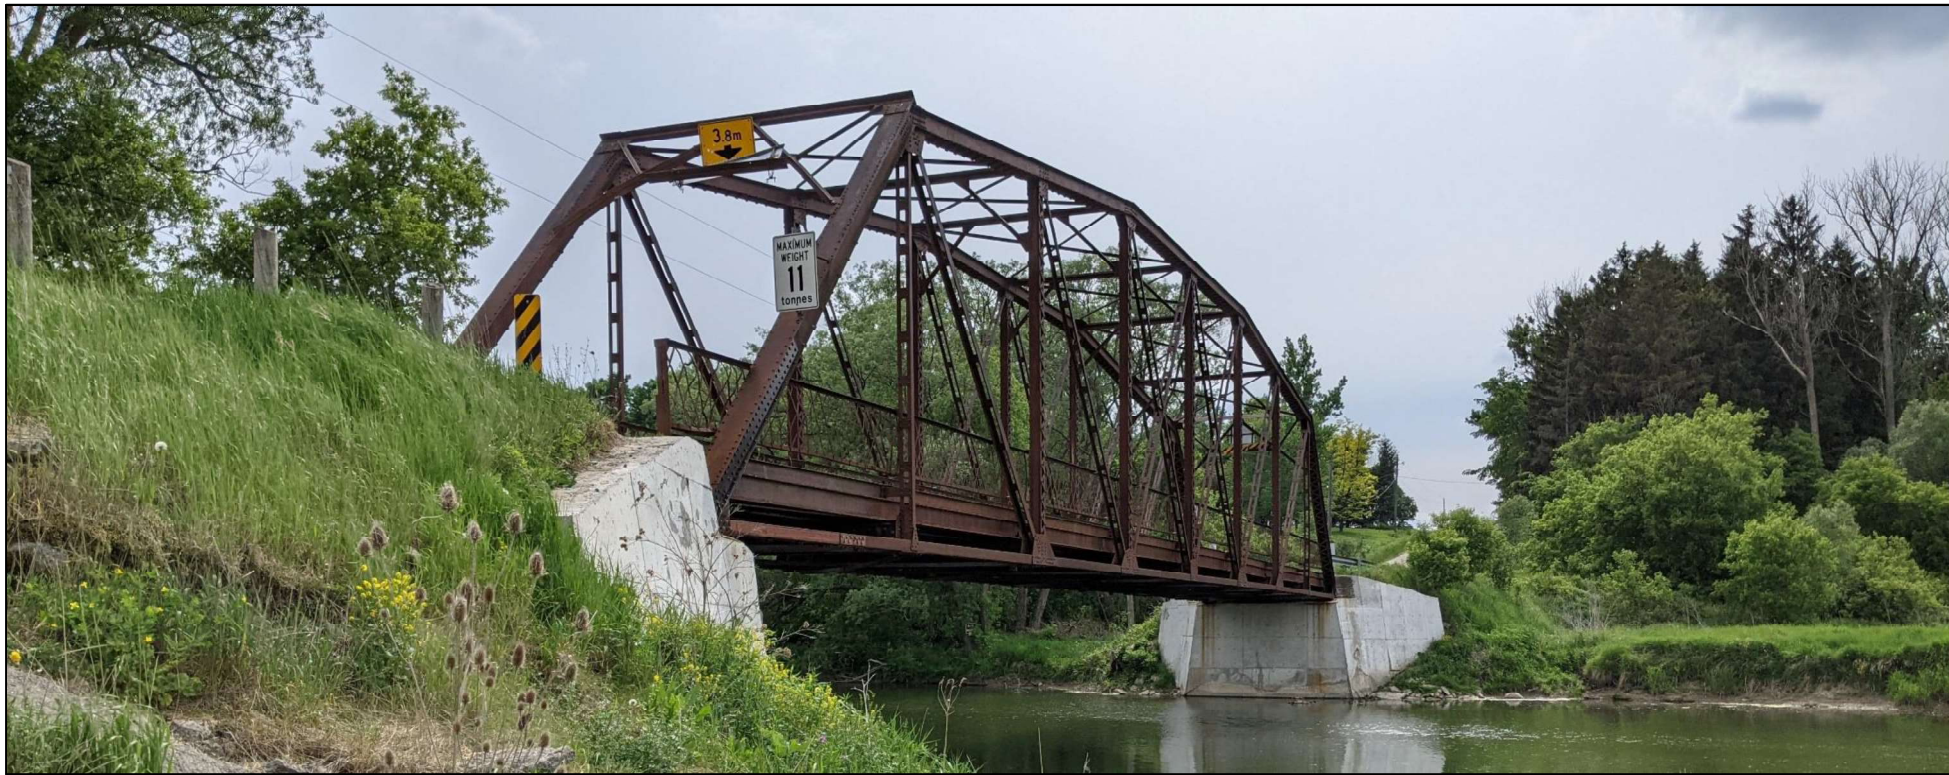
North / Upstream Elevation (looking south)

- **Bridge Street Bridge spans the Nith River on Bridge Street between Tye Road and Puddicombe Road.**
- **Bridge Street Bridge is in overall poor condition and nearing the end of its useful life. In addition, it is deficient in width, vertical clearance, and loading capacity.**
- **The study is being completed as a Schedule ‘B’ project, following the Municipal Class Environmental Assessment (October 2000, as amended)**
- **The Municipal Class EA provides a decision-making process to ensure that all relevant engineering and environmental features are considered in the planning and design of municipal infrastructure. The process requires public and agency involvement.**

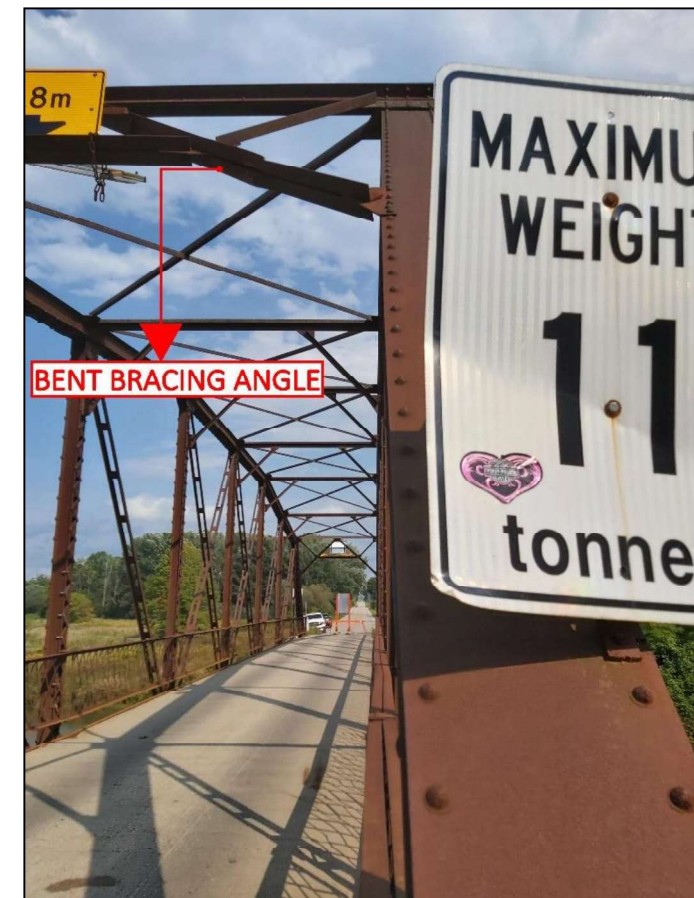
The latest road closure started from mid-September 2021 due to vehicular collision with the overhead bracings. Note one of the bent bracing angles in picture above.

- ▶ **During the last 10 years, this bridge has been closed multiple times. This averages to almost 1 closure per year.**
- ▶ **The overhead bracing (portal bracing) is routinely struck by vehicles. This results in the need for frequent repairs to this element.**
- ▶ **Despite the numerous repairs completed over the last 15 years, every year more of the original remaining bridge continues to deteriorate. It is not sustainable to continually repair this bridge.**

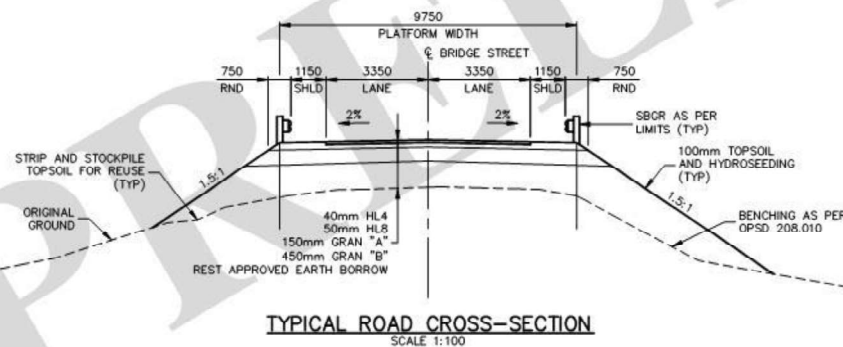
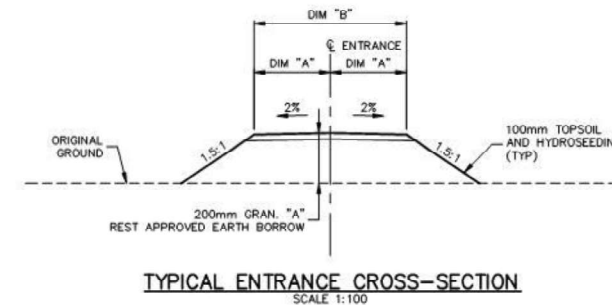
# Preferred Alternative – Drawing 1 of 5

## STEEL BEAM GUIDE RAIL WITH CHANNEL

### NORTHWEST QUADRANT

- 1 - STRUCTURE CONNECTION (OPSD 912.430)
- 9 - SBGR PANELS @ 3.81m = 34.29m (OPSD 912.130)
- 1 - LEAVING END TREATMENT = 3.81m (OPSD 912.235)

### NORTHEAST QUADRANT

- 1 - STRUCTURE CONNECTION (OPSD 912.430)
- 4 - SBGR PANELS @ 3.81m = 15.24m (OPSD 912.130)
- 1 - SBEAT END TREATMENT = 15.24m (SEE SPECIFICATIONS)

### SOUTHWEST AND SOUTHEAST QUADRANTS

LOCATION	DIM "A"	DIM "B"
FIELD ENTRANCE 1	2.5m	5.0m
ENTRANCE 2	1.75m	3.5m
ENTRANCE 3	2.5m	5.0m
FIELD ENTRANCE 4	2.5m	5.0m

PLAN

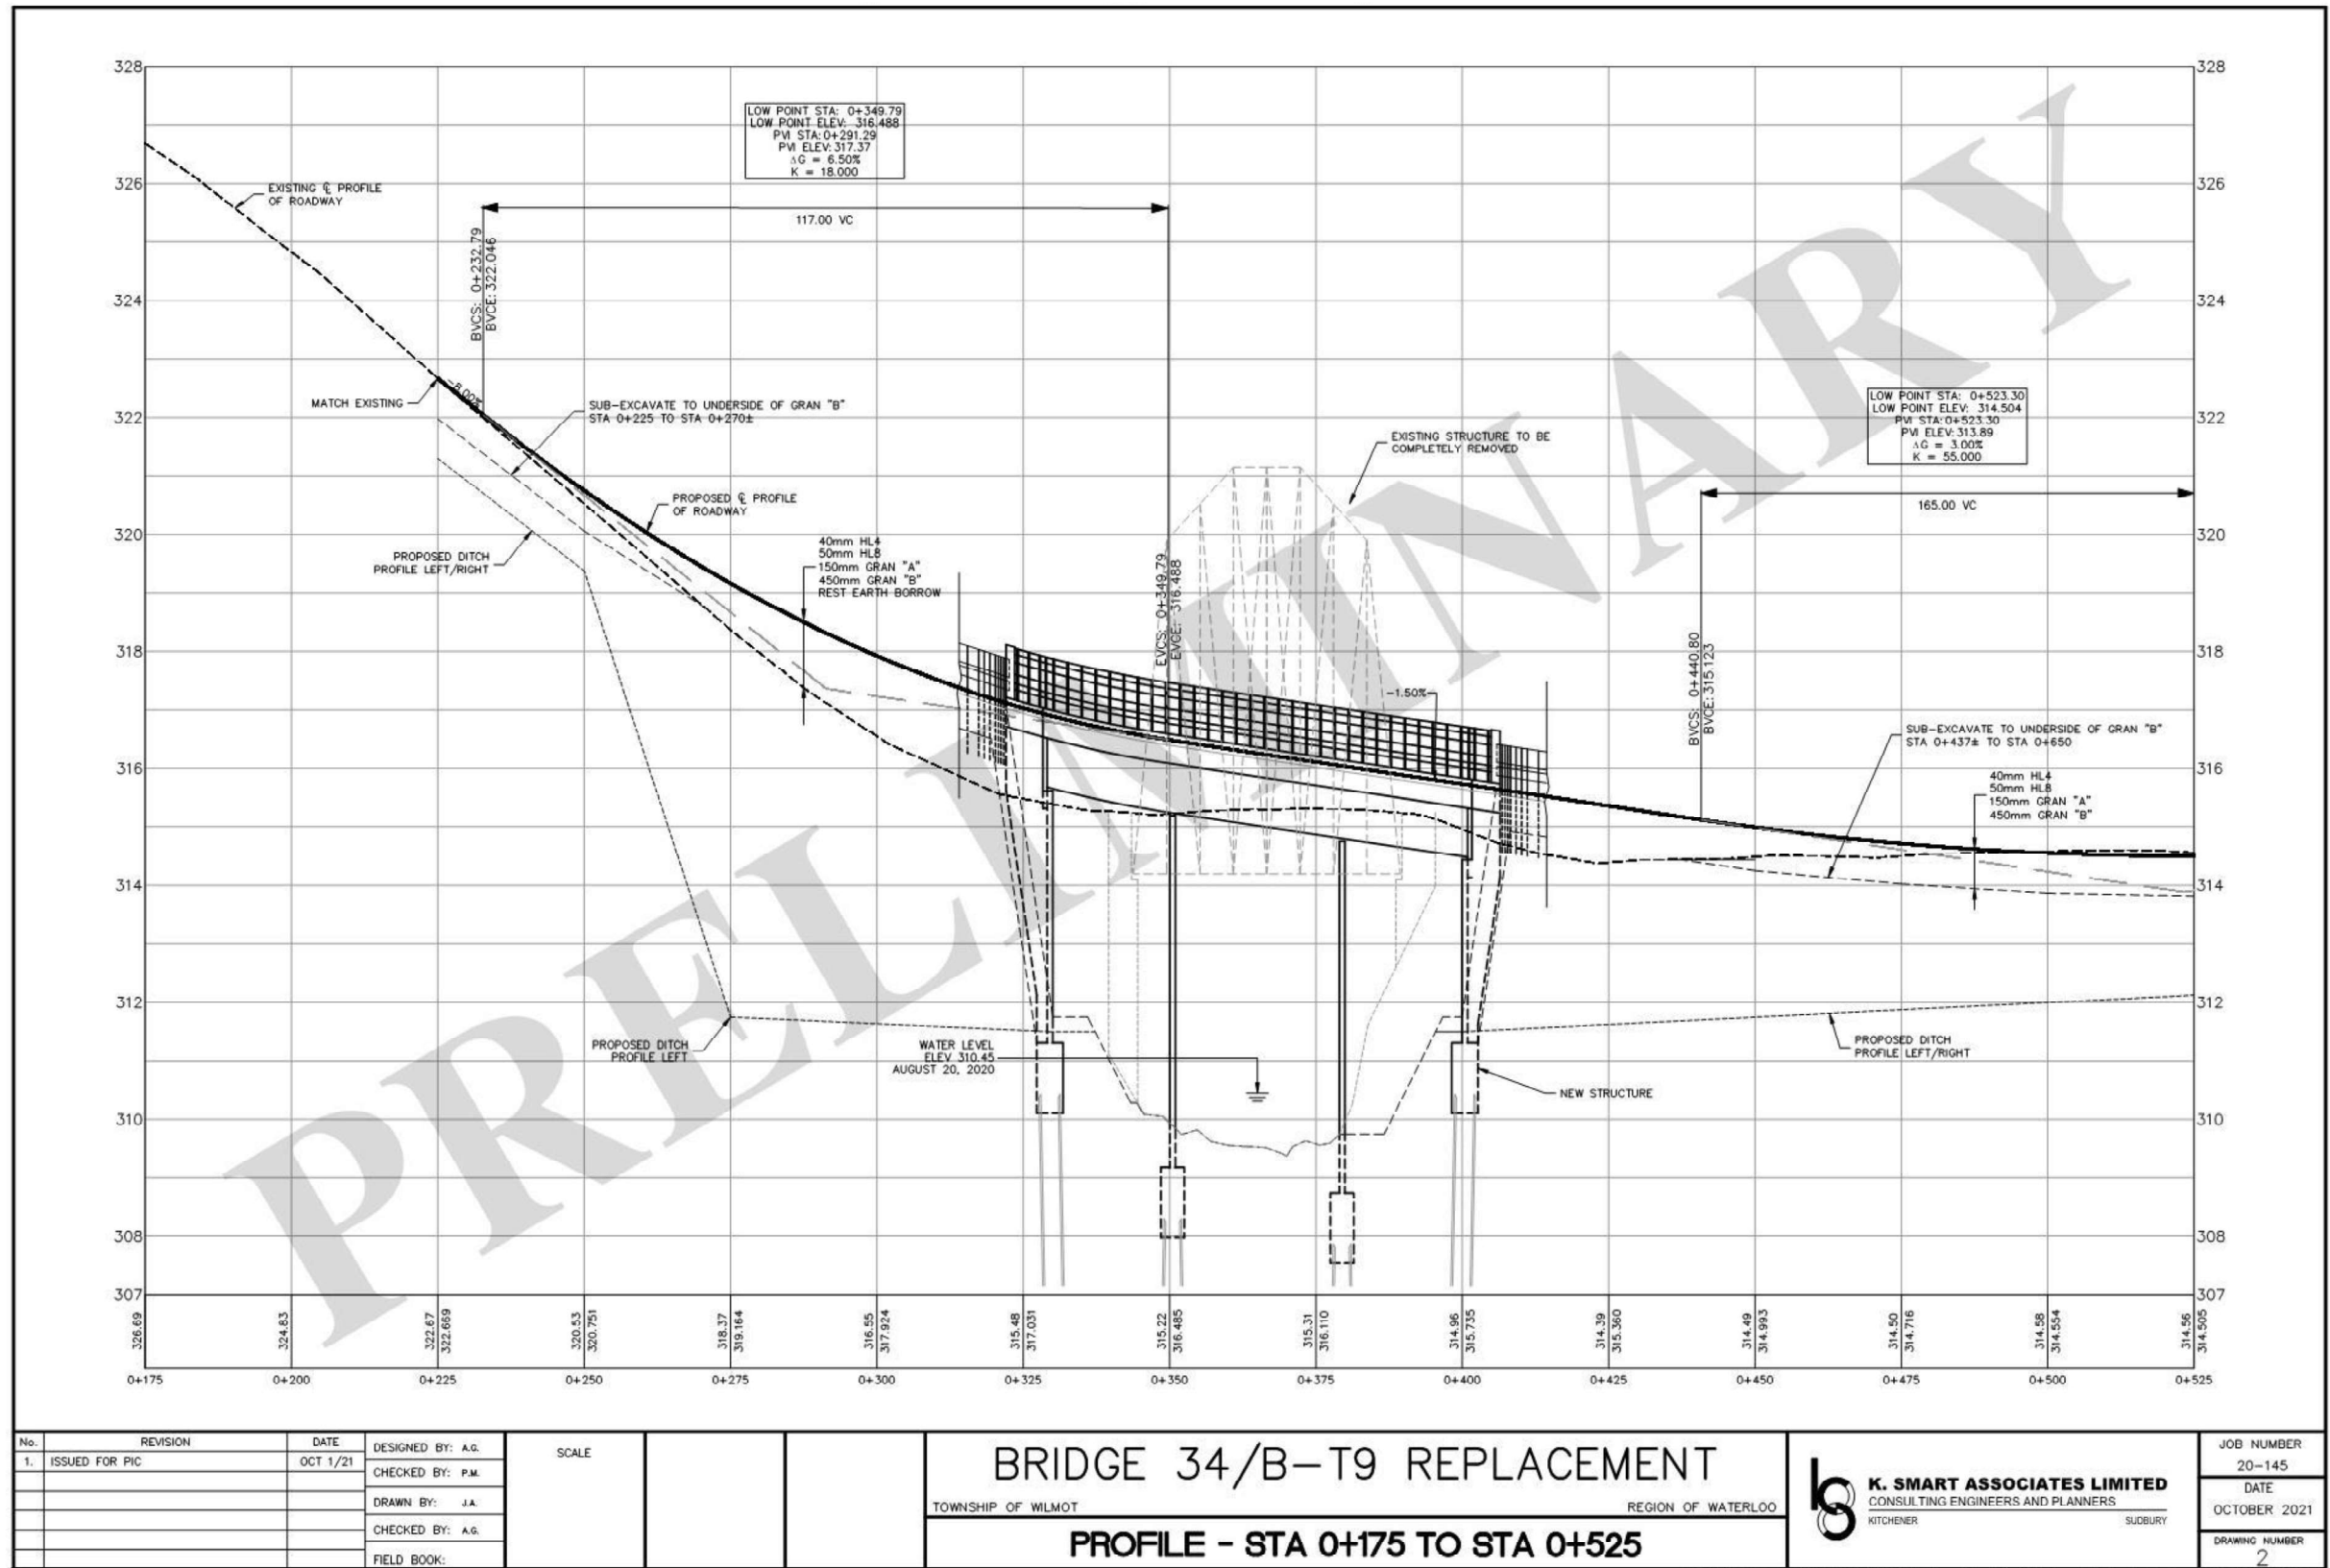
# Preferred Alternative – Drawing 2 of 5

No.	REVISION	DATE	DESIGNED BY: A.G.	SCALE				<div>BRIDGE 34/B-T9 REPLACEMENT</div> <div>TOWNSHIP OF WILMOT<div>REGION OF WATERLOO</div></div> <div>PROFILE - STA 0+175 TO STA 0+525</div>	<div><div><div>bs</div></div><div><div>K. SMART ASSOCIATES LIMITED</div><div>CONSULTING ENGINEERS AND PLANNERS</div><div>KITCHENER</div><div>SUBURBY</div></div></div>	JOB NUMBER
1.	ISSUED FOR PIC	OCT 1/21	CHECKED BY: P.M.							20-145
			DRAWN BY: J.A.							DATE
			CHECKED BY: A.G.							OCTOBER 2021
			FIELD BOOK:							DRAWING NUMBER
										2
