HARDEN ENVIRONMENTAL SERVICES LIMITED

Level 1 and Level 2 Hydrogeological Evaluation for Above Water Table Aggregate Extraction

Hallman Pit

Township of Wilmot Regional Municipality of Waterloo

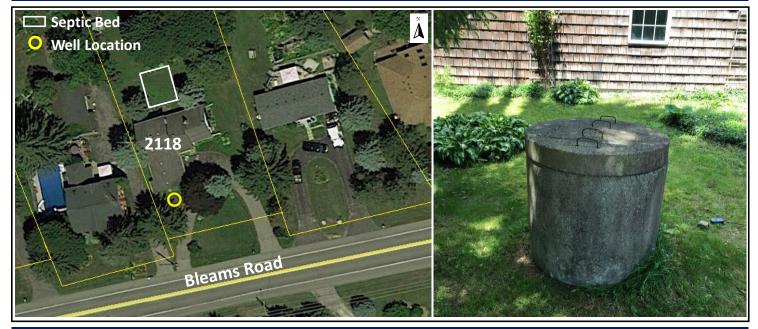
Sketch of Well Location: (house, road, septic, well, etc. north arrow)

Well Tag: None Casing Outside Diameter: 36 inches Well Location: NAD83 UTM17 Easting 531903 Northing 4804111 (+/- 3m)

Casing Type: Concrete Wellhead Condition: Good

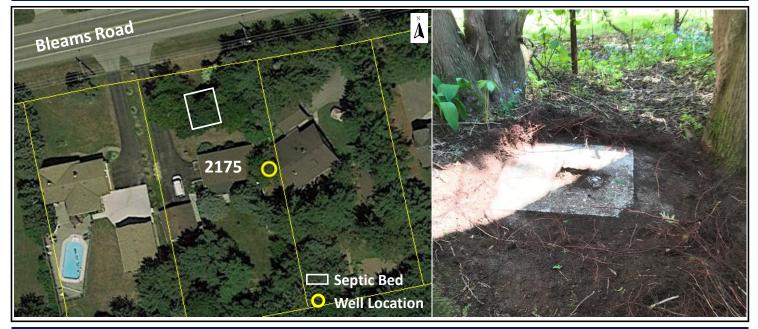
Sketch of Well Location: (house, road, septic, well, etc. north arrow)

Well Tag: None Casing Inside Diameter: Unknown Well Location: NAD83 UTM17 Easting 531666 Northing 4803992 (+/- 3m)

Casing Type: Steel Wellhead Condition: Unknown

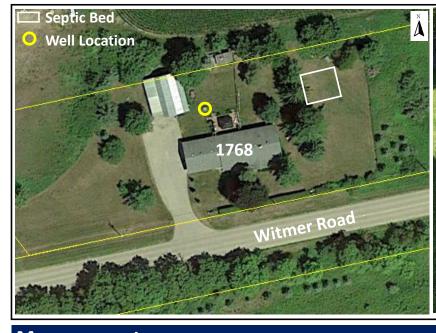
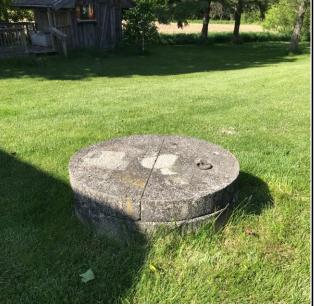
Sketch of Well Location: (house, road, septic, well, etc. north arrow)

Location: 1768 Witmer Road

Stick up: 0.34 m Casing Type: Concrete Wellhead Condition: Needs repair, concrete is deteriorating in spots

Vermin Proof?: no, 1-2 inch gap approximately 5 inches long between lid and upper tile due to missing concrete

Note: Owner planning to repair concrete asap

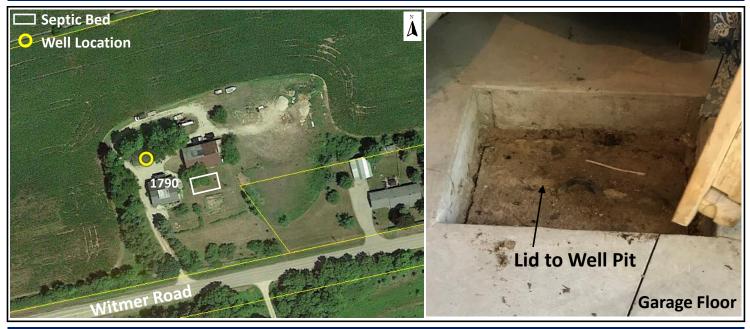
Sketch of Well Location: (house, road, septic, well, etc. north arrow)

Well Tag: None Casing Inside Diameter: 6 to 6 1/4 inches Vermin Proof?: Yes

Stick up: 5 1/2 feet below grade (1.68 metres) Casing Type: Steel Wellhead Condition: Good Note: Top of well casing is 5 1/2 feet below grade, 6 inches above well pit floor. Well pit is dry.

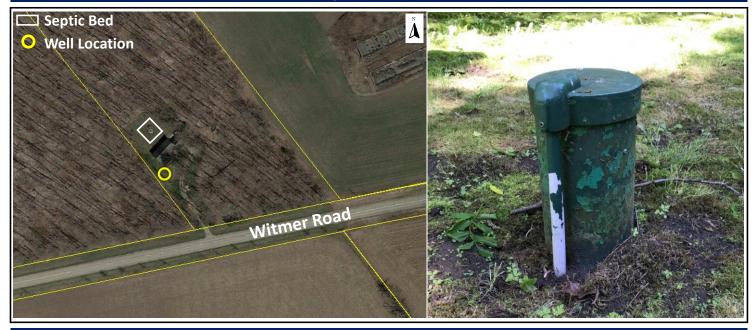
Sketch of Well Location: (house, road, septic, well, etc. north arrow)

Well Tag: None Casing Inside Diameter: 6 1/4 inches Well Depth: 100 feet Well Location: NAD83 UTM17 Easting 532226 Northing 4802825 (+/- 3m)

Stick up: 0.31 m Casing Type: Steel Wellhead Condition: Good

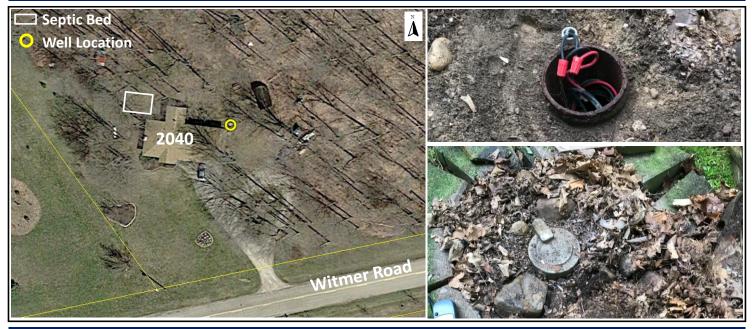
Sketch of Well Location: (house, road, septic, well, etc. north arrow)

Well Tag: None Casing Inside Diameter: 5 inches

Stick up: 0.02 m Casing Type: Steel Wellhead Condition: Good

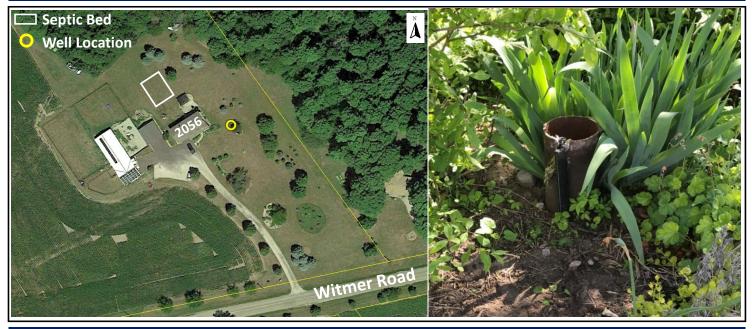
Sketch of Well Location: (house, road, septic, well, etc. north arrow)

Well Tag: None Casing Inside Diameter: 6 inches

Stick up: 0.26 m Casing Type: Steel Wellhead Condition: Good

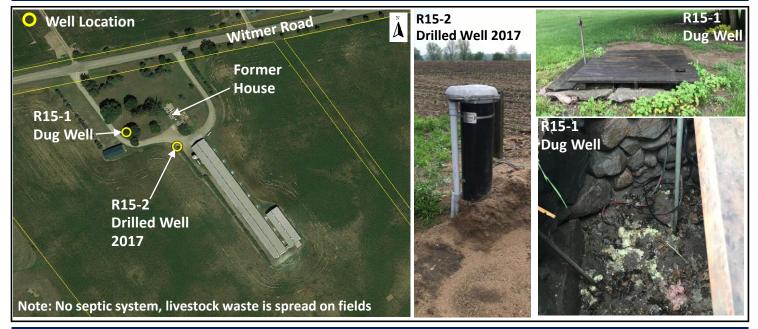
Sketch of Well Location: (house, road, septic, well, etc. north arrow)

Well Tag: A216960 Casing Inside Diameter: 6 inches Well Depth: 82 feet below ground surface
