# RE: Environmental Study to Support the Bridge Street Replacement, south of Haysville, in Wilmot Township

Environmental Liability Management Inc. (ELM) is pleased to submit this revised Environmental Study to K.Smart Associates Limited (KSAL) to support a proposal for the replacement of the Bridge Street Bridge, south of Haysville, in Wilmot Township (hereinafter, the Site).

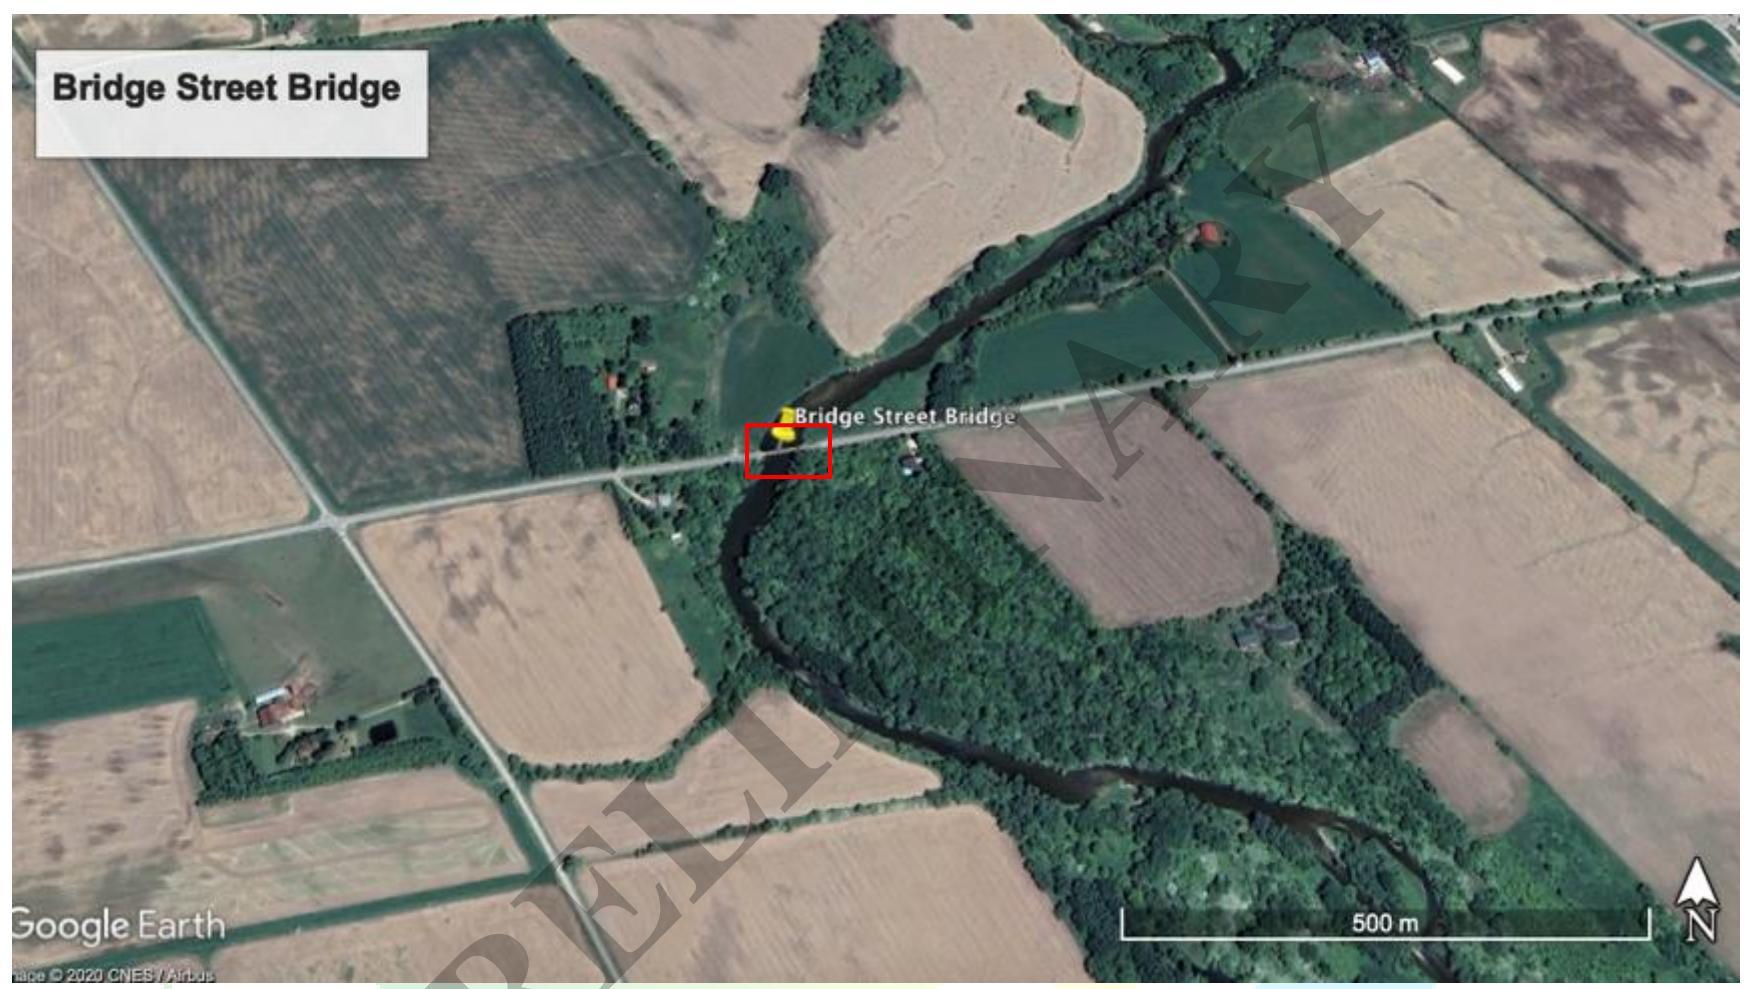
**Figure 1a:** A high elevation aerial photograph of the Site during 2019. This study will be focused on completing an environmental screening of the Bridge Street Bridge and nearby natural areas. The Site is located within the red rectangle, with the Bridge Street Bridge indicated with a yellow marker. Aerial imagery was obtained from a public database (i.e., Google Earth).

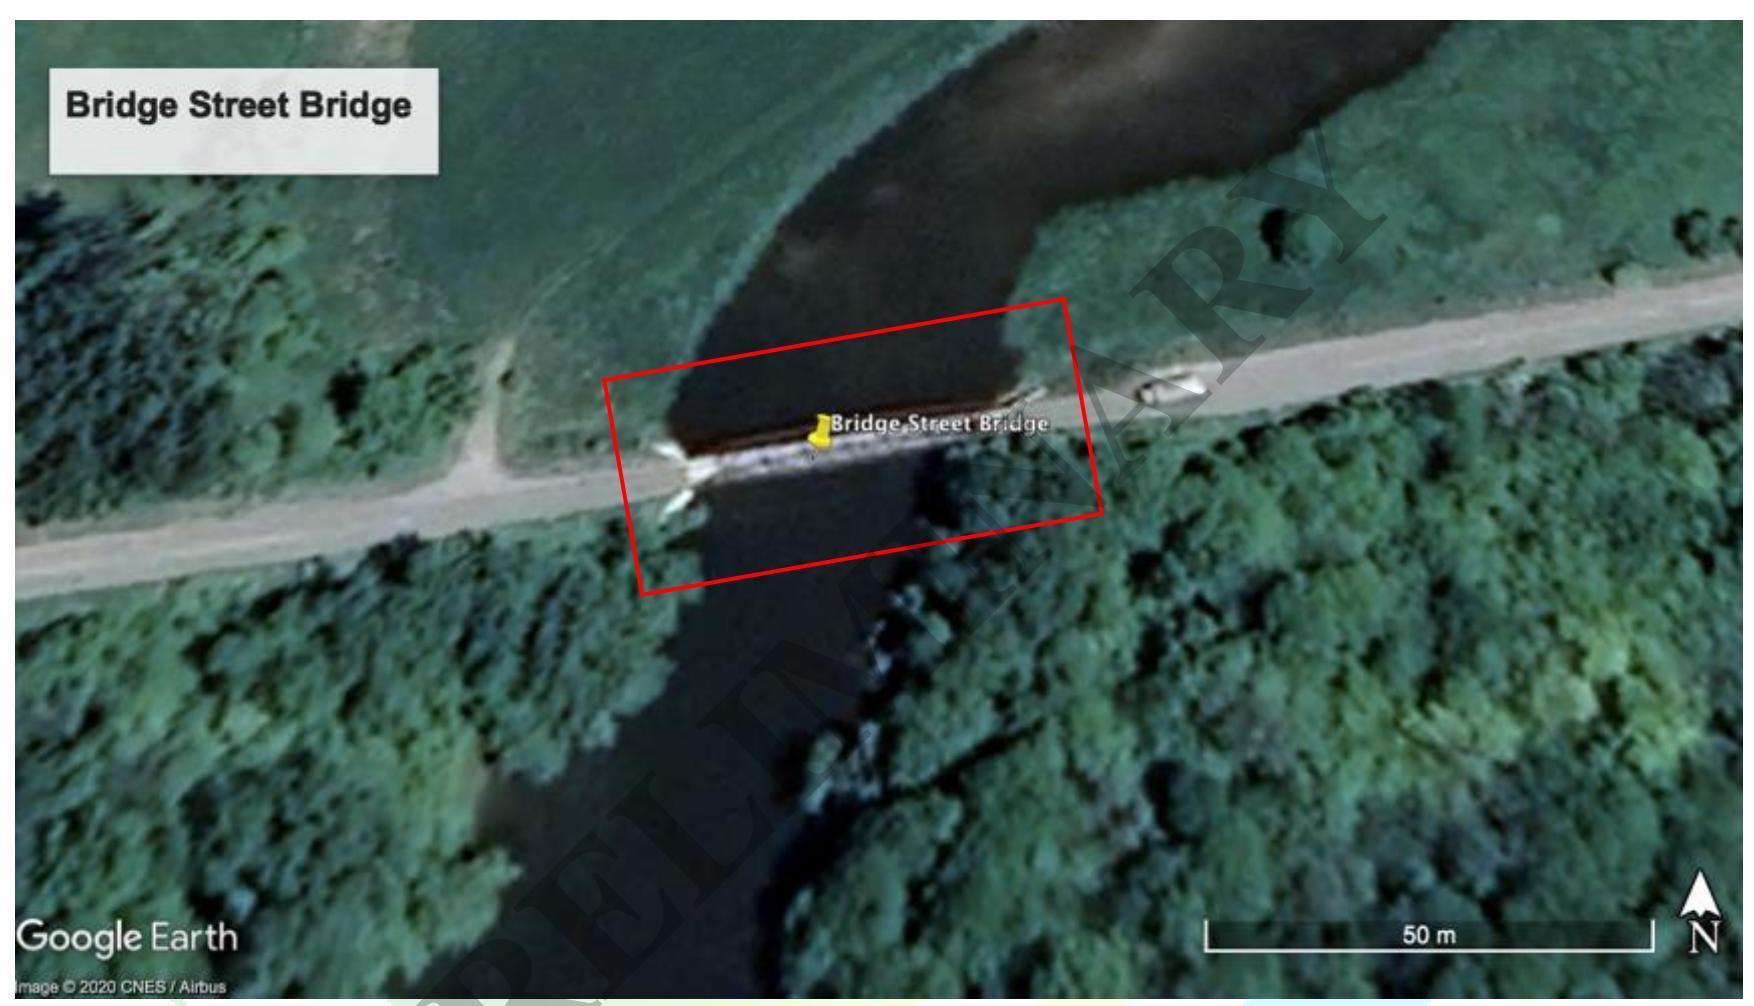
**Figure 1b:** A low elevation aerial photograph of the Site during 2019. This study will be focused on completing an environmental screening of the Bridge Street Bridge and nearby natural areas. The Site is located within the red rectangle, with the Bridge Street Bridge indicated with a yellow marker. Aerial imagery was obtained from a public database (i.e., Google Earth).

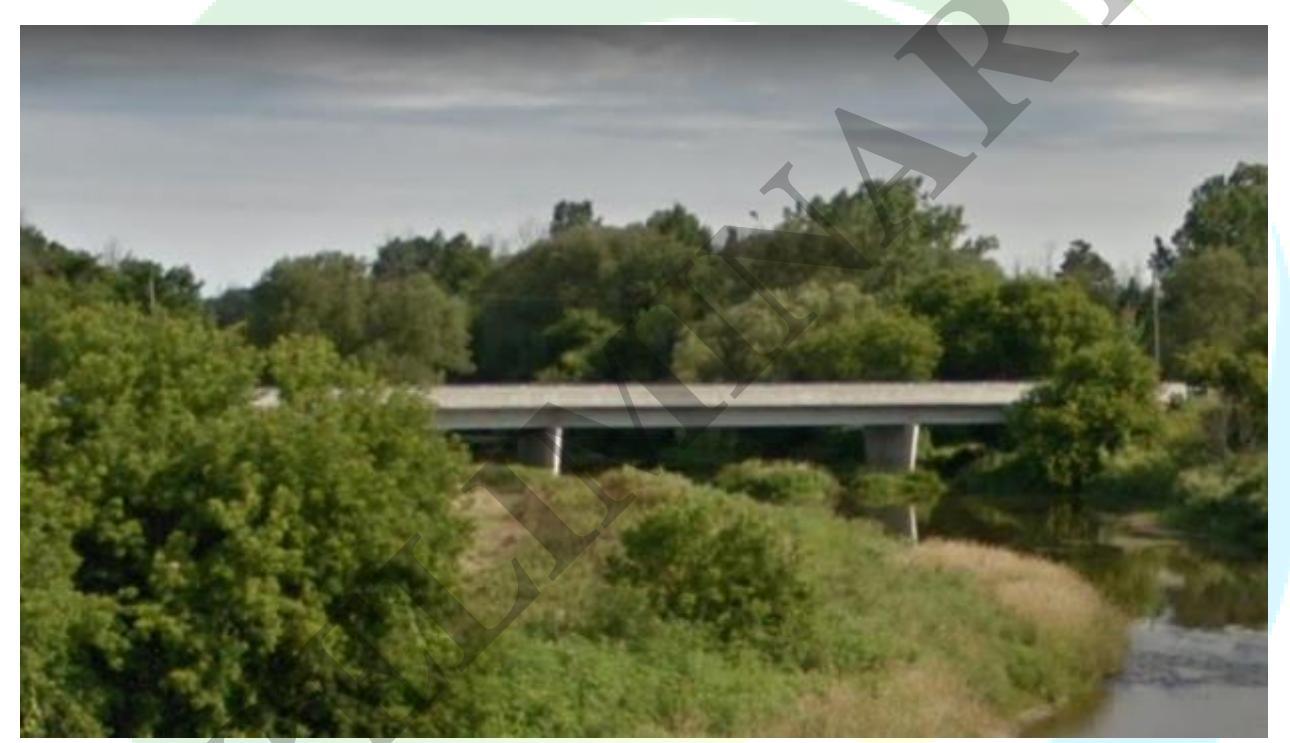
**Figure 2a:** View, looking south of a bridge located along Township Road 11, near Ayr, ON. This structure also crosses over the Nith River, and was constructed with two in-water pillars.

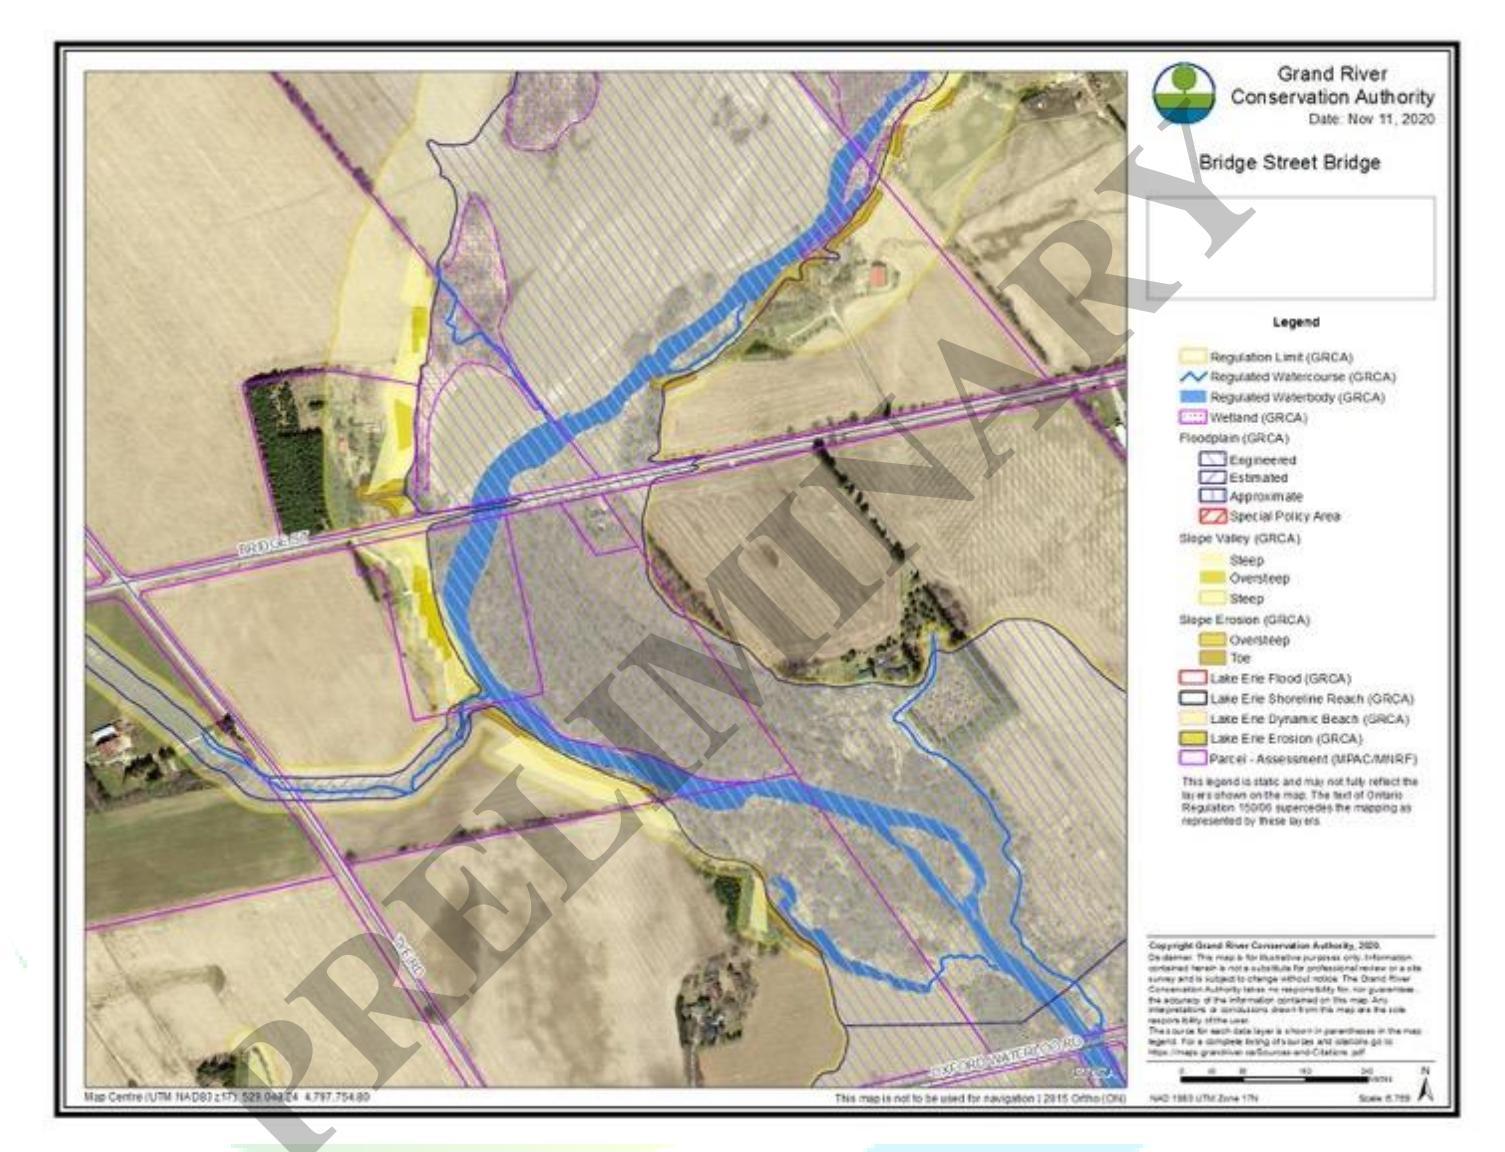
**Figure 4:** View of available floodplain mapping in proximity to the Bridge Street Bridge. The Nith River exists within land currently regulated by the GRCA. Mapping demonstrates that the Bridge lies in an area with engineered floodplains with steep slopes located west of the Nith River. Produced using information under License with the Grand River Conservation Authority © Grand River Conservation Authority, 2020.

Available flood plain mapping was examined in order to further identify natural features at the Site. The Nith River falls within the jurisdiction of the GRCA. Flood plain mapping reveals that the Bridge Street Bridge lies within a large area of engineered floodplain, which extends over adjacent fields and woodland areas. West of the Nith River, an area with slopes ranging from steep to over steep is documented. At the base of this sloped area a number of regulated wetlands exist. It is likely that water from flooding is trapped at the base of these slopes following seasonal flooding events, allowing moisture tolerant vegetation to thrive and creating micro wetland ecosystems. It is also prudent to document the presence of two small tributary creeks located downstream of the Bridge and two small tributary creeks located upstream from the Bridge. These areas are not expected to be disturbed by the proposed activities given the distance at which they exist from the Site.

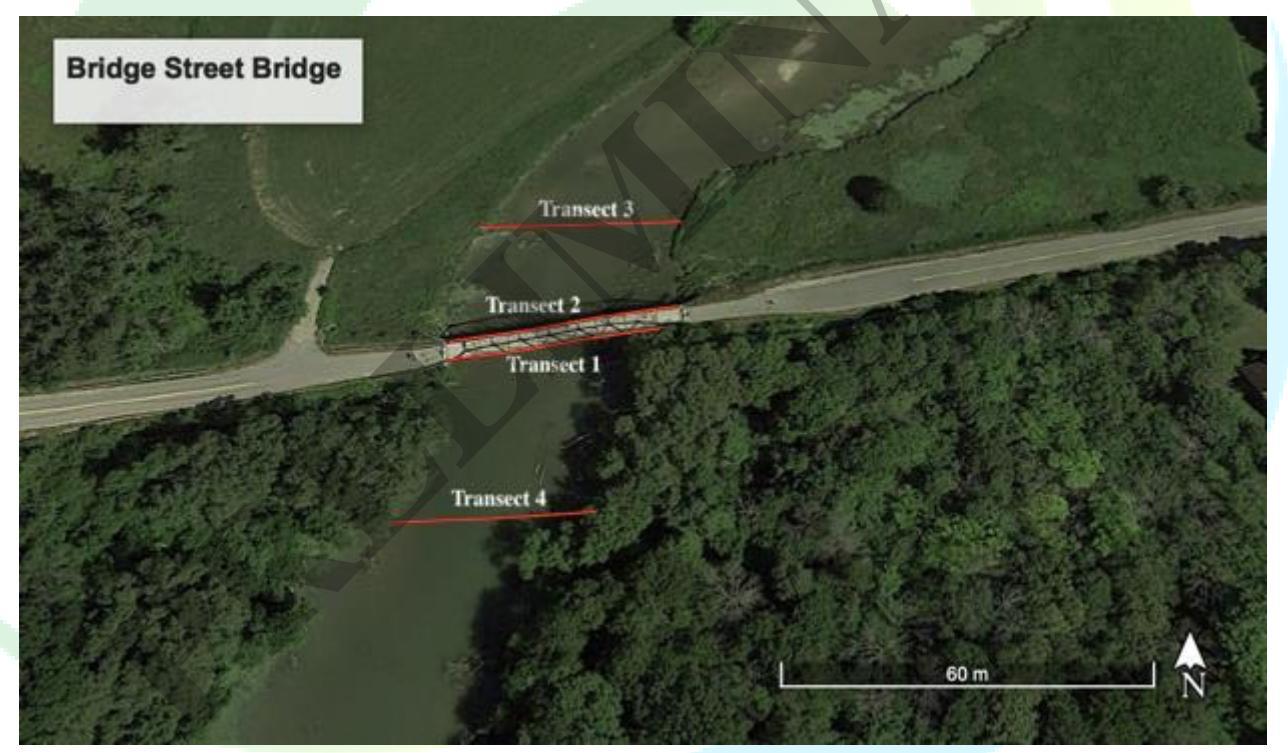
**Figure 6:** The depth of water across the Nith River was documented to range from approximately 30 cm along the shoreline to more that 1.5 m at the deepest points in proximity to the center of the River. Based on depth measurements, the River appears to be shallowest upstream of the Bridge and gradually gets deeper as water flows downstream.

Water depth across the River was measured at four different transects. All transects were measured form the eastern shoreline or abutment to the western shoreline or abutment. Measurements were completed using two, wooden 1-metre sticks. Transect 1 was measured from abutment to abutment beneath the southern edge of the Bridge. Transect 2 was measured from abutment to abutment beneath the northern edge of the Bridge. Transect 3 was measured from shoreline to shoreline approximately 30 m upstream of the Bridge, while Transect 4 was measured from shoreline to shoreline approximately 30 m downstream of the Bridge. Transects have been depicted within Figure 6.

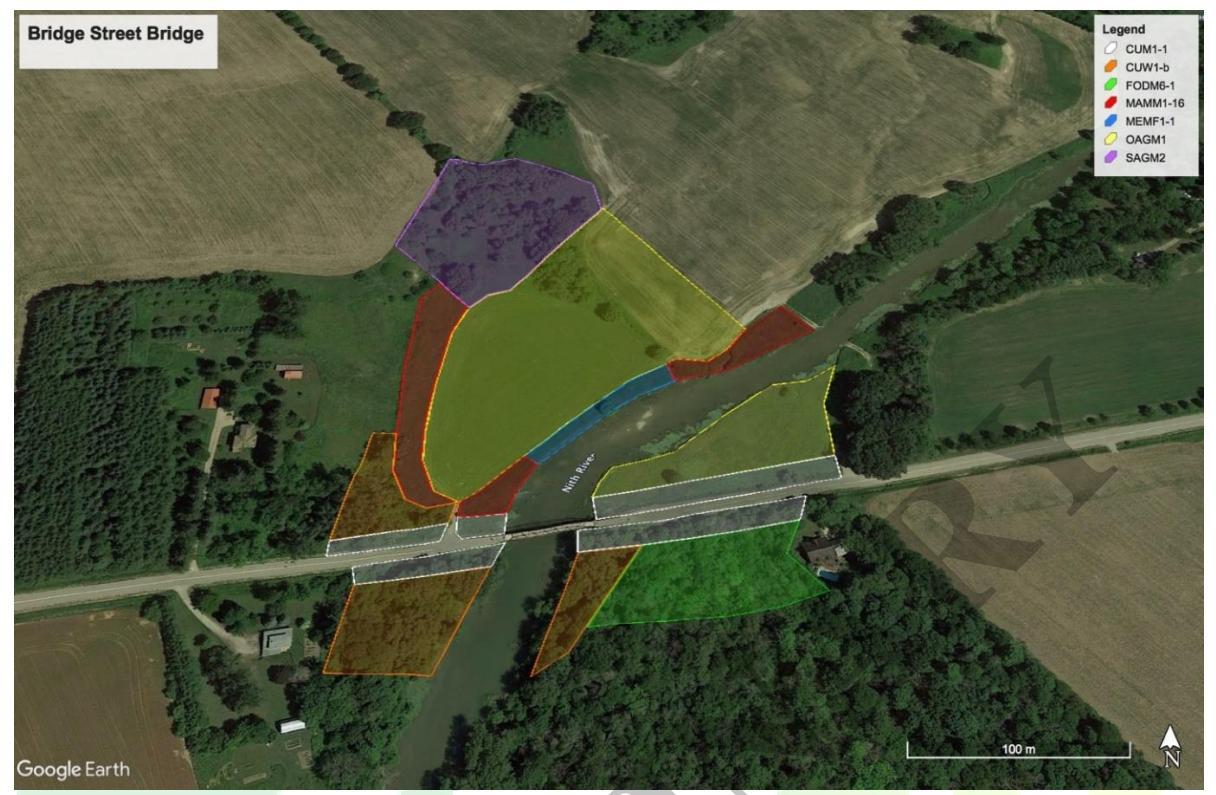
**Figure 7:** Aerial view of the Bridge Street Bridge with ELC polygons overlaid. A total of seven different ELC polygons were documented based on vegetation communities and soil.

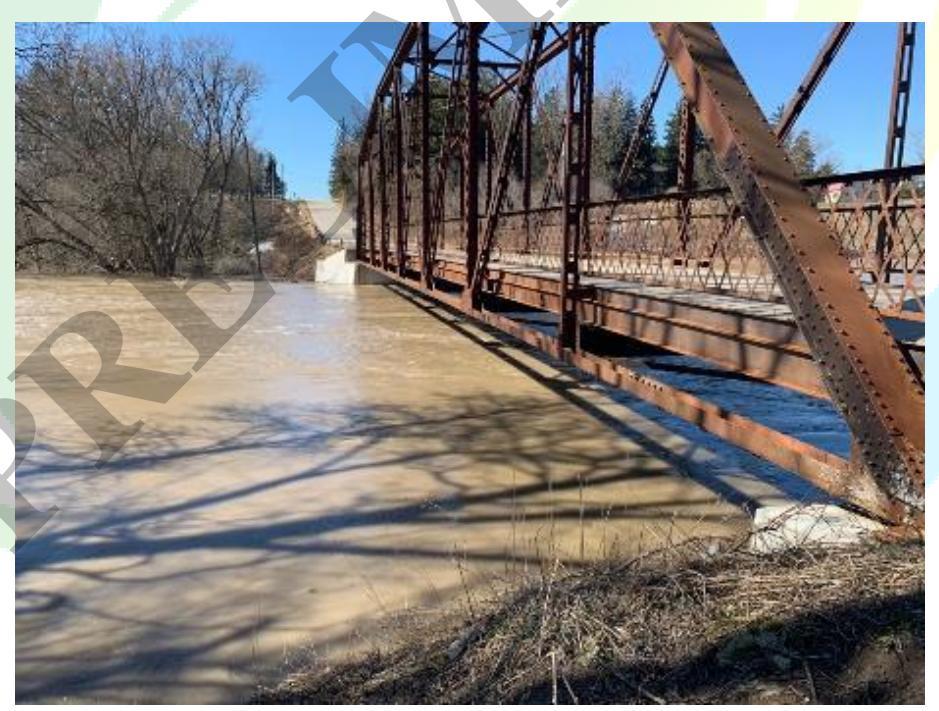
**Figure 8:** View of the Nith River during the March 12, 2021 flooding event. Water was documented to exist nearly 30 cm from the Bridge deck, and flood into surrounding fields and woodlands.

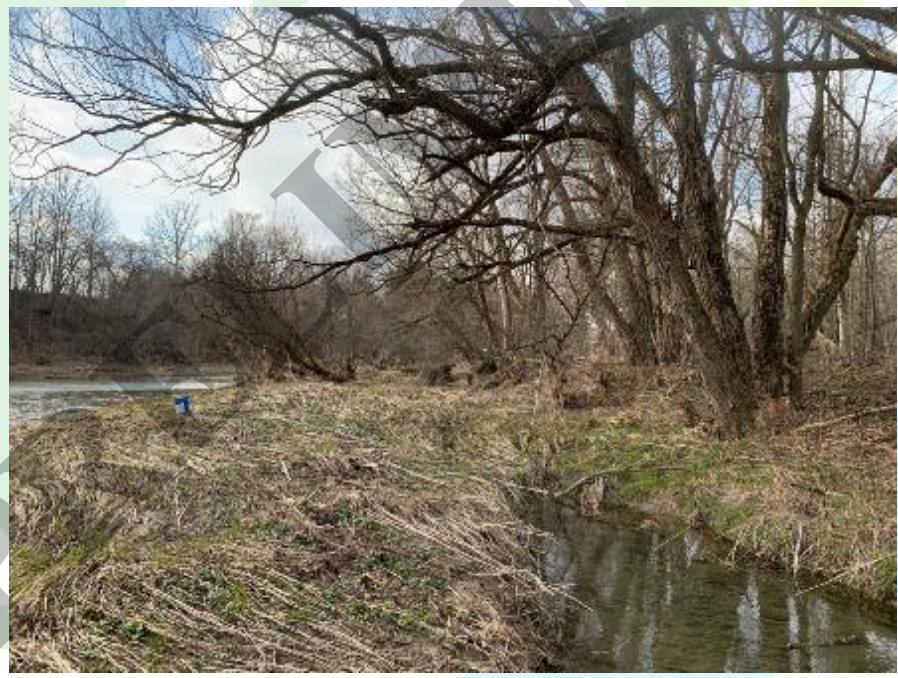
**Figure 17:** View of the same shoreline on April 1, looking north, once flooding has receded. This phot demonstrate the effects of episodic flooding, vegetation may be observed to have been matted down in the downstream direction, as a result of past fast flowing water moving through the area.

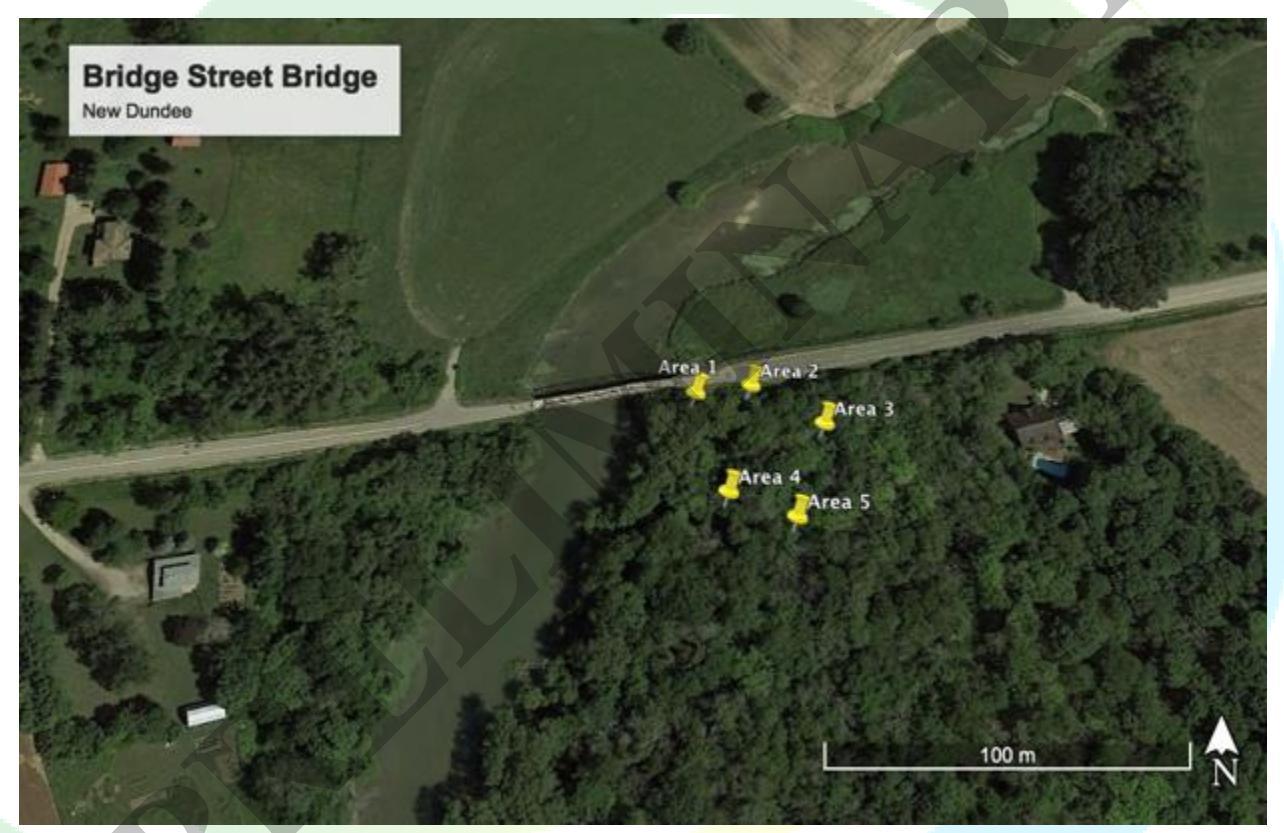
**Figure 21:** View of the five different areas from which mussel shells were collected. Collection of mussel shells was performed with a radius of approximately 10 m surrounding each marker.

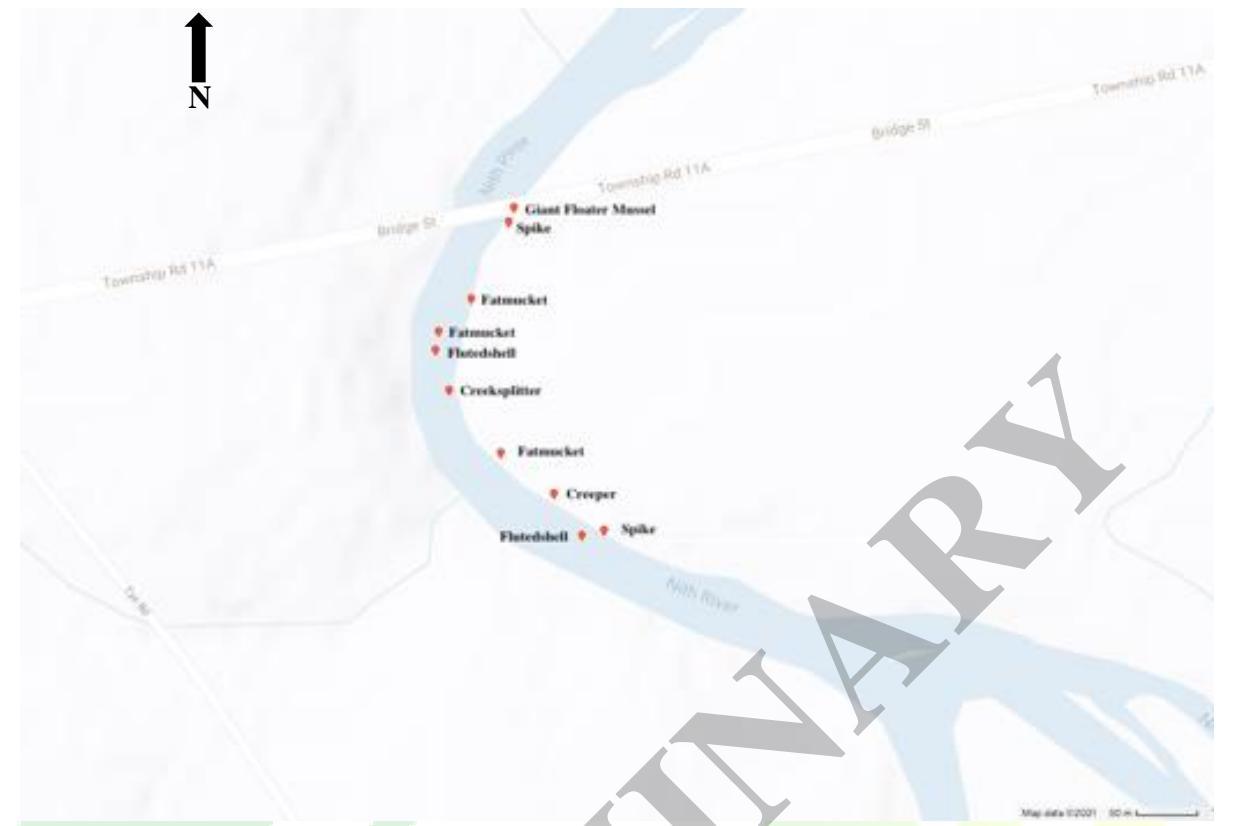
**Figure 23:** Summary of observations of freshwater mussels made by Mr. Fraser Gibson along the Nith River in proximity to the Bridge Street Bridge.

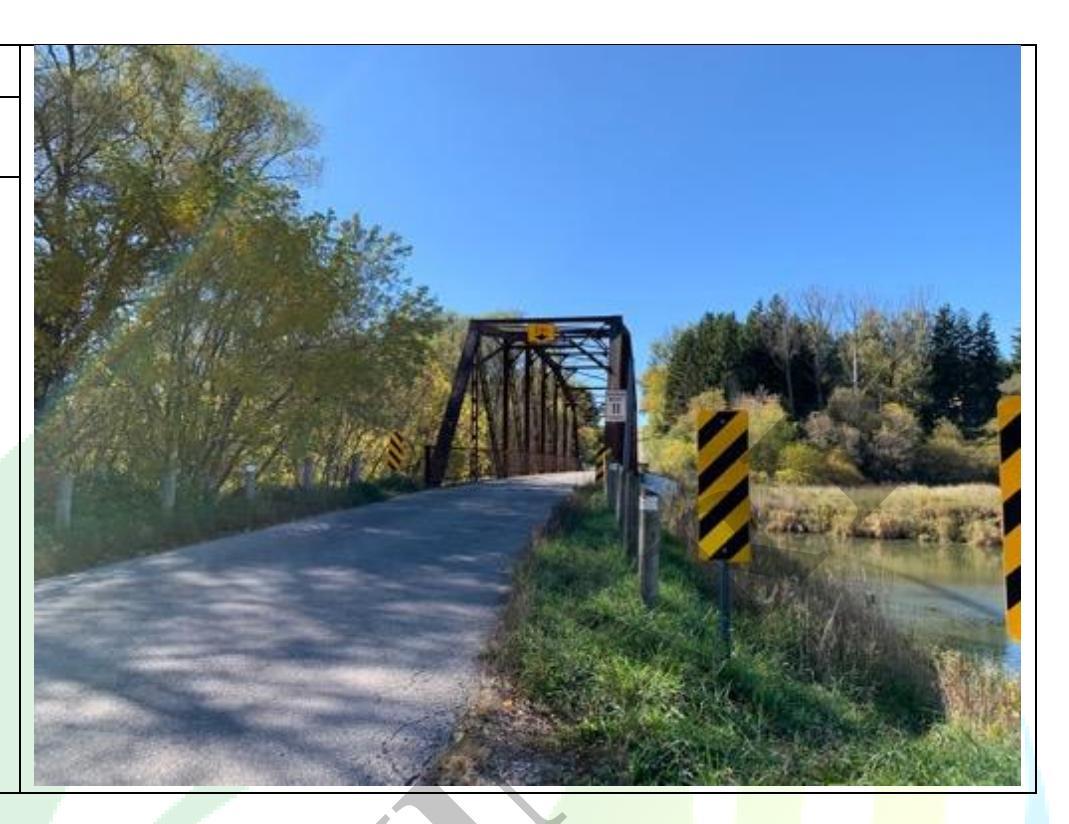
Photo No. 2 Date: October 13, 2020 Description: View, looking east, of the Bridge Street Bridge and Nith River.

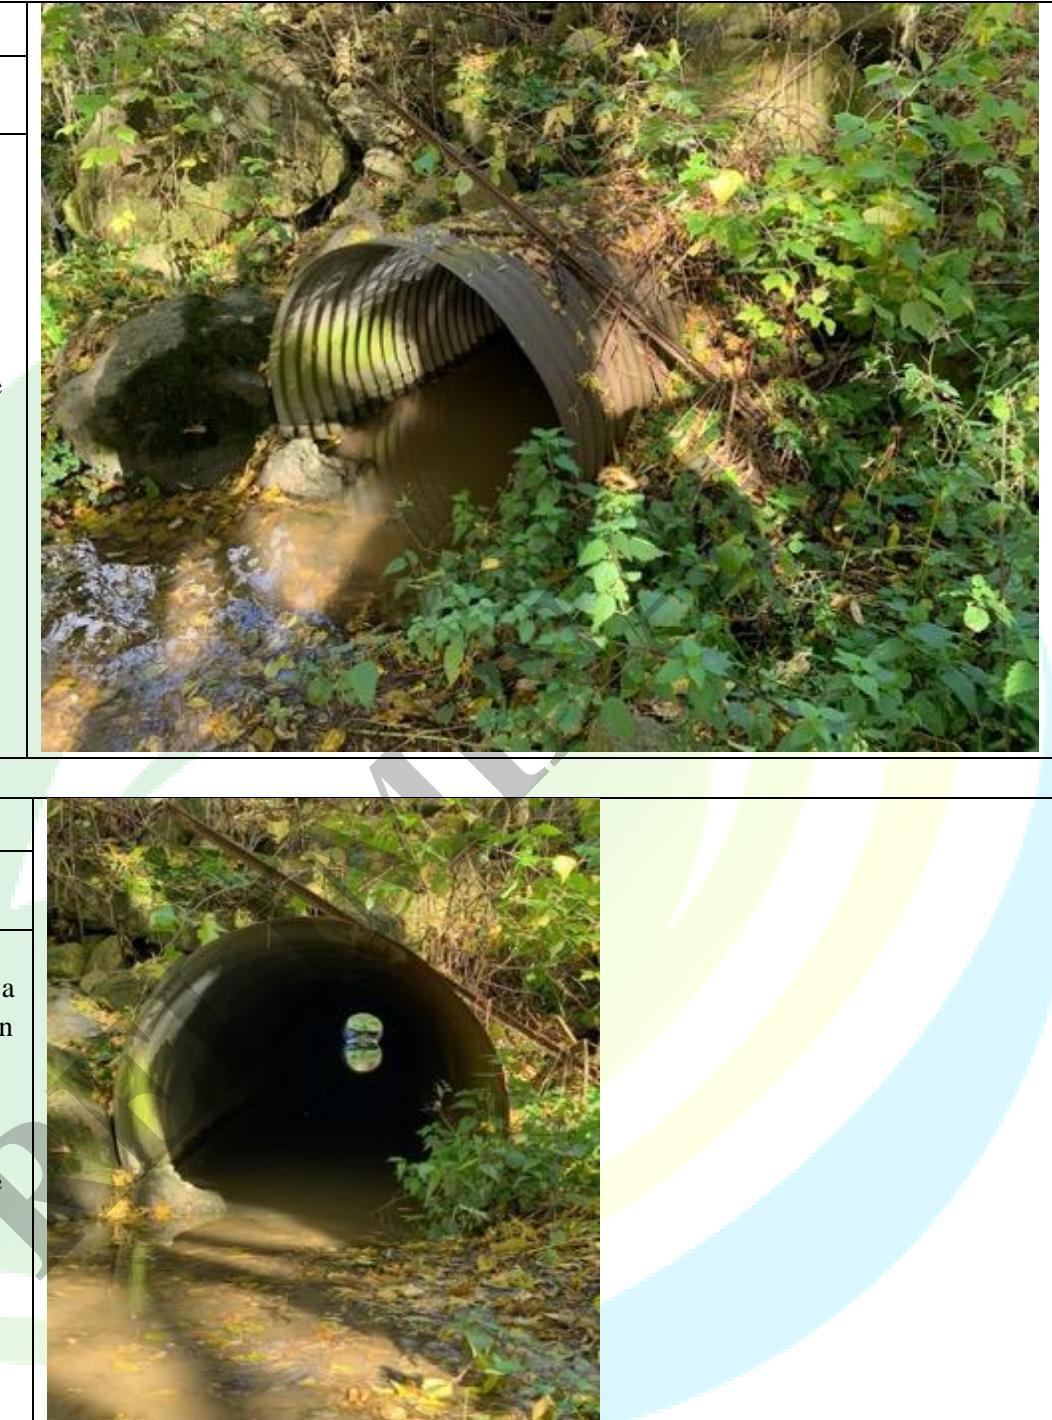
Date: October 13, 2020 **Description:** Another view of a culvert, present in proximity to the south-facing rocky slope present along the edge of Bridge Street. This culvert likely allows the safe passage of wildlife under Bridge Street.

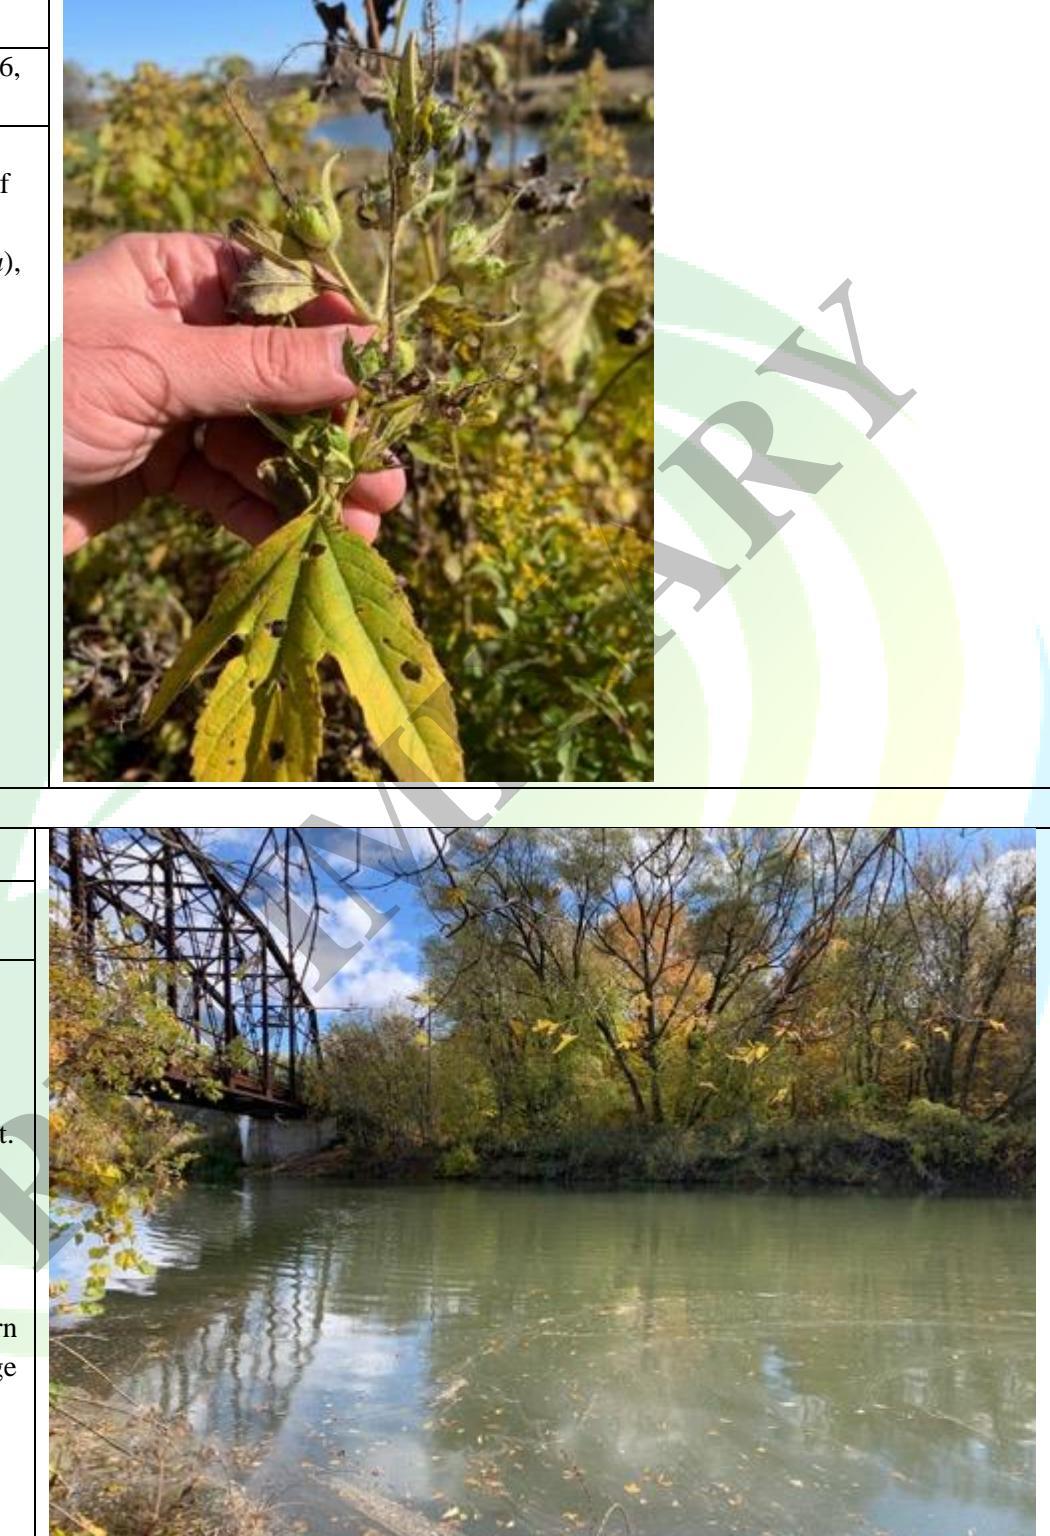
Date: October 16, 2020 Description: View, looking east, from the south side of the western abutment. Water depth (Transect 1) was measured across the River, just under the southern edge of the Bridge Street Bridge.
